INTERGRANULAR CRACKING OF INOR-8 IN THE MSRE

H. E. McCoy
B. McNabb

ORNL-4829
UC-25 — Metals, Ceramics, and Materials

NOVEMBER 1972

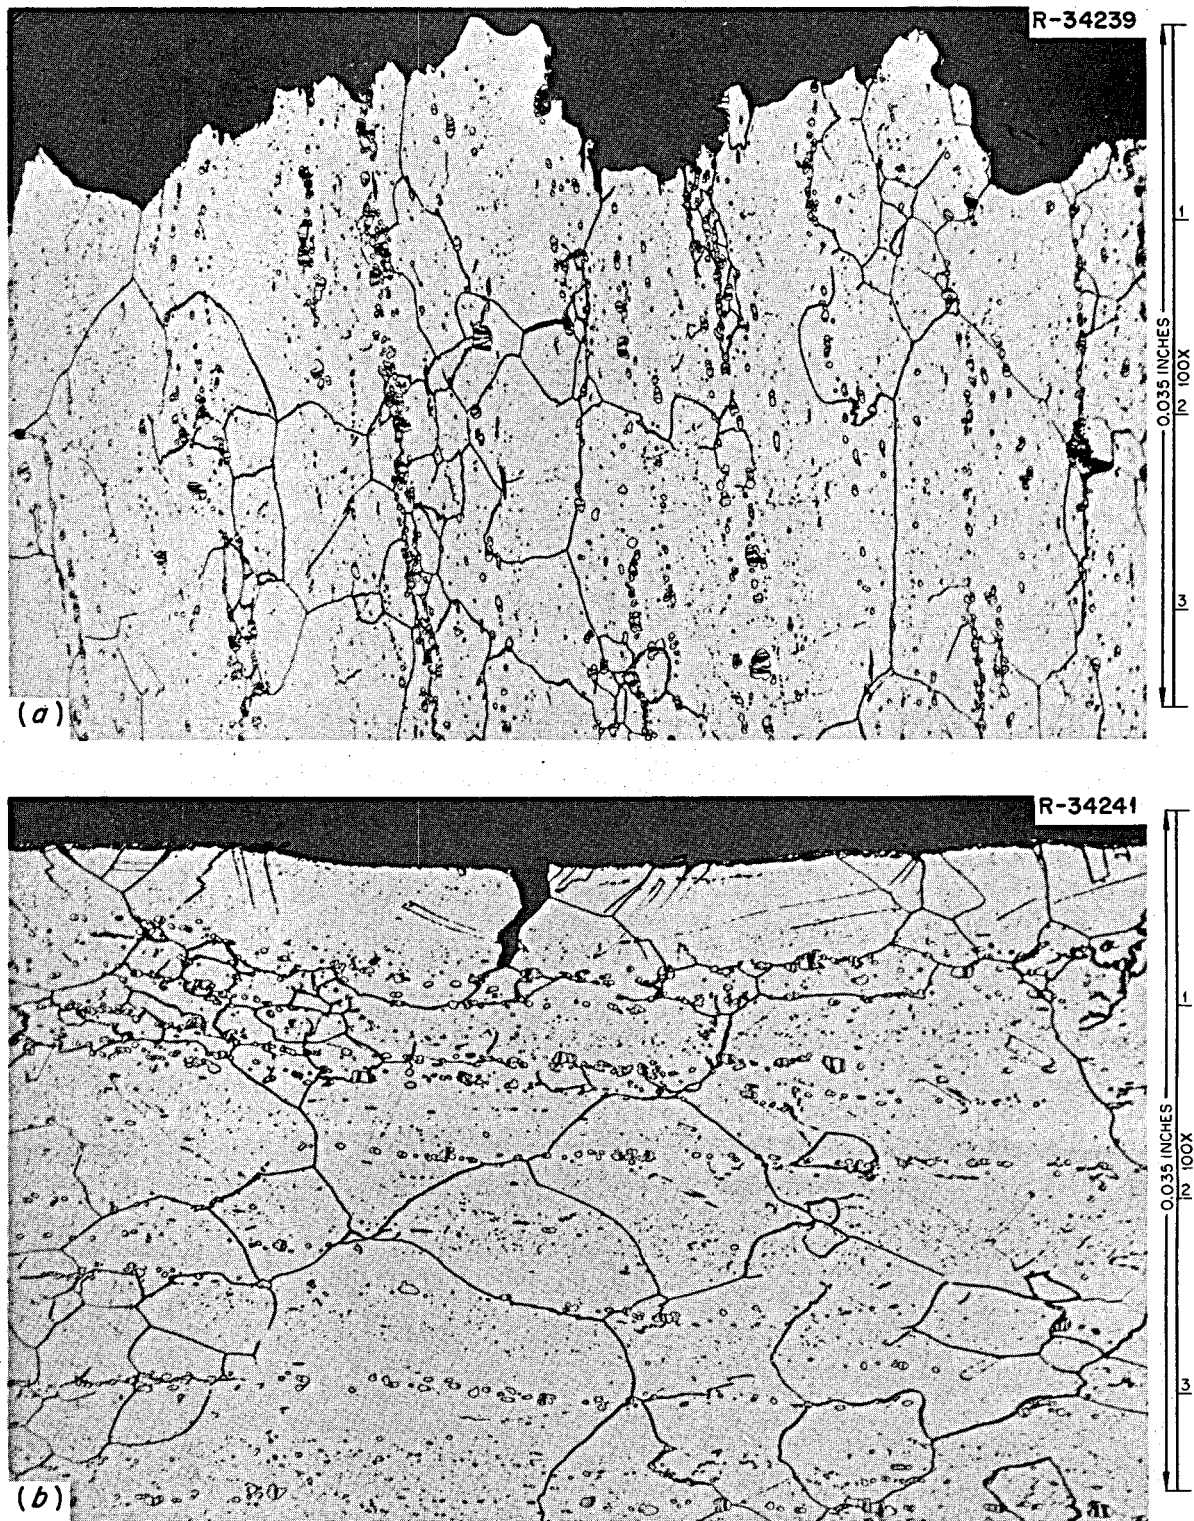
Specimens of both heats exposed in the control facility and tested in tension showed no cracks except very near the fractures. The core specimens of both heats, on the other hand, showed several intergranular cracks along the gage lengths. The difference is clearly shown in Fig. 12, which is a composite of photomicrographs of longitudinal sections of strained control and core specimens of heat 5085. Pictures of the sections along the entire gage lengths were examined to determine

Fig. 11. Photomicrographs of Surveillance Specimen A-16 from Heat 5085 Tested at 25°C and at a Strain Rate of 0.05/min. (a) Fracture. (b) Edge of Specimen about 1/4 in. from fracture. Etchant: glyceria regia.

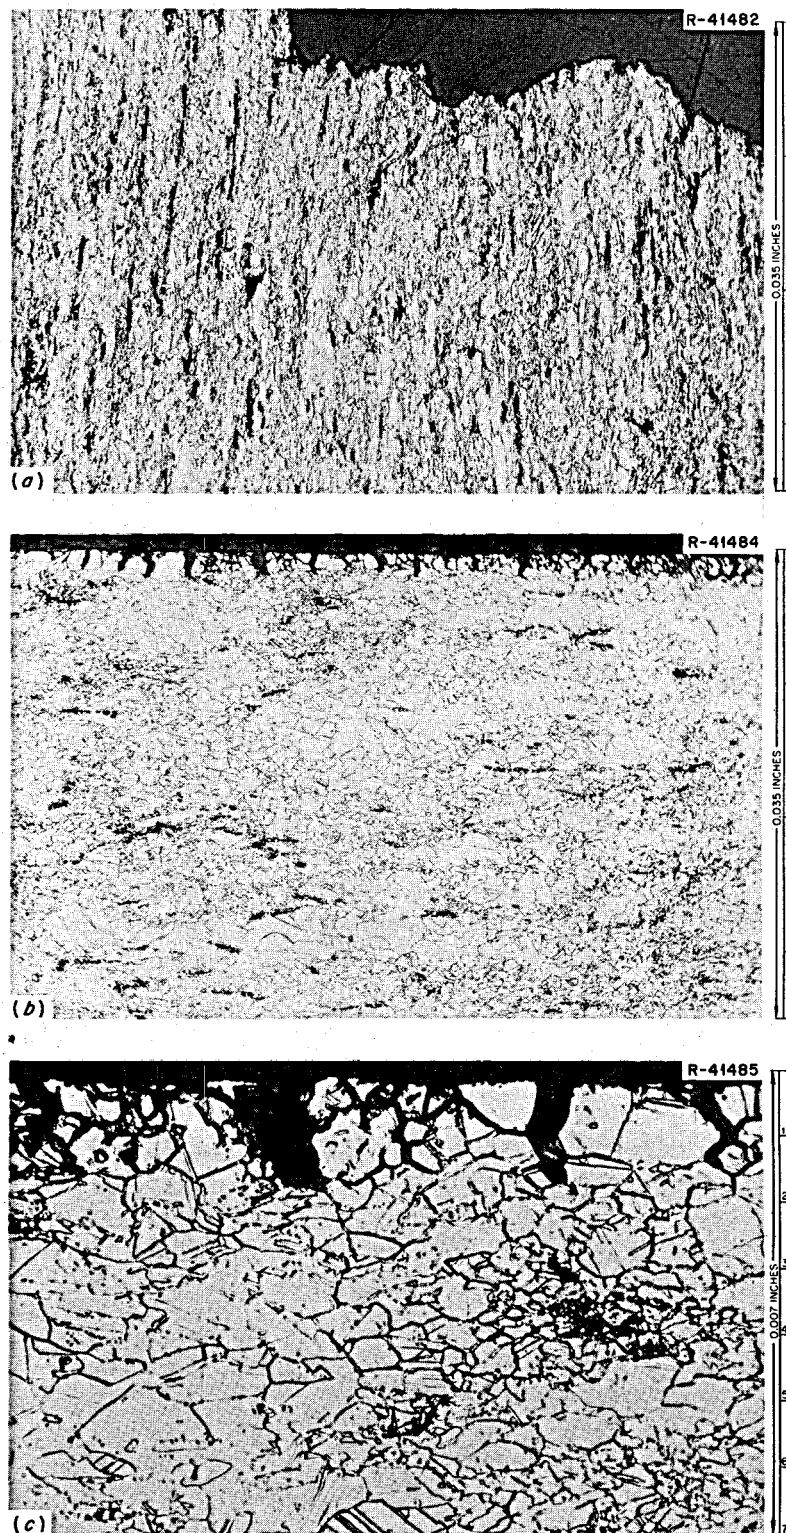
Core specimens of both heats tested to failure in tension developed numerous intergranular cracks along the surfaces, while control specimens tested similarly showed few or no surface cracks. The difference is illustrated in Figs. 15-18. Figure 15 and 16 are control and core specimens respectively of heat 21554. In the core specimen surfaces nearly every grain boundary is cracked to a consistent depth of about 2 mils. In the control specimen there is no evidence of intergranular edge cracking. Figures 17 and 18 show the same thing for heat 21545.

Fig. 16. Photomicrographs of a Zirconium-Modified INOR-8 Surveillance Sample (Heat 21554) Tested at 25°C at a Strain Rate of 0.05/min. Exposed in the MSRE core for 5554 hr above 500°C to a thermal fluence of 4.1×10^{20} neutrons/cm². Etchant: aqua regia. (a) Fracture. 100x. (b) Edge of sample about 1/2 in. from fracture. 100x. (c) Edge of sample showing edge cracking. 500x. Reduced 31.5%.

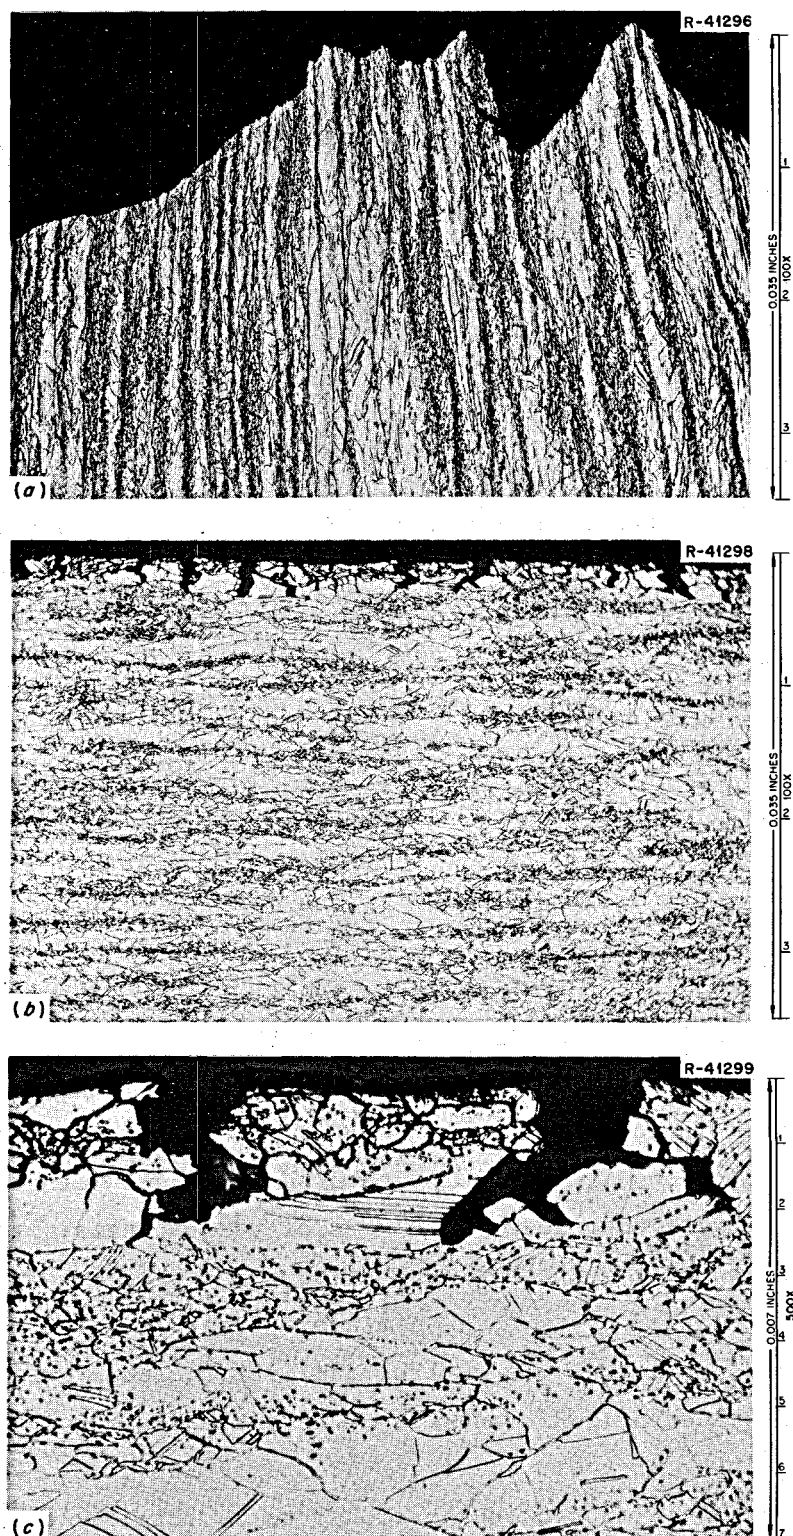
Fig. 18. Photomicrographs of a Titanium-Modified INOR-8 Surveillance Sample (Heat 21545) Tested at 25°C at a Strain Rate of 0.05/min. Exposed in the MSRE core for 5554 hr above 500°C to a thermal fluence of 4.1×10^{20} neutrons/cm². Etchant: aqua regia. (a) Fracture. 100x. (b) Edge of sample about 1/2 in. from fracture. 100x. (c) Edge of sample showing edge cracking. 500x. Reduced 32%.

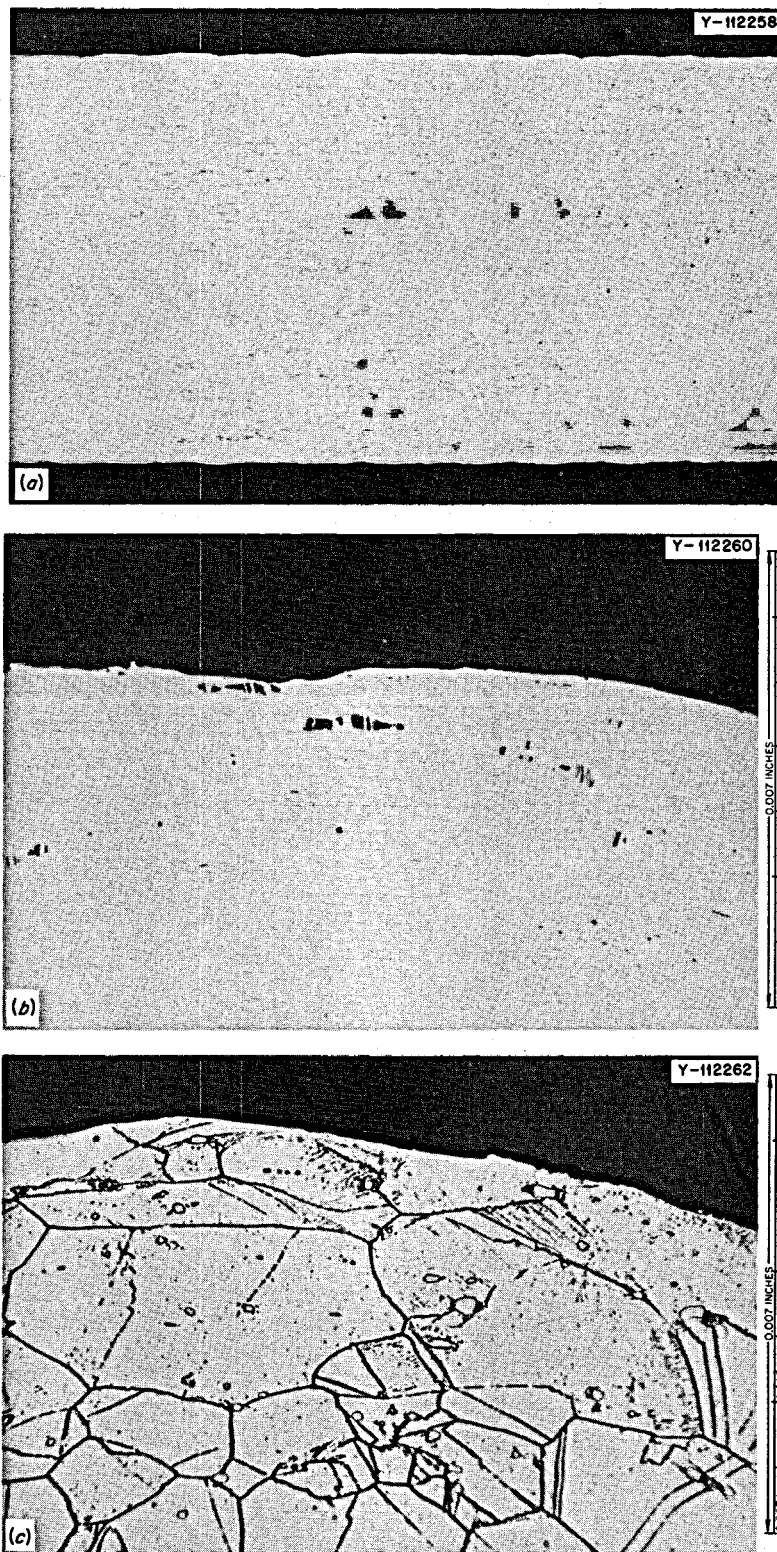
Fig. 40. Photomicrographs of INOR-8 (Heat 5055) Straps Exposed to Static Unenriched Fuel Salt 7203 hr Above 500°C. (a) As-Polished 33x, (b) As Polished, 500x, cracked regions are carbide that fractured during initial forming, (c) Etched with glyceric regia, 500x. Reduced 33%.

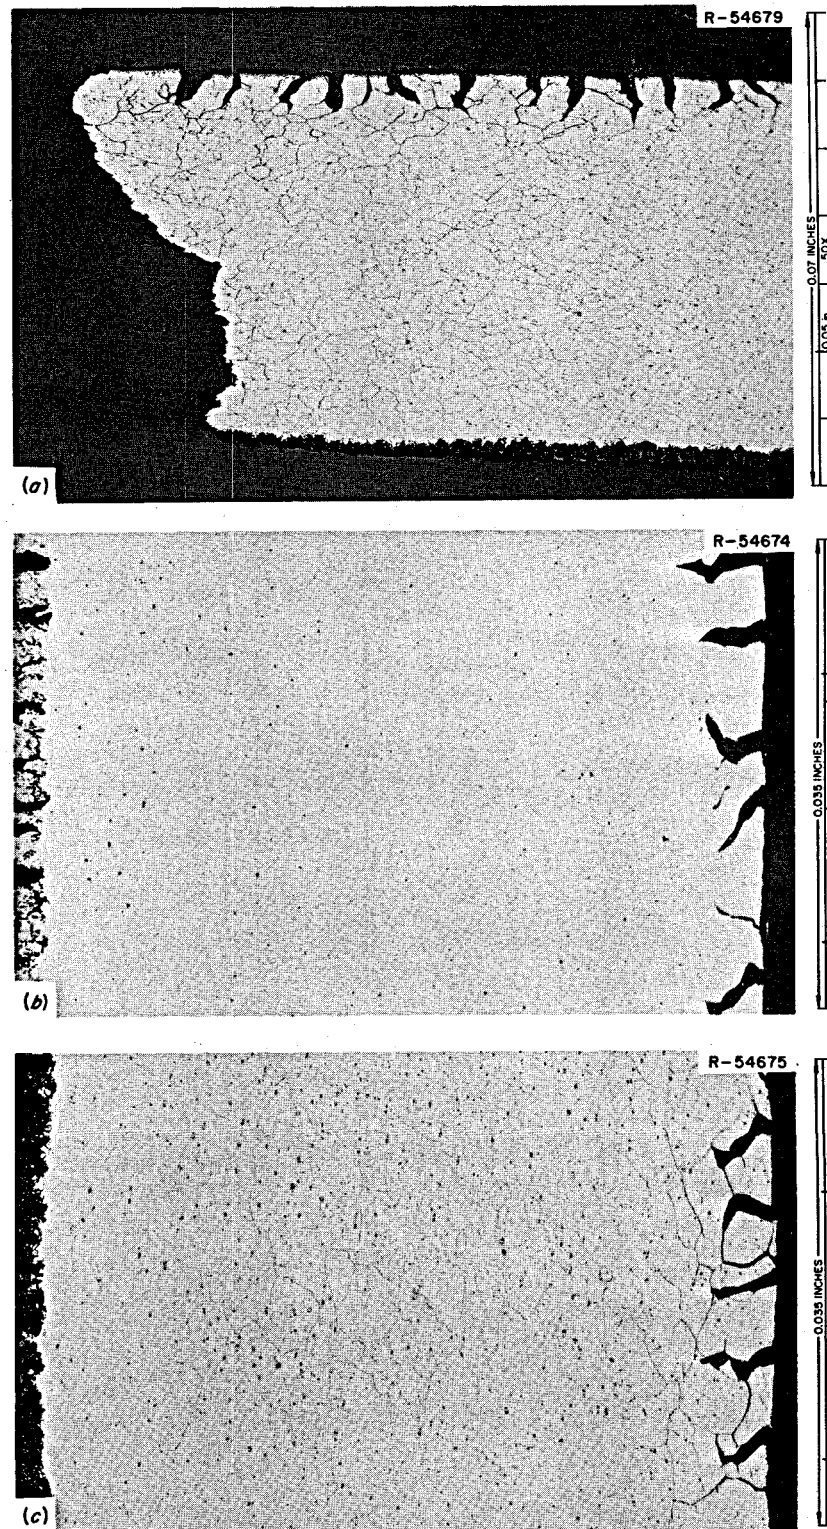
Fig. 68. Photomicrographs of Control Rod Thimble Specimen Exposed to Flowing Salt and Tested at 25°C. (a) Fracture - dark edge is oxide on inner surface of tube, and cracks formed on the outer surface; etched. (b) Cracks in outer surface of tubing as polished. (c) Cracks in outer surface of tubing etched. Etchant: Aqua regia. Reduced 30.5%.

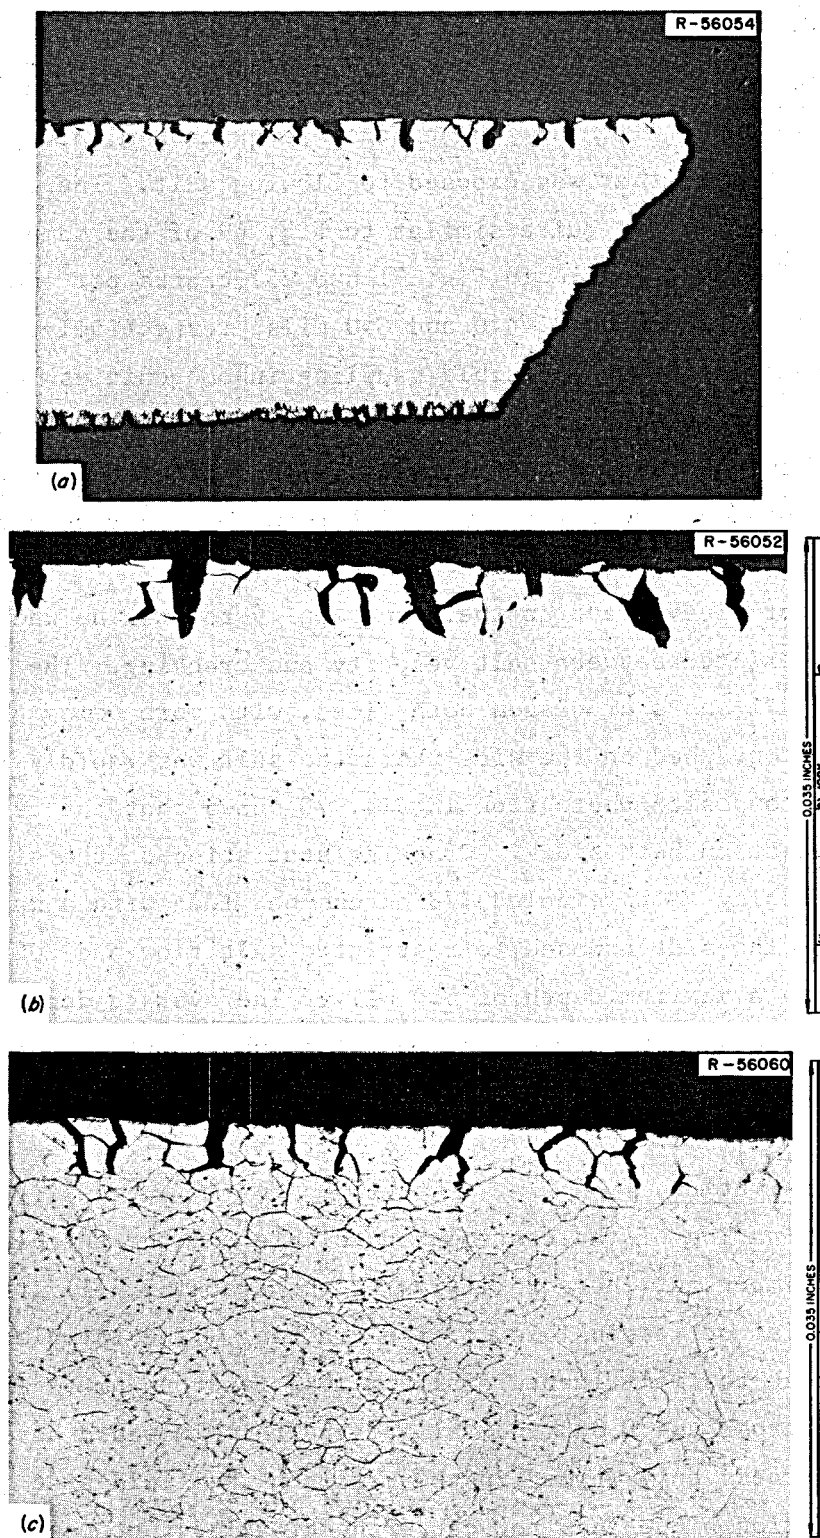
Fig. 70. Photomicrographs of Control Rod Thimble Exposed to Fuel Salt Under a Spacer Sleeve and Tested at 25°C. (a) As-polished view of fracture. 40x. (b) As-polished view of cracks. (c) Etched view of cracks. Etchant: Aqua regia. Reduced 30.5%

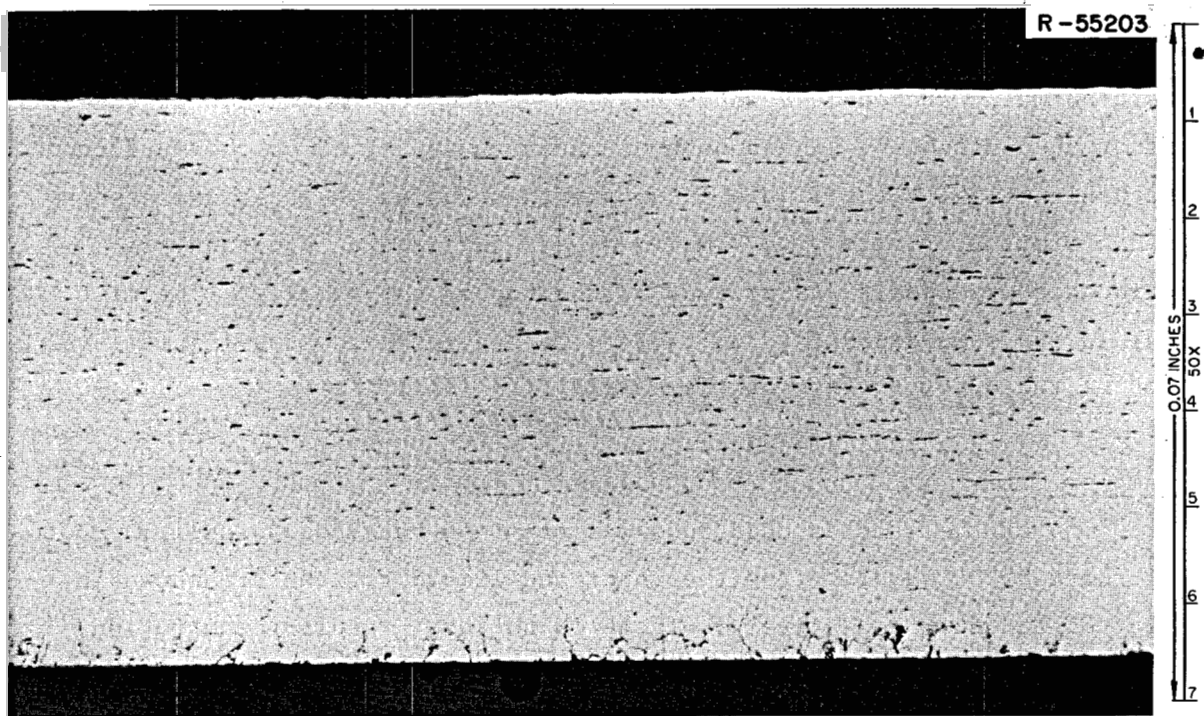
Fig. 82. Photomicrograph of Heat Exchanger Tubing in the Unstressed Condition. The side with the small cracks was exposed to fuel salt and the other was exposed to coolant salt.
