ORNL-2833
UC-25 - Metals, Ceramics, and Materials

CORROSION ASSOCIATED WITH
HYDROFLUORINATION IN THE
OAK RIDGE NATIONAL LABORATORY
FLUORIDE VOLATILITY PROCESS

METALLURGY DIVISION

A. E. Goldman and A. P. Litman

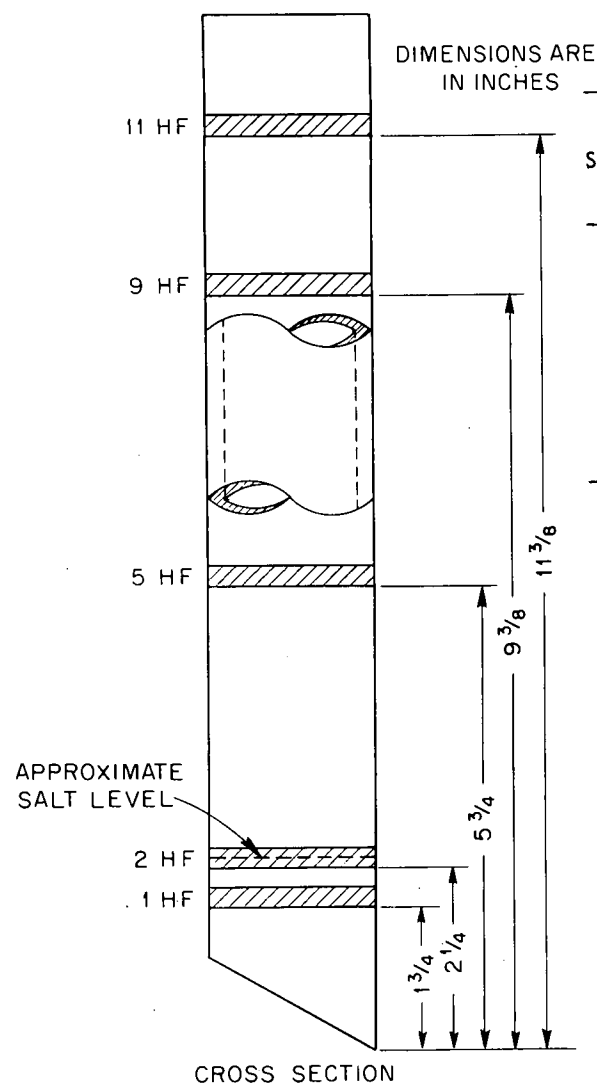
The Inconel Hot-Facility Hydrofluorinator Dissolver demonstrated poor resistance to the Volatility Process dissolution environment. Both the salt bath region and the salt-vapor interface region had corrosion rate losses

Section	Region	Estimated Operating Temperature (°C)	Maximum Corrosion Rates (mils/month) ^a	Metallographic Observations
11 HF	Vapor	150	19	Smooth interior surfaces
9 HF	Vapor	250	32	Smooth interior surfaces
5 HF	Vapor	500	19	Slightly roughened interior
2 HF	Interface	600	32	Severe pitting attack – maximum depth of pits 2 mils
1 HF	Salt	600	38	Irregular interior surfaces – appearance of pitting-type attack and subsequent washing action

Fig. 2. Regional Corrosion Losses and Metallographic Observations for the Inconel Hot-Facility Hydrofluorinator Dissolver.

greater than 30 mils/month. In addition, a portion of the middle vapor region also had losses of the same magnitude. Of particular interest are the metallographic sections removed from these three major loss regions which are pictured in Fig. 3. The salt and salt-vapor interface samples had extremely rough surfaces and showed evidence of pitting attack. However, the sample removed from the middle vapor region had a smooth surface and no indication of preferential corrosion was noted.

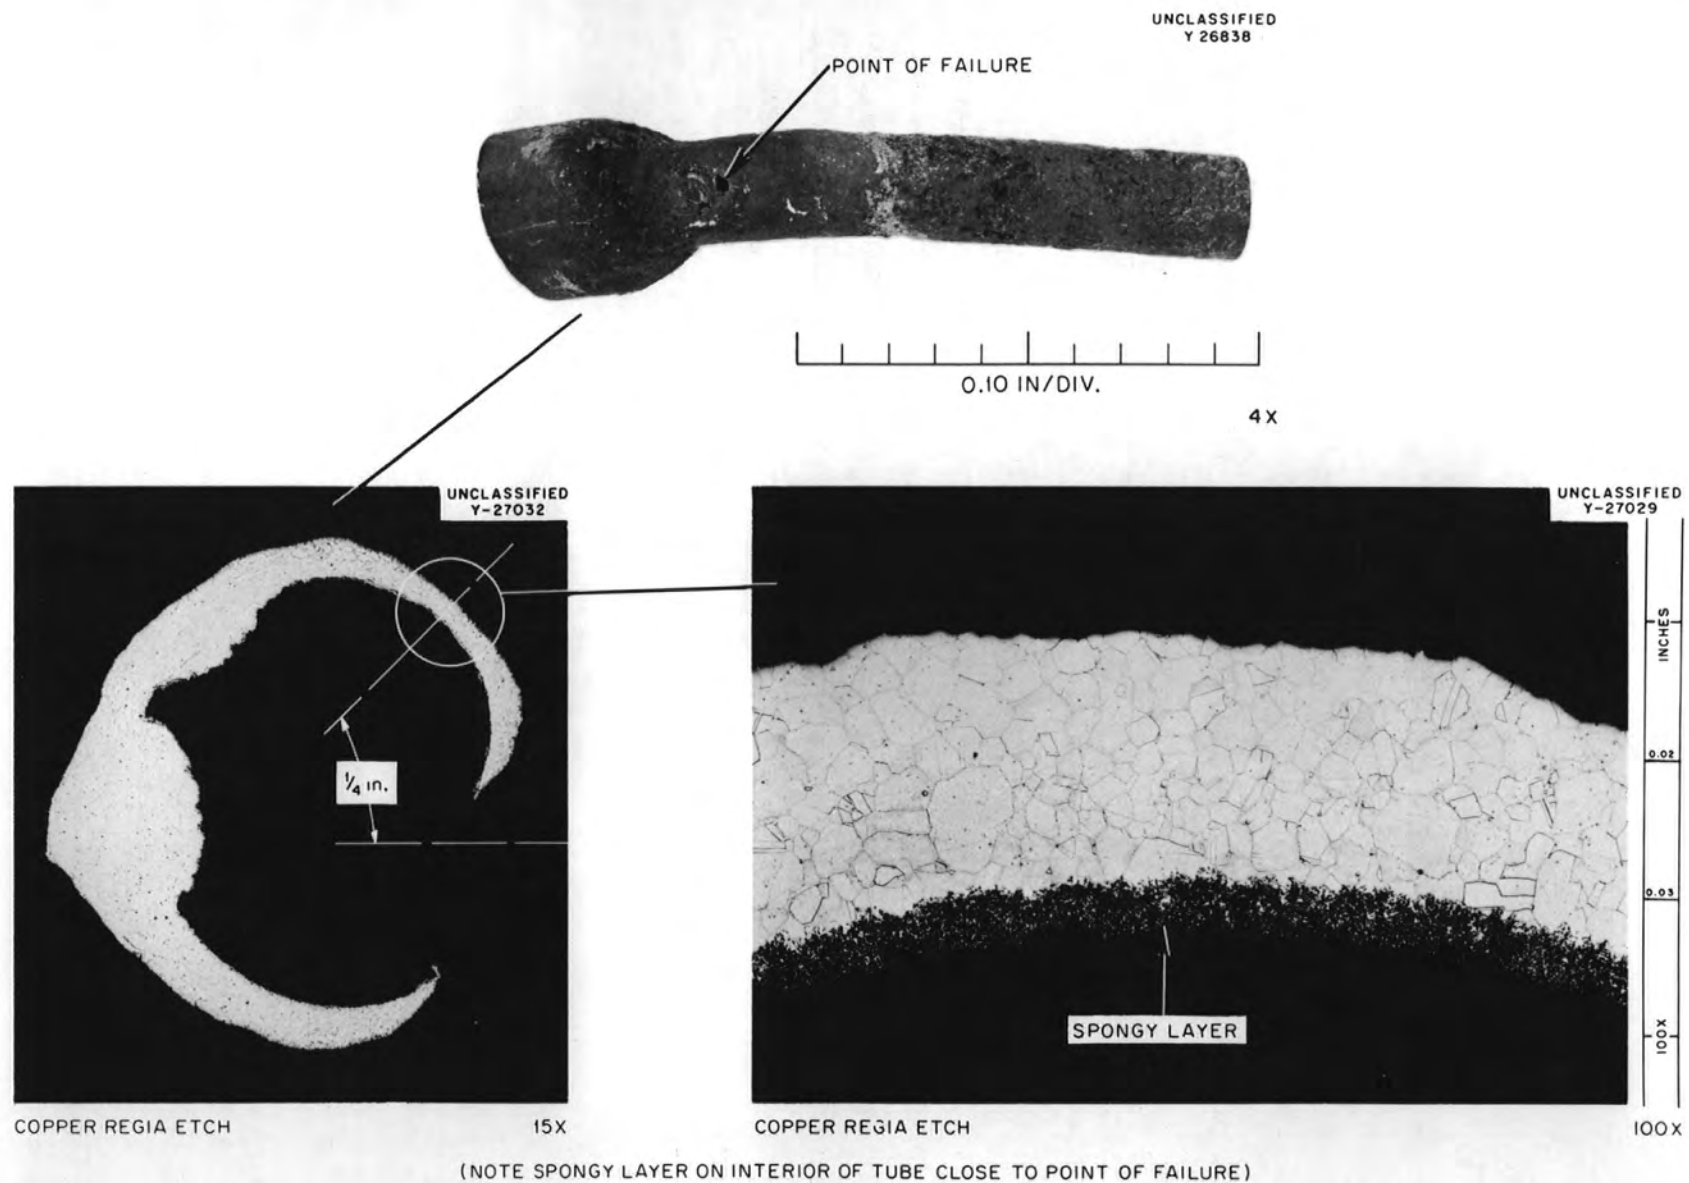
Following the exposure listed above, failure occurred in the salt-transfer line at a point 1/8 in. above the tube-to-pipe weld shown in Fig. 4. The failure permitted molten salt to drain out, filling the recess between the vessel and the external furnace wall and reacting vigorously with the vessel's external surfaces. Figure 5 illustrates the point of failure and corroded exterior surfaces.

Visual and metallographic examination of the failure area revealed that the cross section of the transfer line had been reduced prior to service because of field repairs made on the adjacent socket weld (Fig. 5) and that a porous corrosion product layer was visible on the interior of the pipe close to the point of failure.

The corrosion product layer on the interior wall of the Inconel salt-transfer line was 0.004 in. thick and had the characteristic appearance of Inconel from which chromium has been selectively leached. The corrosion product and the Inconel line in proximity to the failure were highly ferromagnetic. It has been reported previously that hydrogen fluoride, produced from the contact of fluoride with moist air in a fluoride salt system, preferentially removes chromium from Inconel.^{4,5} No analysis of the product layer was obtained because of the small amounts available.

The failure described apparently occurred when the previously thinned weld repair area was weakened further by corrosion to the point where it could not withstand the internal salt pressure of a regular salt transfer. The failure allowed molten salt to flow outward, greatly enlarging the original hole. No further study was carried out on the vessel. Presumably, similar corrosive attack had occurred on the parts of the vessel in contact with salt and hydrogen fluoride.

Fig. 5. Salt-Transfer Line Failure from Inconel Hydrofluorinator Dissolver.

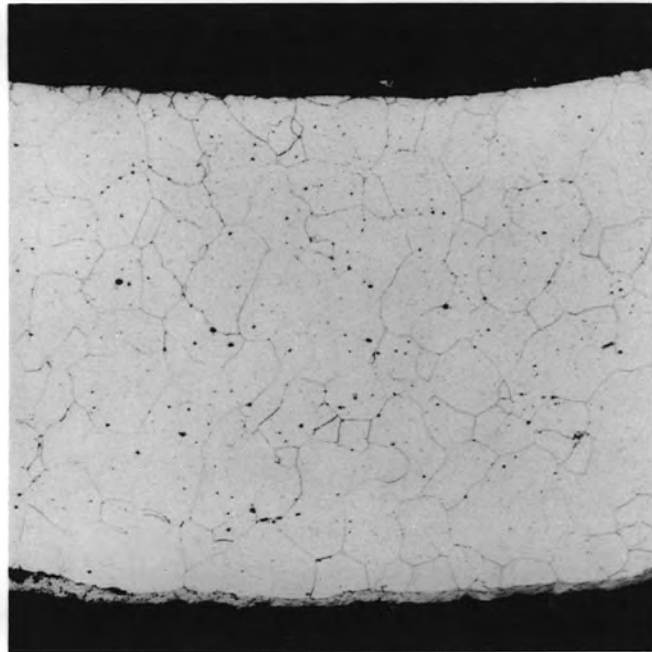
VAPOR-SALT INTERFACE SAMPLE

Maximum corrosive attack occurred on the hydrogen fluoride entry tube in the region of the vapor-salt interface. If the assumption is made that all corrosion occurred during the hydrogen fluoride sparge, the rate loss for this area would be 6.5 mils/month for the combined inside and outside-diameter losses or 3 mils/month for the outside diameter in contact with the hydrofluorination environment. These rates were unusually low and lent impetus toward building a semiworks-size INOR-8 hydrofluorinator dissolver discussed below.

← DEPOSIT

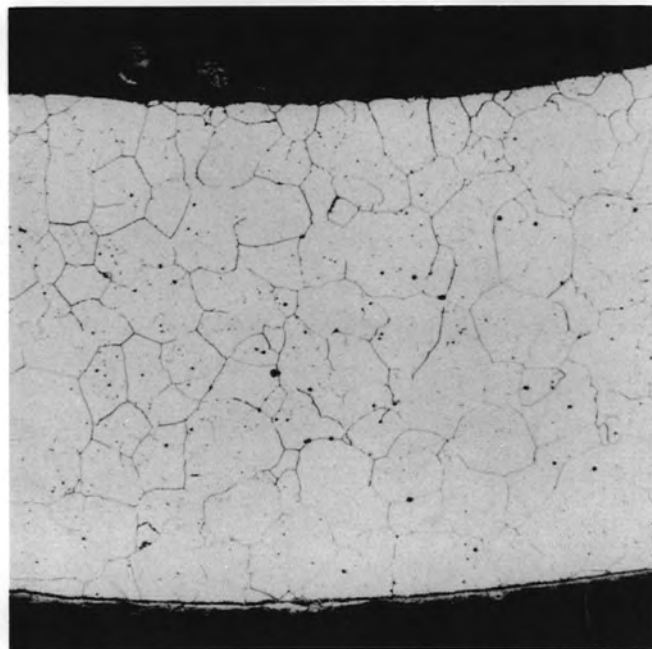
SALT PHASE SAMPLE

← DEPOSIT

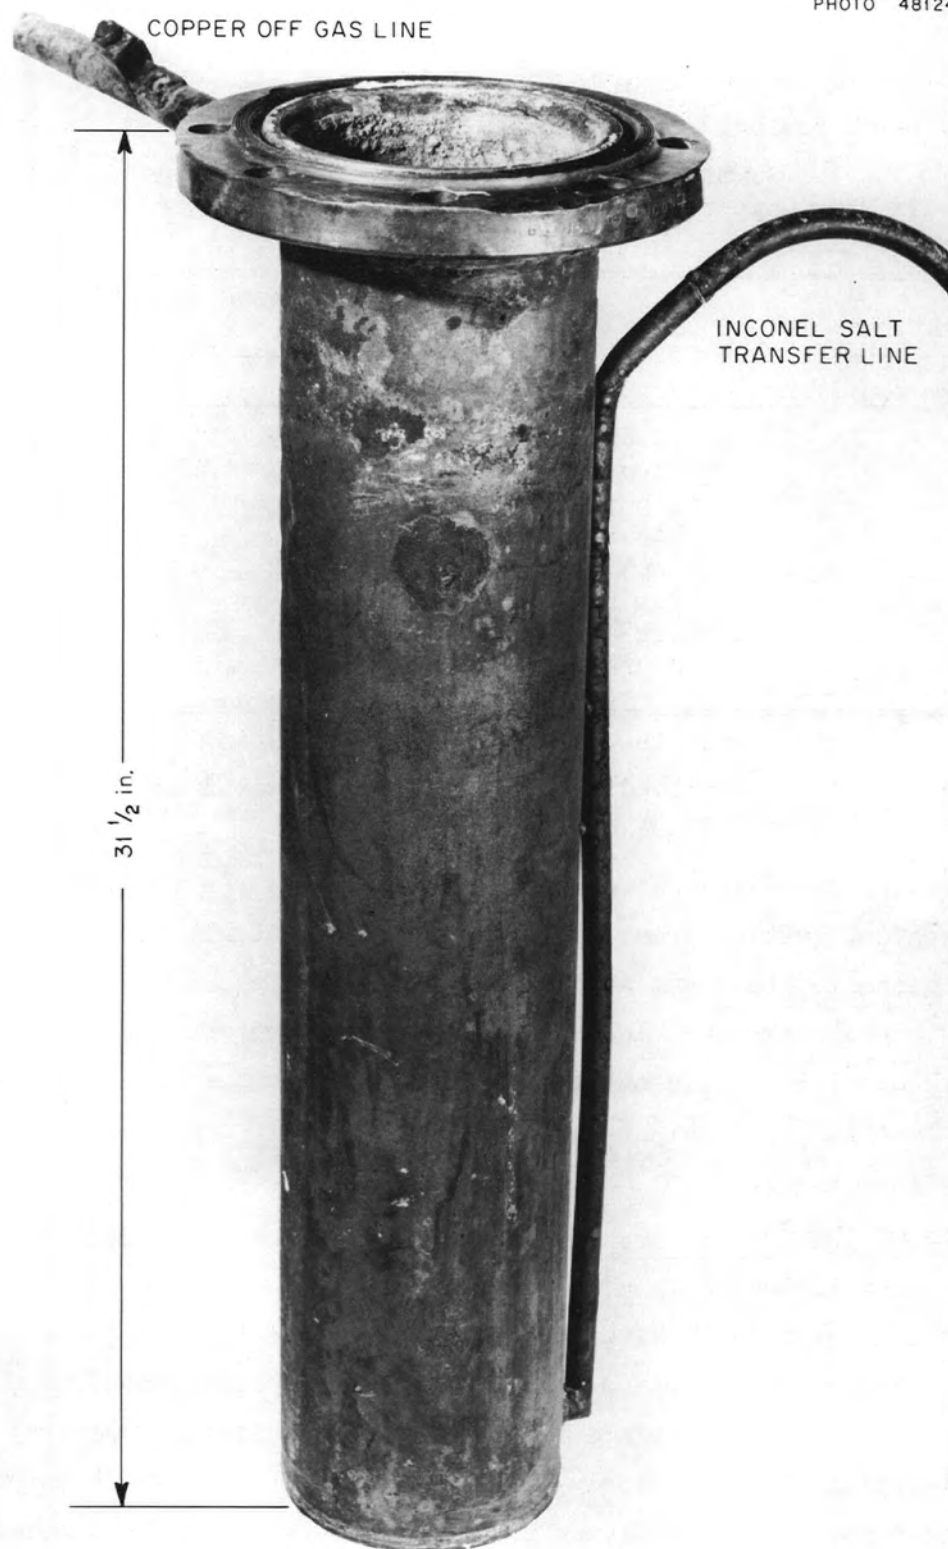
UNCLASSIFIED
PHOTO 48124

Varying amounts of surface roughening, indicative of corrosive attack, were noted on the interior walls of the vessel. The roughening appeared to increase in the lower regions and some pitting attack was evident from the middle interface area down through the salt area.

Fig. 11. Mark I Copper-Lined Hydrofluorinator
Dissolver after 24 Dissolution Runs.

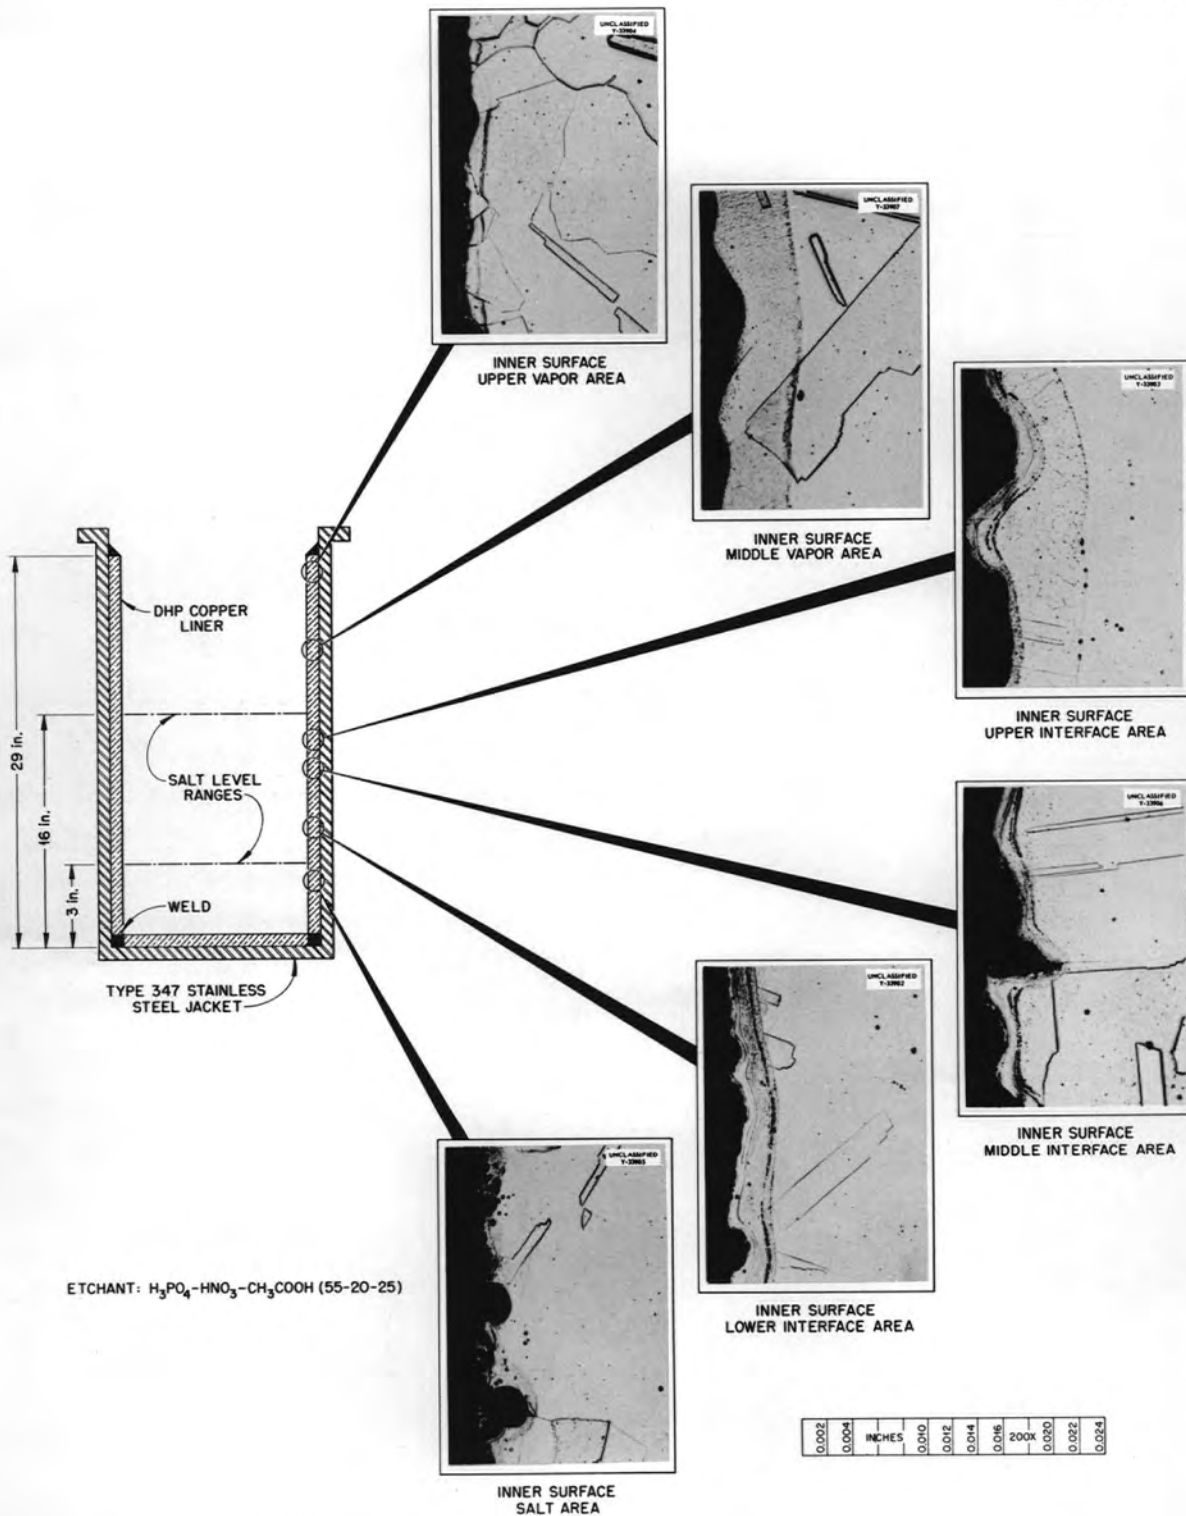
Fig. 12. Typical Microstructures of Samples from the Copper Liner of the Mark I Hydrofluorinator Dissolver. Etchant: Phosphoric-acetic-nitric acid. Reduced 62%. 200X.

specimens showed duplex layers and at various distances below the surface the layers appeared to be separated by alignment of voids. Of particular interest were the particles in the subscale of the upper interface specimen in that they seemed to be deposited in subgrain boundaries.

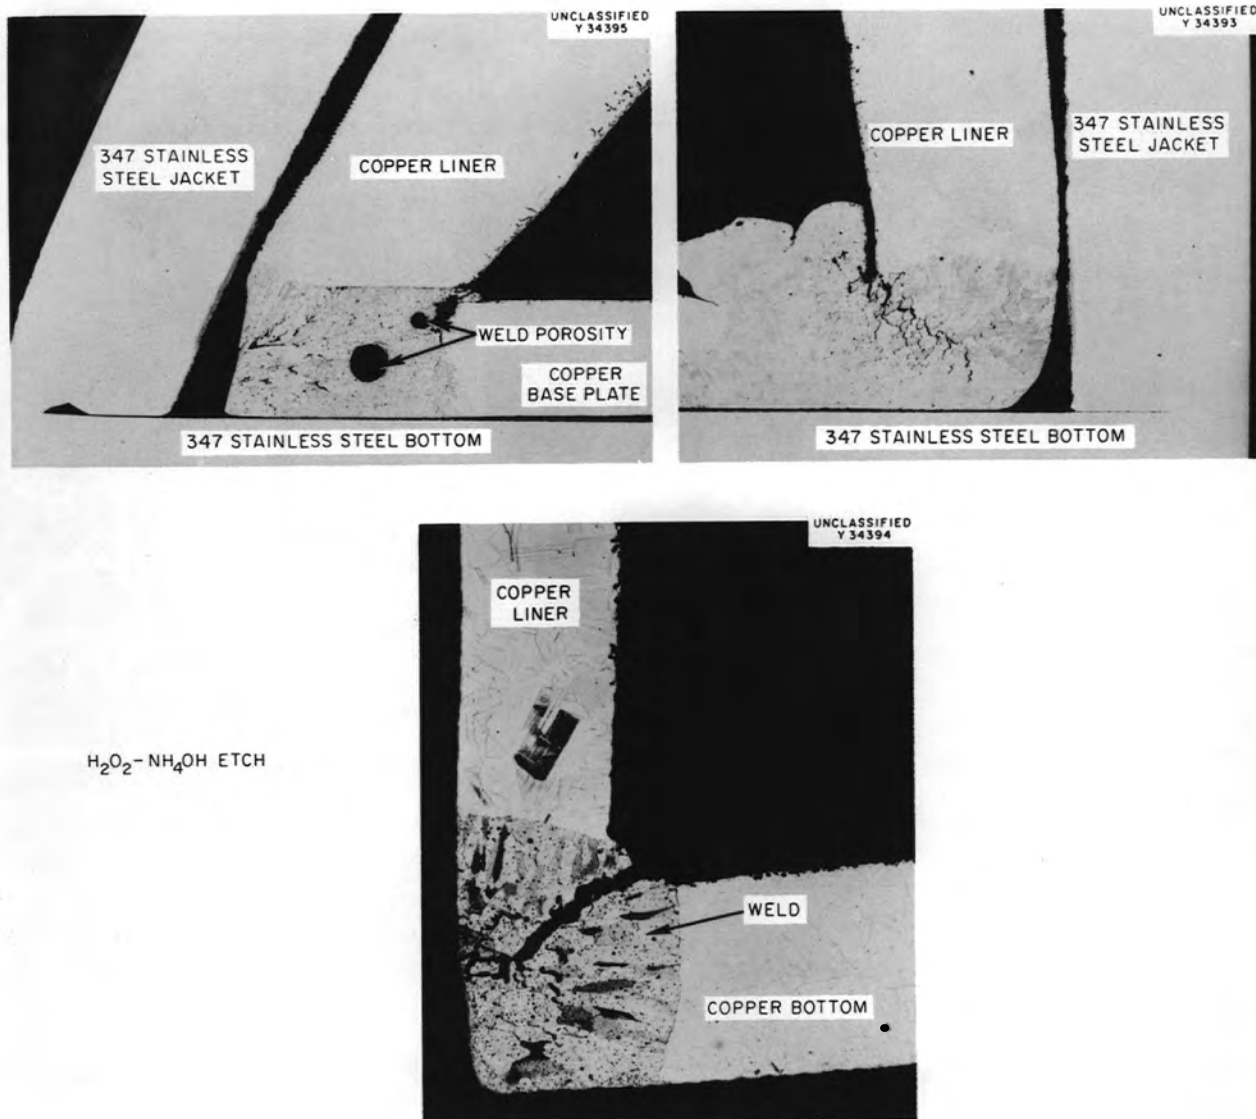
Fig. 13. Typical Microstructures of Copper Liner-to-Bottom Head Weld from the Mark I Hydrofluorinator Dissolver. Etchant: Hydrogen peroxide-ammonium hydroxide. 5X.

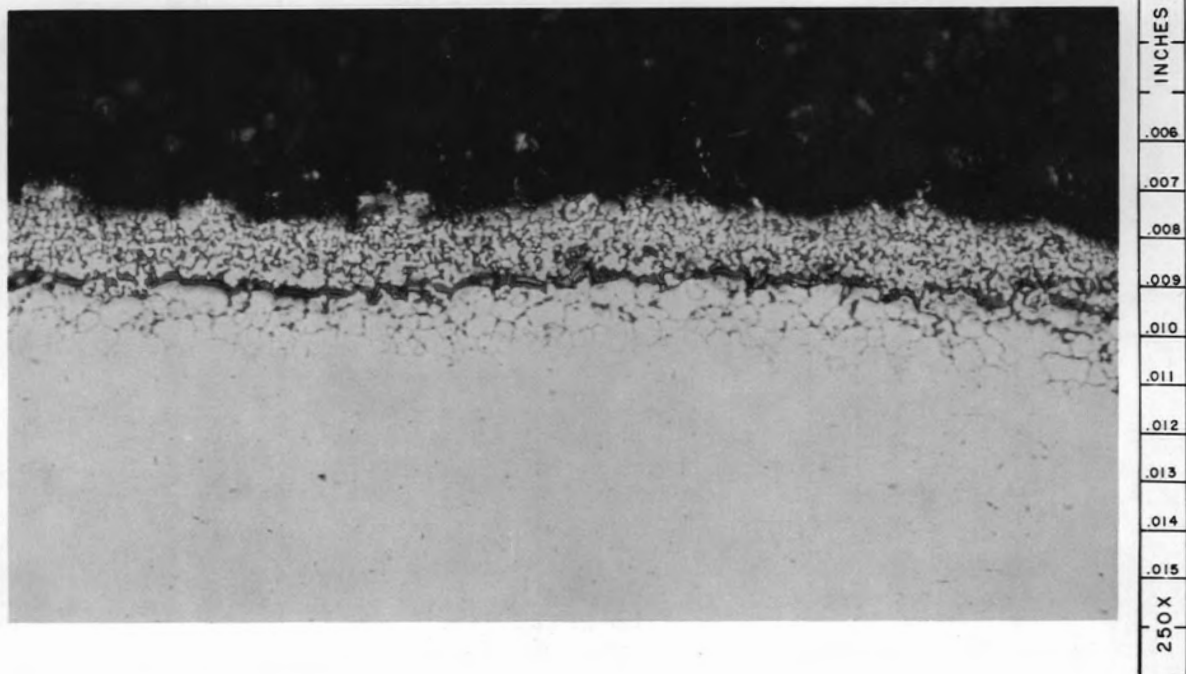
Fig. 14. Photomicrograph of Type 347 Stainless Steel Jacket from Copper-Lined Hydrofluorinator Dissolver. (Note spongy surface layer and intergranular modifications on side unintentionally exposed to the hydrofluorination environment.) As polished. 250X.

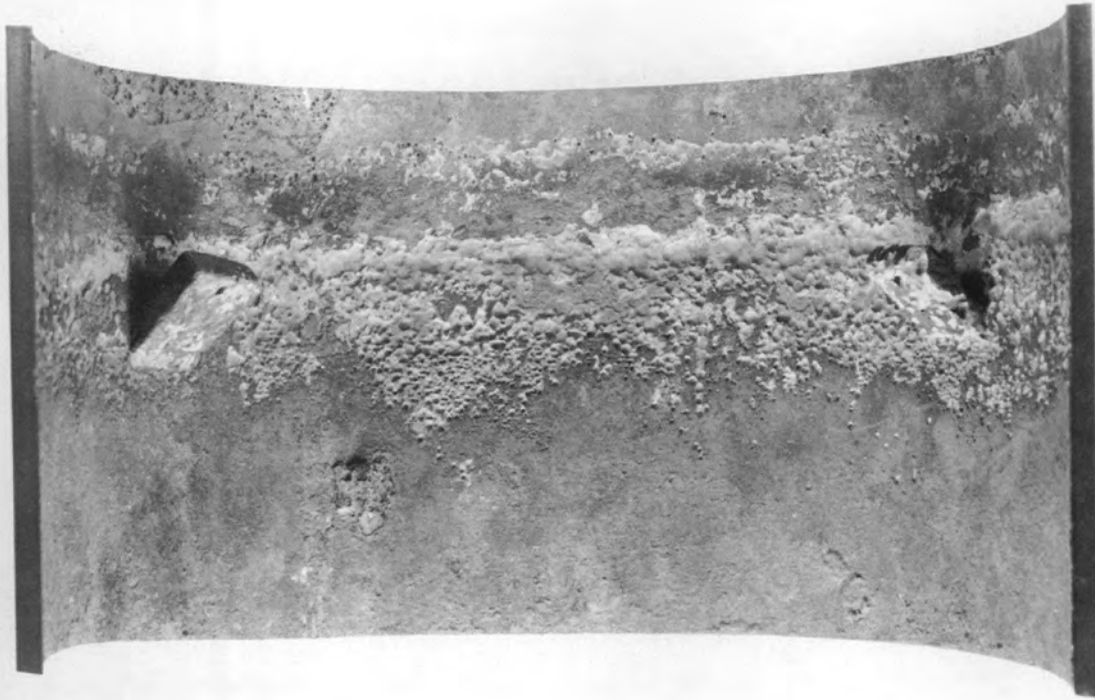
Unclassified
BMI 61958

Fig. 18. Appearance of the INOR-8 Hydrofluorinator Dissolver Vapor-Salt Interface Region after Ten Experimental Runs. (Most of the corrosive attack shown occurred during run No. 10 during which time zirconium metal was not dissolving.)

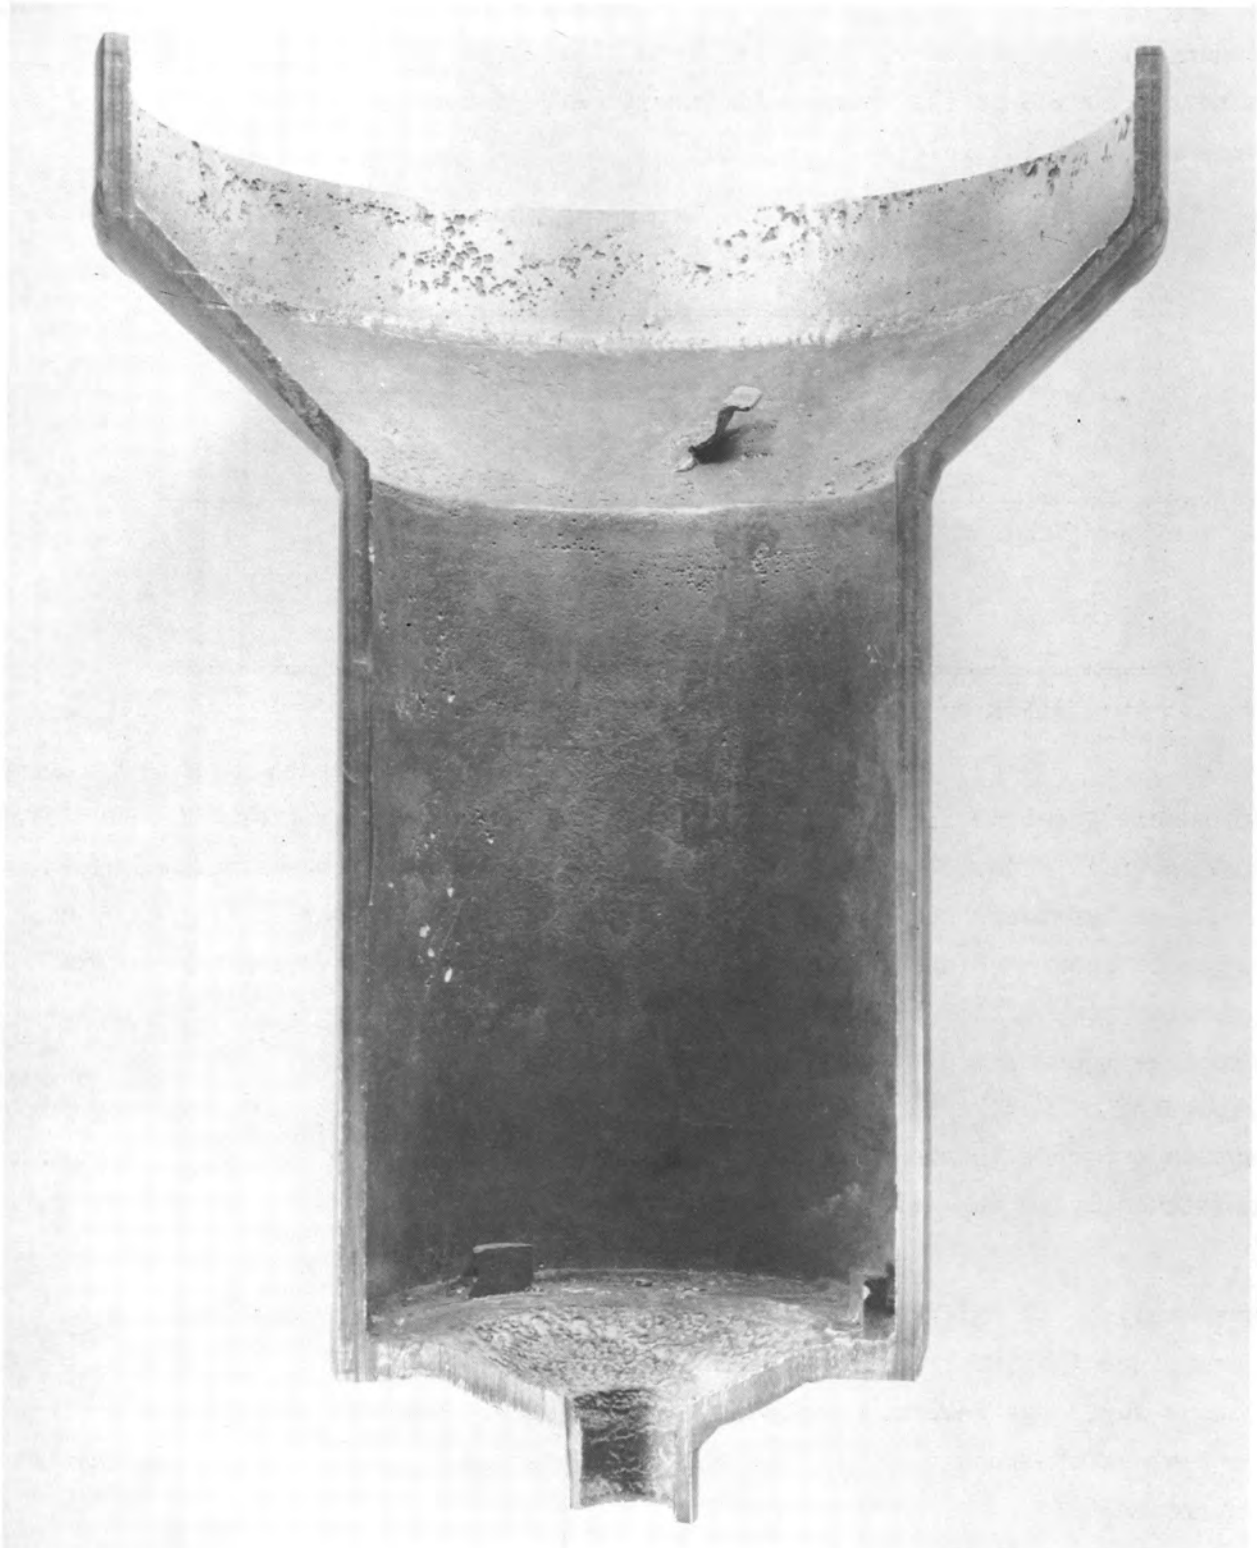
Unclassified
BMI 61959

Fig. 19. Appearance of the INOR-8 Hydrofluorinator Dissolver Salt Region after Ten Experimental Runs. (Most of the pitting attack occurred during the last run when bulk zirconium was not present.)

After the ten runs described, BMI personnel conducted a survey of the pitting attack and bulk-metal losses on the Mark I INOR-8 vessel. A summary of these data, shown in Table XII, indicates that the most severe attack occurred at the vapor-salt interface region. Pit depths up to 72 mils were noted in the interface region.

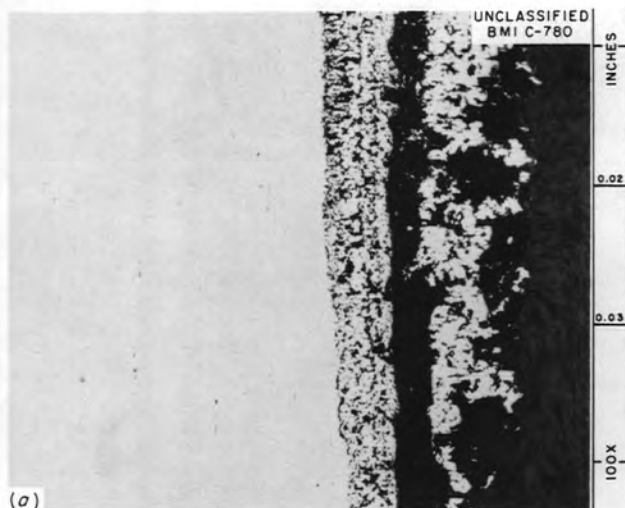
(4) Chemical Analyses. The surface layer shown in Fig. 21(a) was analyzed at BMI by spectrographic and wet analysis methods. Table XIII summarizes the information obtained on the major elements and indicates the porous layer was severely depleted in chromium and moderately depleted in iron content as the result of contact with the Volatility Process hydrofluorination environment.

100X UNETCHED
CROSS SECTION OF WALL SHOWING POROUS SURFACE LAYER

Fig. 20. Microstructures from the Mark I INOR-8 Hydrofluorinator Dissolver Vapor-Salt Interface Region Showing Typical (a) Corrosion Product, (b) Intergranular Attack, and (c) Pit Cross Section.

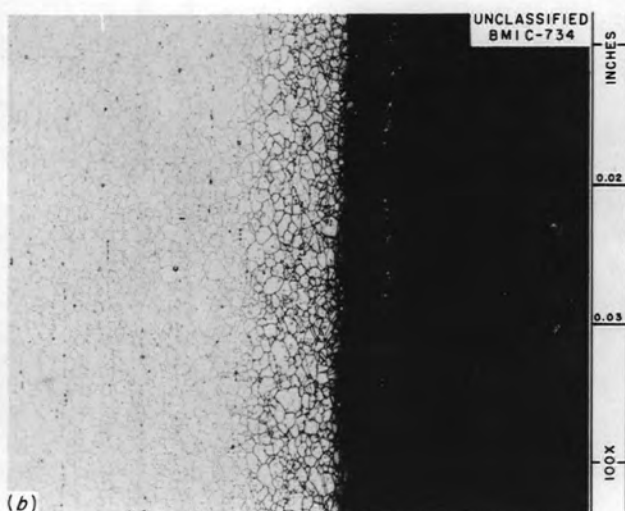
100X ETCH H_2CrO_4-HCl
CROSS SECTION OF WALL SHOWING SAME REGION AS ABOVE IN ETCHED CONDITION AND ILLUSTRATING INTERGRANULAR ATTACK

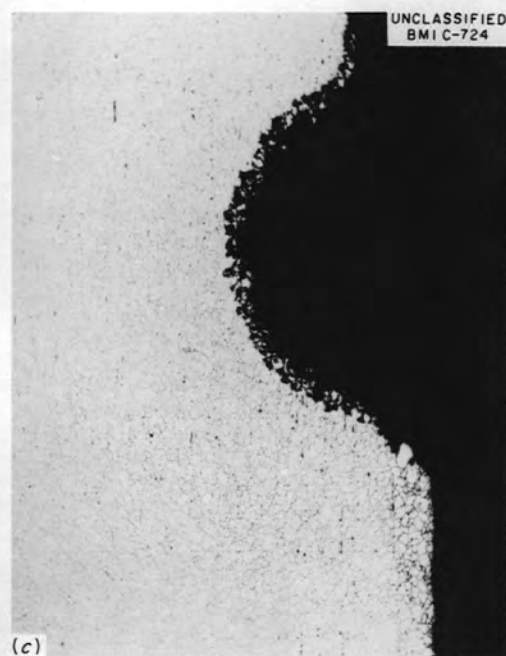
70X ETCH H_2CrO_4-HCl
CROSS SECTION OF TYPICAL PIT SHOWING SLOUGHING OF GRAINS AS THE RESULT OF INTERGRANULAR ATTACK

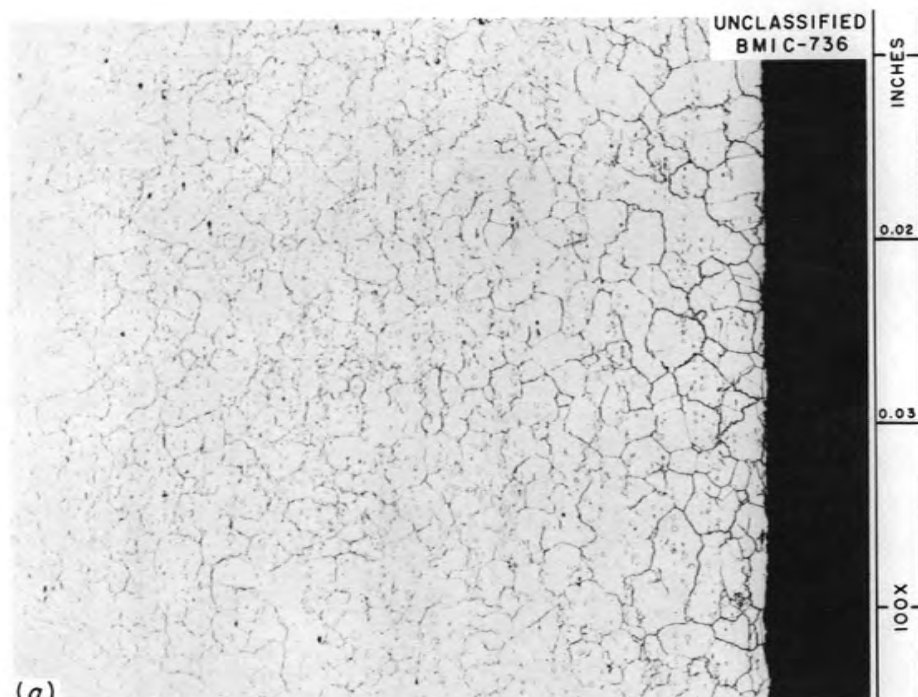
(a)

CROSS SECTION OF WALL FROM LOWER PORTION OF SALT
REGION IN PROXIMITY TO DRAFT TUBE

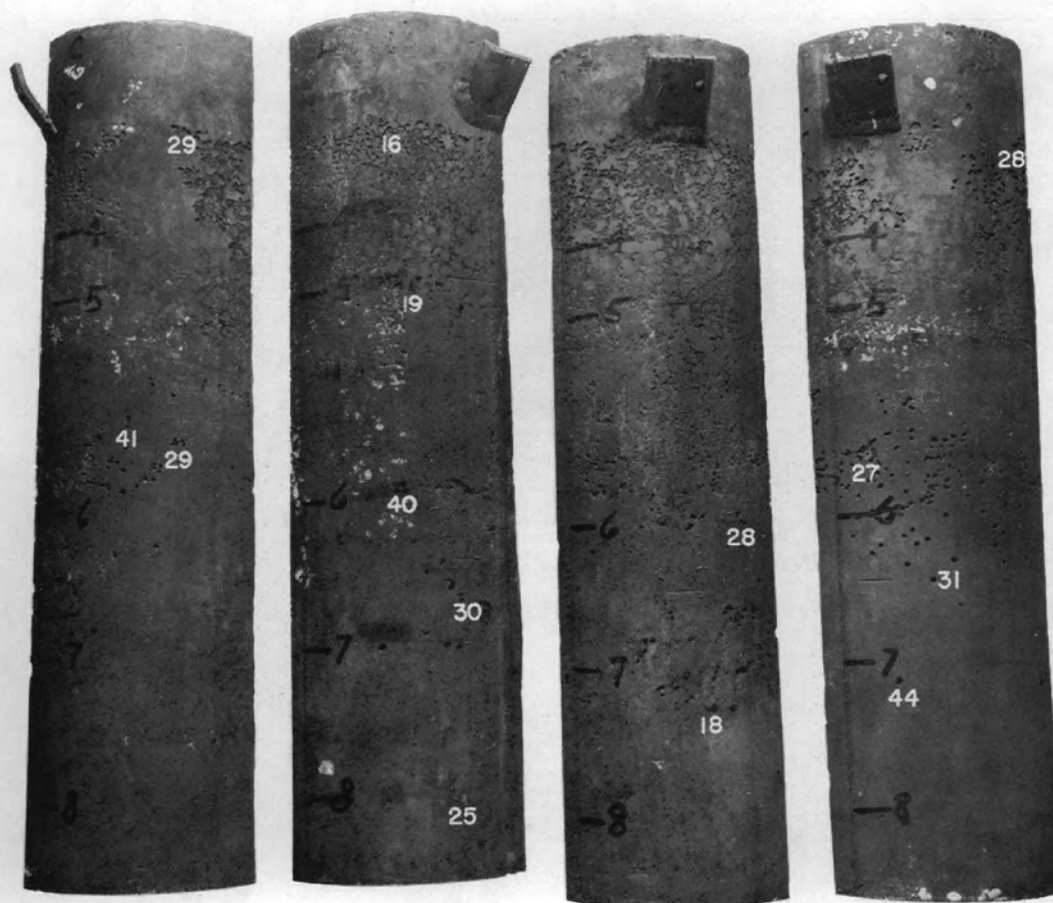
Unclassified
BMI N-60572

Fig. 22. Several Views of INOR-8 Draft Tube used in Mark I INOR-8 Hydro-fluorinator Dissolver. White numbers indicate pit depth in mils. Approximately one fourth actual size.

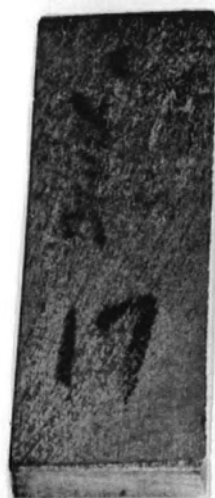
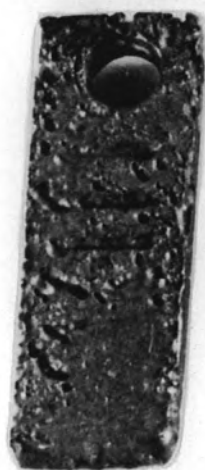
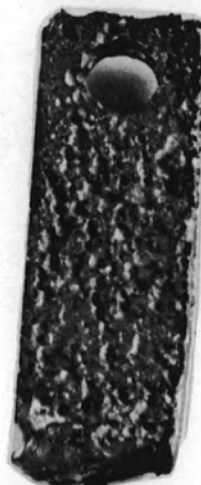
Fig. 25. Vapor-Salt Interface Corrosion Specimens Exposed during Runs No. 9 and 10 in the Mark I INOR-8 Dissolver. (Weight-loss data indicated all corrosion occurred during run No. 10.)

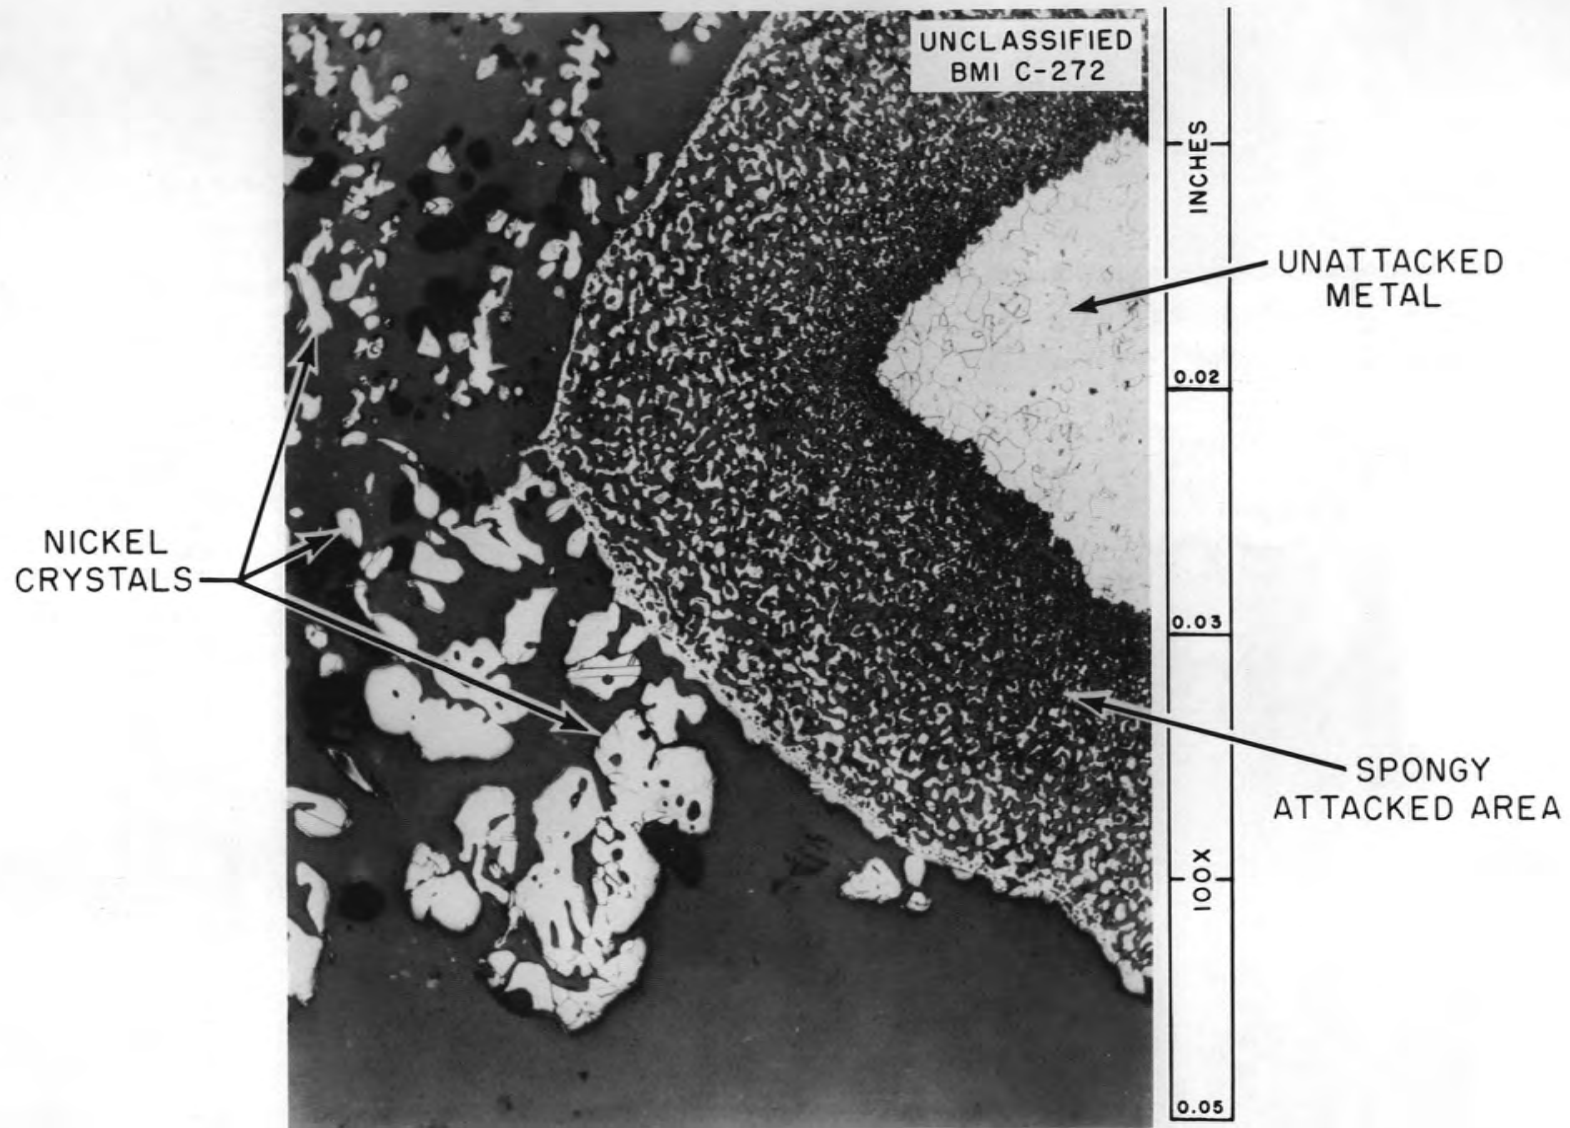
Fig. 29. Photomicrograph of Inconel Sparge Tube which Failed during Early BMI Tests.
Etchant: Nitric-hydrochloric acid. 100X.

sparge tube indicating the spongy areas where leaching of chromium occurred and where the metal crystals were deposited. Similar results were found during operations of a semiworks-scale vessel at ORNL when an Inconel salt line and hydrogen fluoride carrier line failed in service (see Section I of this report).
