ORNL-3253

CORROSION OF VOLATILITY PILOT PLANT  
MARK I INOR-8 HYDROFLUORINATOR  
AND MARK III L NICKEL FLUORINATOR  
AFTER FOURTEEN DISSOLUTION RUNS

A. P. Litman

**FEB - 9 1962**

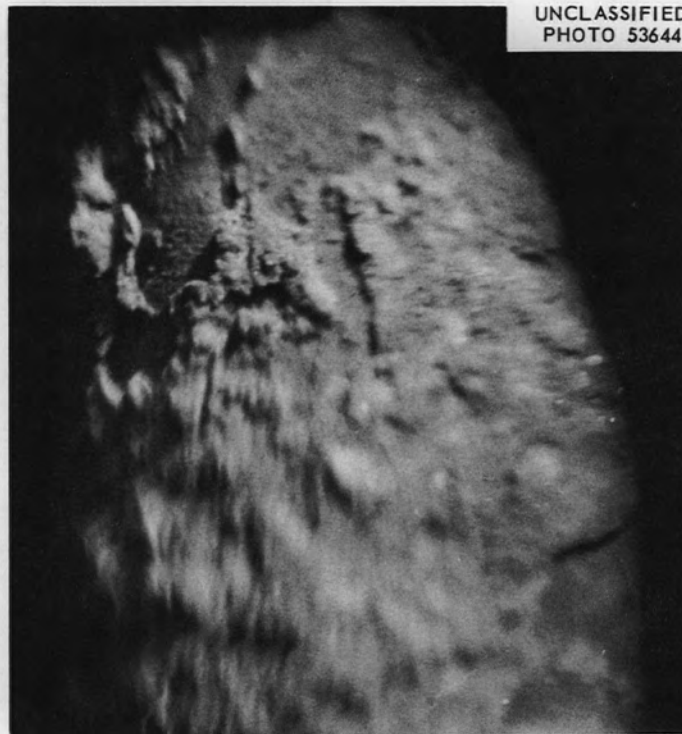
The regions of the hydrofluorinator that had been in contact with process vapors were covered with a beige-colored deposit, while the salt-containing area appeared to be black with tints of green and brown. Dark-colored coarse flakes of material were noted on top of the hydrogen fluoride distributor plate (Fig. 2). The flakes had the appearance of dried salts discolored by corrosion-dissolution products. (The  $\text{LiF-NaF-ZrF}_4$  salts used during dissolution are white in color and develop a greenish cast as  $\text{UF}_4$  is added to the mixture.) The deposits on the distributor plate also appeared to contain metallic particles. Some of the deposits adhering to the vertical walls and interior piping in the salt region were of appreciable thickness and were loosely adherent. Typical of these regions is the deposit noted on the thermocouple well and shown in Fig. 3.

Fig. 3. Portion of the Thermocouple Well in the Lower Salt Region of the VPP Mark I INOR-8 Hydrofluorinator After Run TU-7 Showing Typical Loosely Adherent Deposits. Photograph taken through the Omniscope optical system. Approx 4X.

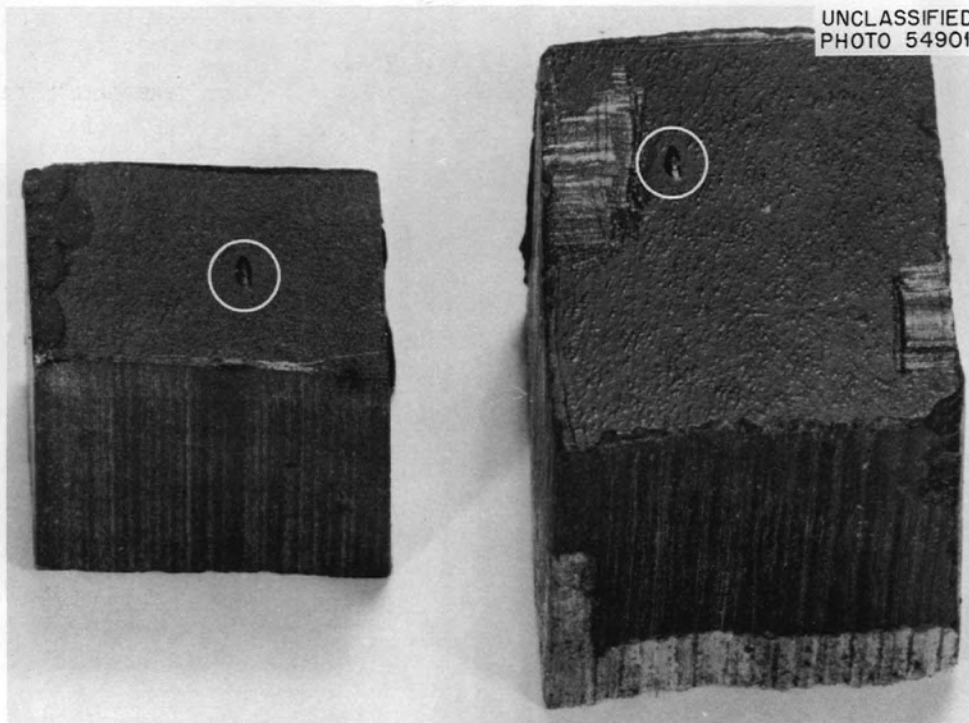
Initial replication confirmed the pitting attack in the vapor-phase region observed on the radiographic film. Duplicate impressions, at different times, disclosed that the maximum pitting depth here was 8 mils. Figure 6 shows portions of the replications illustrating the configuration of the pit. The height of the replication was measured by a toolmaker's microscope and was cross-checked by an optical comparator and a dial gage with a long lever arm.

Fig. 6. Duplicate Wax Replications of an 8-mil Pit (Encircled) Found in the VPP Hydrofluorinator North Quadrant, About 36 in. Down from the Top of the Upper Cylinder.

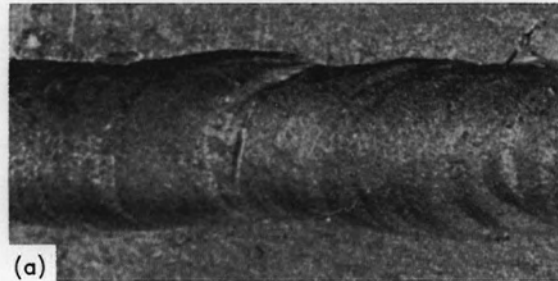
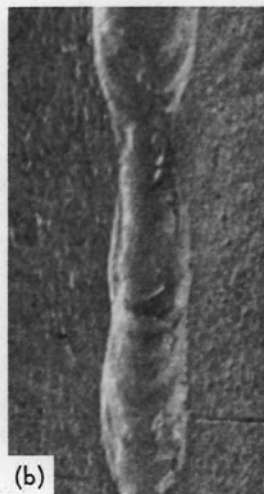
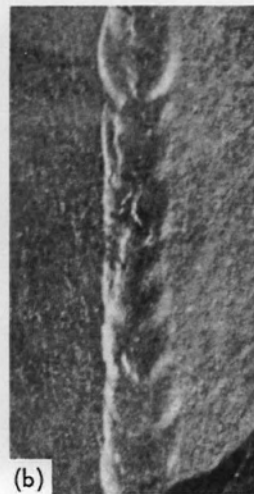
Replications were also made of portions of circumferential and longitudinal welds in the hydrofluorinator; portions of the replications are shown in Fig. 7. The impressions indicated the welds to be in good condition with little, if any, evidence of corrosive attack.

Fig. 7. Portions of Wax Replications of Welds in the VPP Hydrofluorinator. (a) Circumferential weld, southwest quadrant, 48 in. down from top of vessel; (b) longitudinal weld, southeast quadrant, 21 in. down from top of vessel. Approx 4X.

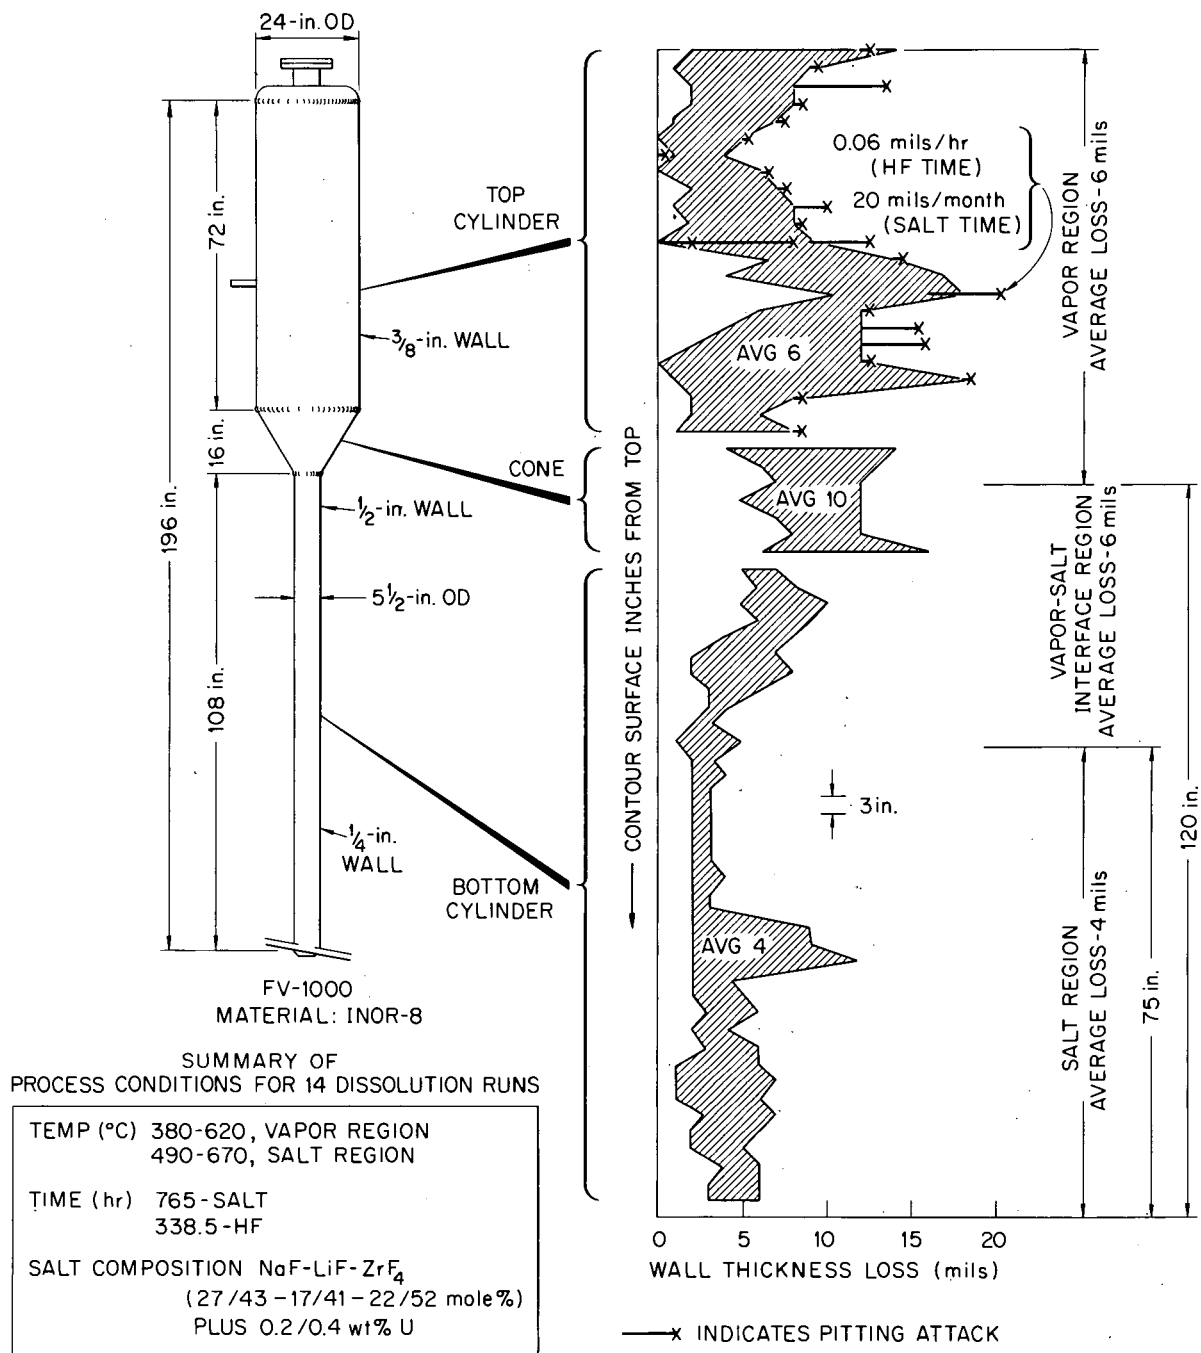
Fig. 8. Wall-Thickness Losses and a Portion of the Pitting Attack on the VPP Mark I INOR-8 Hydrofluorinator.

The depths of the pits in the upper portion of the hydrofluorinator, as determined by wax replication, are shown in Fig. 8 as extensions of the appropriate wall-thickness loss points, depending on the particular quadrants where each form of corrosion was found.

The maximum attack to date occurred in the middle vapor region at a calculated corrosion rate of 20 mils/month, based on 765 hr of molten fluoride salt residence time, and 0.06 mil/hr, based on 338.5 hr of HF exposure time.

Based on the 125-mil design corrosion allowance for the hydrofluorinator, an average of 18 hr per dissolution run, and an admittedly questionable linear extrapolation of the 0.06 mil/hr current corrosion rate, the useful life of the VPP Mark I hydrofluorinator seems to be 116 runs.

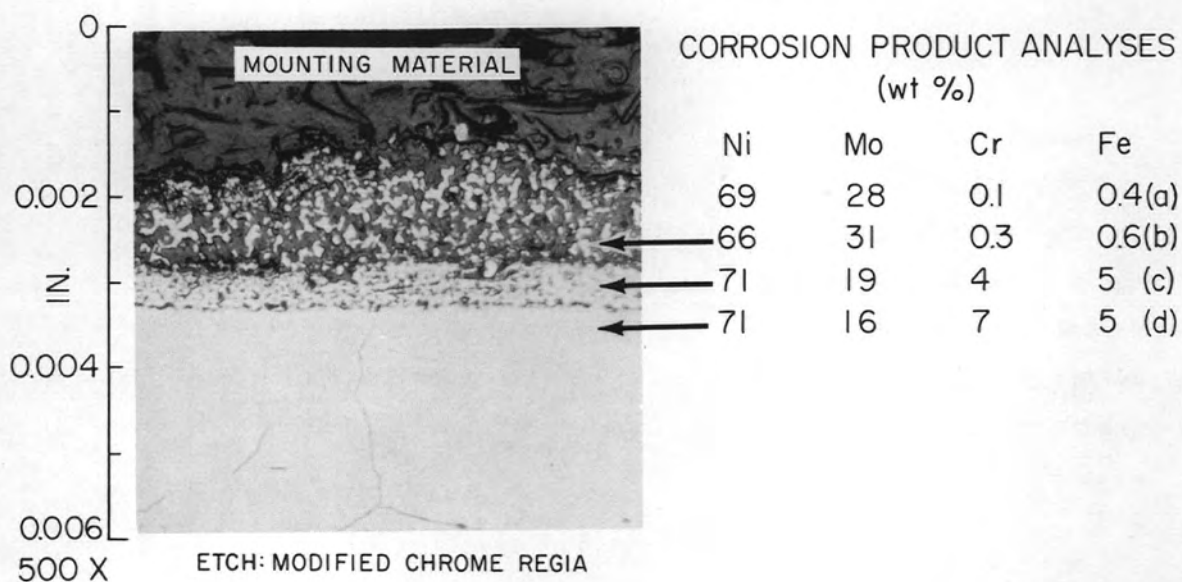
A black, semiadherent scale was present on the clip and was found to be depleted in chromium and iron when compared with the base metal (Fig. 9). The nickel content of the scale was comparable with the nominal INOR-8 analysis, but the molybdenum content was considerably higher. Scale x-ray diffraction patterns could not be matched with known compounds. Since the metallic content of the scale was less than 50% of the total weight, a good possibility exists that the scale is an Ni-Mo-F complex.

Fig. 9. Corrosion Product Layers on INOR-8 as the Result of Hydrofluorination Service Showing Composition of (a) Surface Scale (Not Shown in Photomicrograph), (b) Spongy-Surface Layer, (c) Subsurface Layer, and (d) Substrate Base Metal.

Metallographic examination of the clip disclosed a soft (53-63 diamond-point hardness) spongy-surface layer and a subsurface layer of variable hardness (115-335 DPH) as compared with a base INOR-8 value of 210 to 234 DPH (Fig. 10). Millings from the two layers were subjected to spectrochemical analyses, with the results shown in Fig. 9. The spongy-surface layer had approximately the same metallic composition as the scale previously described. The subsurface layer was deficient in chromium, had a slightly higher molybdenum content, and had the same iron content when compared with the base metal.

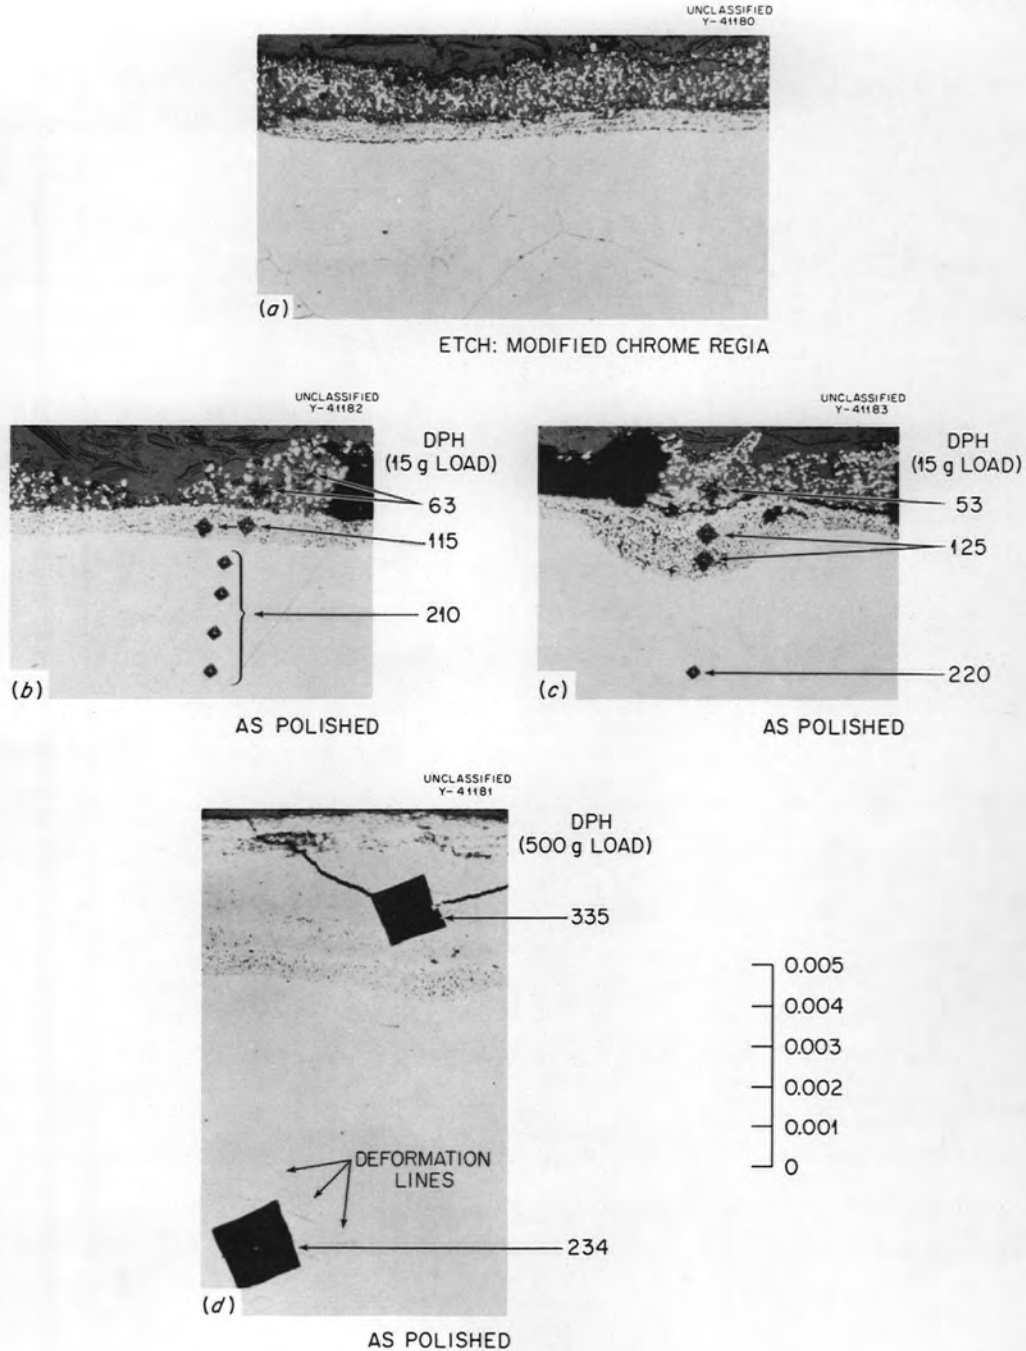
Fig. 10. Corrosion Product Layers on INOR-8 After Exposure to Anhydrous HF and Fused  $\text{LiF-NaF-ZrF}_4$  at 500–650°C. Typical areas showing (a) uniform duplex surface layers, (b) uniform intermediate layer, discontinuous surface layer, and hardness impressions, (c) variable thickness intermediate layer, discontinuous surface layer, and tendency for separation of the product layers, (d) an unusually thick intermediate layer showing brittle nature of layer compared with base metal.

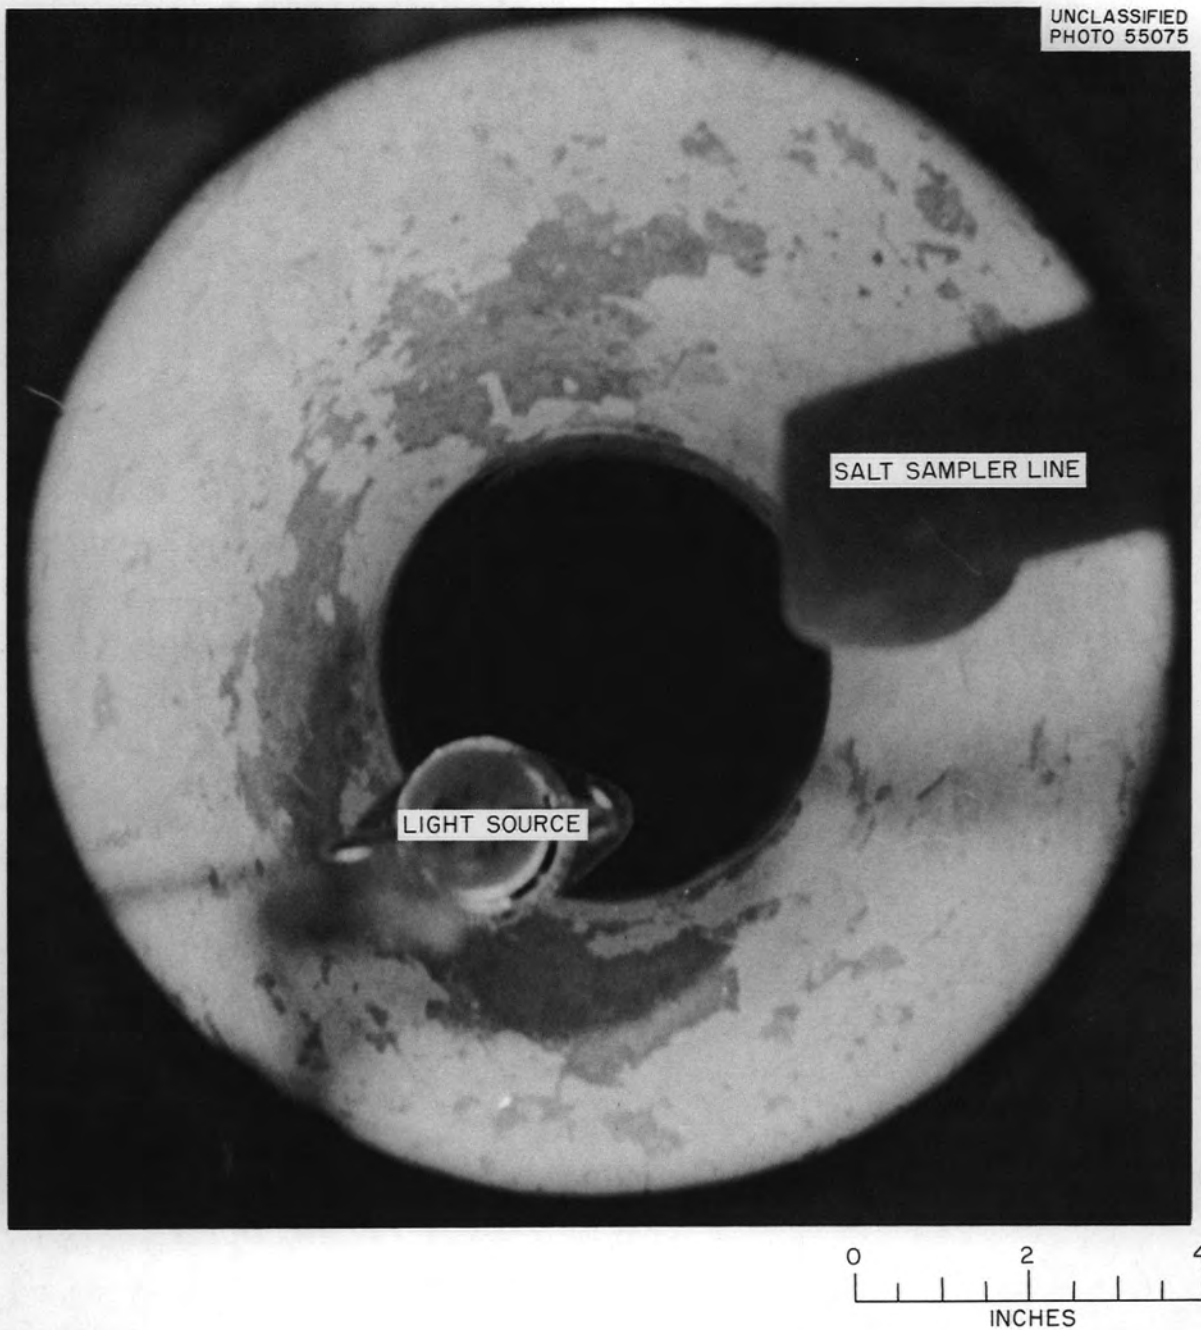
process vapors were covered with relatively thick, light-green deposits. The process vapors were usually  $F_2$  and  $UF_6$  plus volatile molybdenum and chromium fluoride corrosion products, probably as  $MoF_6$  and  $CrF_5$ . The middle-neck region of the vessel, which joins the top and bottom right cylinders, showed the heaviest deposits. Most of the deposits seemed to be loosely adherent, and where the deposits had flaked off, the substrate metal had a dark, dull appearance. Figure 11 illustrates these findings in the upper conical section of the fluorinator. At higher magnification evidence of pitting corrosion was found, especially in the top cylinder of the vessel.

Fig. 11. Interior of the VPP Mark III L Nickel Fluorinator After Run TU-7 Showing Upper Conical Section. Loosely adherent  $\text{NiF}_2$  deposits have flaked off in several regions, revealing darker colored substrate metal. Approx 1/2 size.

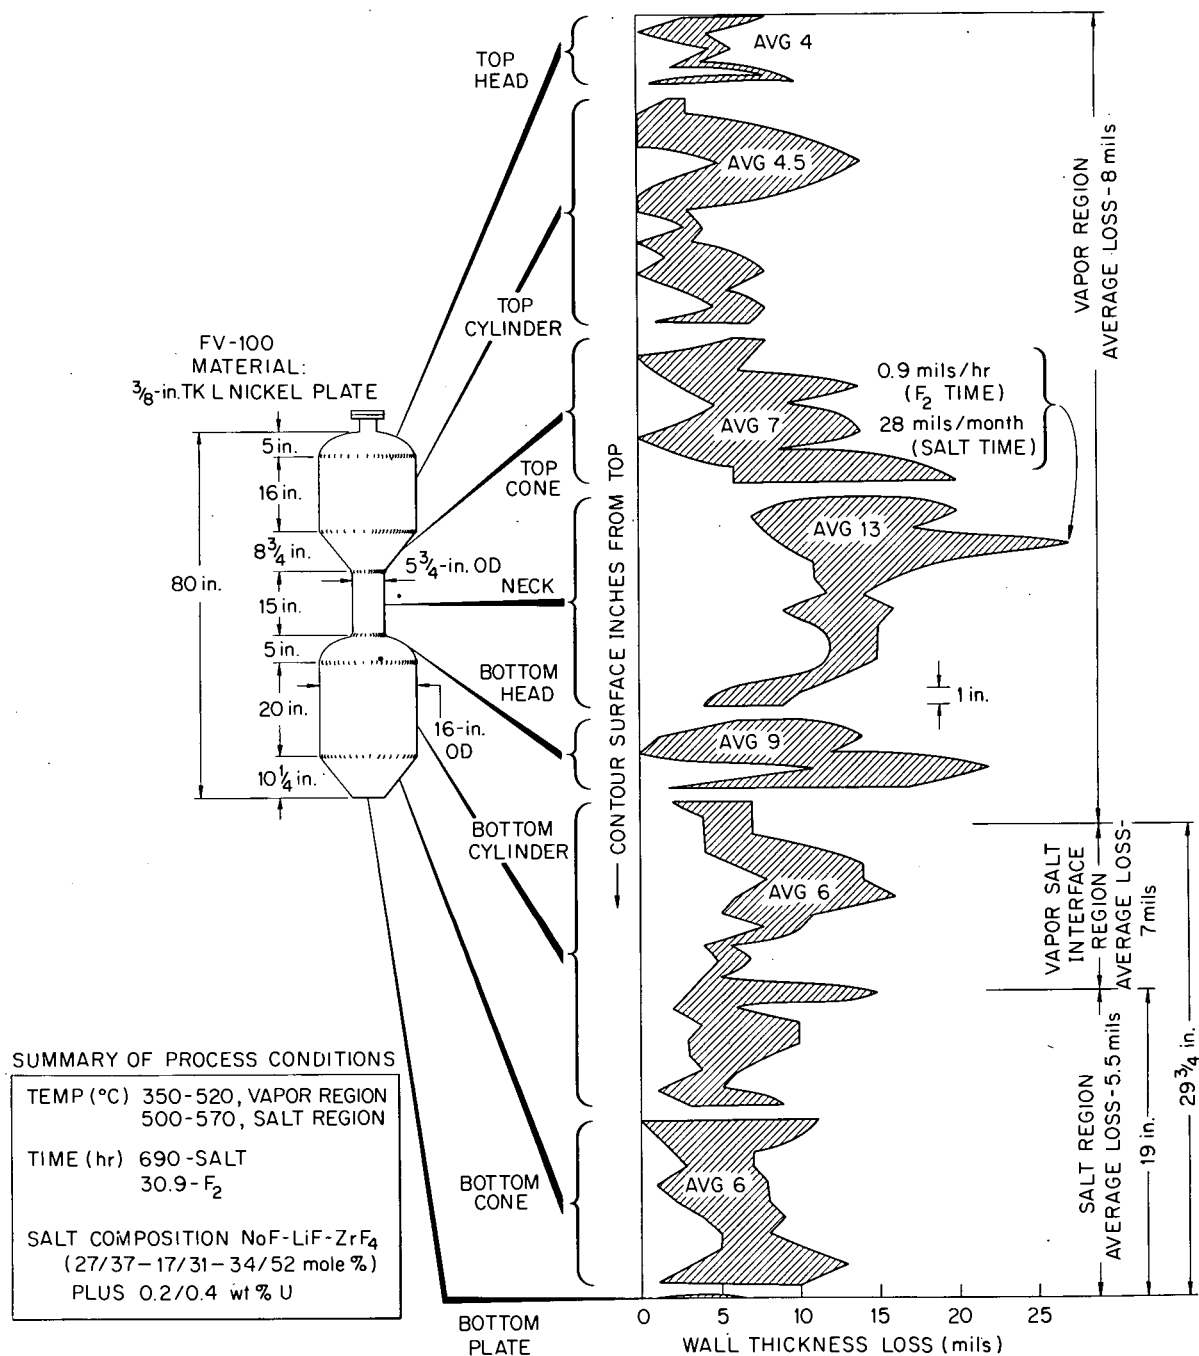
Wall thinning on the VPP fluorinator was determined by Vidigage measurements taken every contour surface inch in each quadrant, and the results were compared with base-line data. Figure 12 shows the bulk metal losses found. Quadrant geometry did not appear to be significant in analyzing the data, and so all data are presented at each elevation and the loss ranges outlined.

Fig. 12. Wall-Thickness Losses on VPP Mark III L Nickel Fluorinator.

Based on a corrosion rate of 1 mil/hr based on fluorine time and assuming a corrosion allowance of 175 mils, a fluorine exposure time of 1.5 hr per run, and linear extrapolation, the VPP Mark III fluorinator should have a useful life of 117 runs to match the predicted life of the hydrofluorinator. This calculation does not include intergranular or other forms of selective attack.
