ORNL-2337

INTERIM REPORT ON CORROSION

BY ALKALI-METAL FLUORIDES:

WORK TO MAY 1, 1953

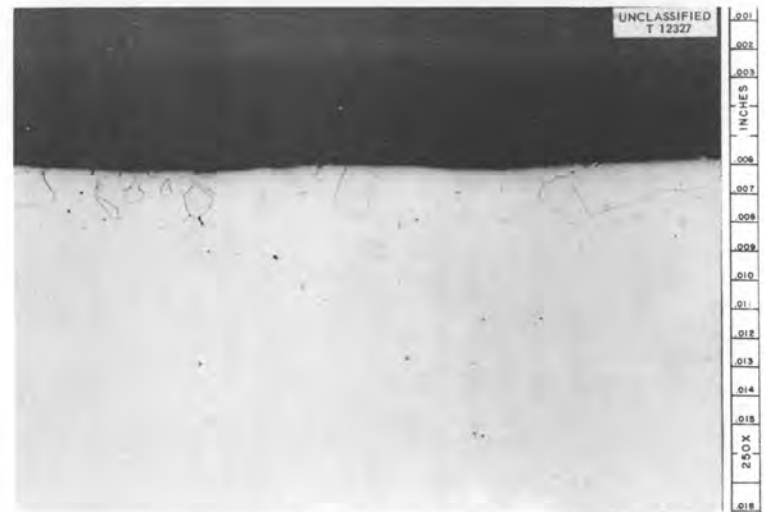
INCONEL, 500 HOURS

NICKEL, 500 HOURS

316 STAINLESS STEEL, 82 HOURS

410 STAINLESS STEEL, 12 HOURS

Fig. 5. Typical Hot-Leg Sections from Thermal Loops Made of Various Materials After Circulating Alkali-Metal Fluorides. 250X. Reduced 39%.
 (Secret with caption)

gives the results obtained. Figures showing samples taken from the hot legs of the loops are presented in several sections of this report: loop 229 is shown in Fig. 7, loop 227 in Fig. 9, loop 219 in Fig. 12, and loop 210 in Fig. 5. The loops were operated over a considerable time span with fuel from various batches that showed considerable variation in chemical composition. Chemical analyses of the fluorides after the loops had been operated all showed an increase in chromium and a decrease in iron content. The depth and intensity of attack found in the hot legs of the loops checked fairly well, except that the attack in loop 211 was slightly less than that in the other loops.

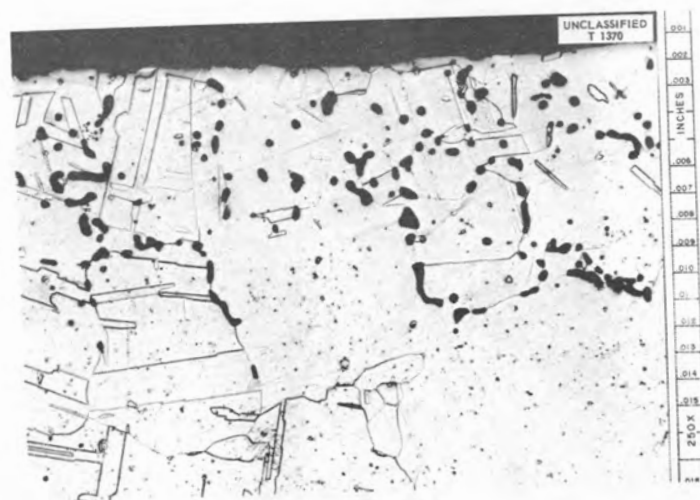
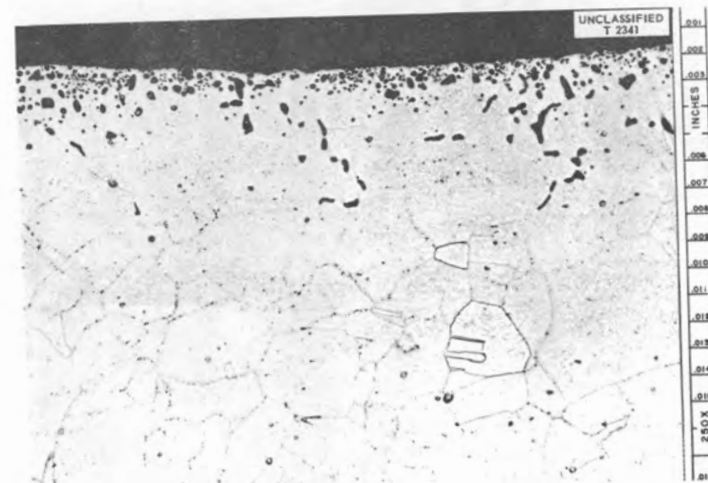
FLUORIDE 12

FLUORIDE 14

FLUORIDE 17

FLUORIDE 35

Fig. 8. Corrosion of Inconel by Various Fluoride Mixtures. 250X. Reduced 43.5%. (Swelling with caption)

Table 5 lists the corrosive effects found in Inconel loops after they had circulated various fluoride mixtures (see Table 1 for compositions). The variation in attack is shown by the typical hot-leg sections presented in Figs. 8 and 9. These loops were operated not necessarily to give a minimum amount of corrosion but to be as nearly comparable as possible. In the case of fluoride 30, it was shown that lower corrosion rates were possible with changes in the production procedure, and it seemed likely that similar reductions could be made with the other compositions.

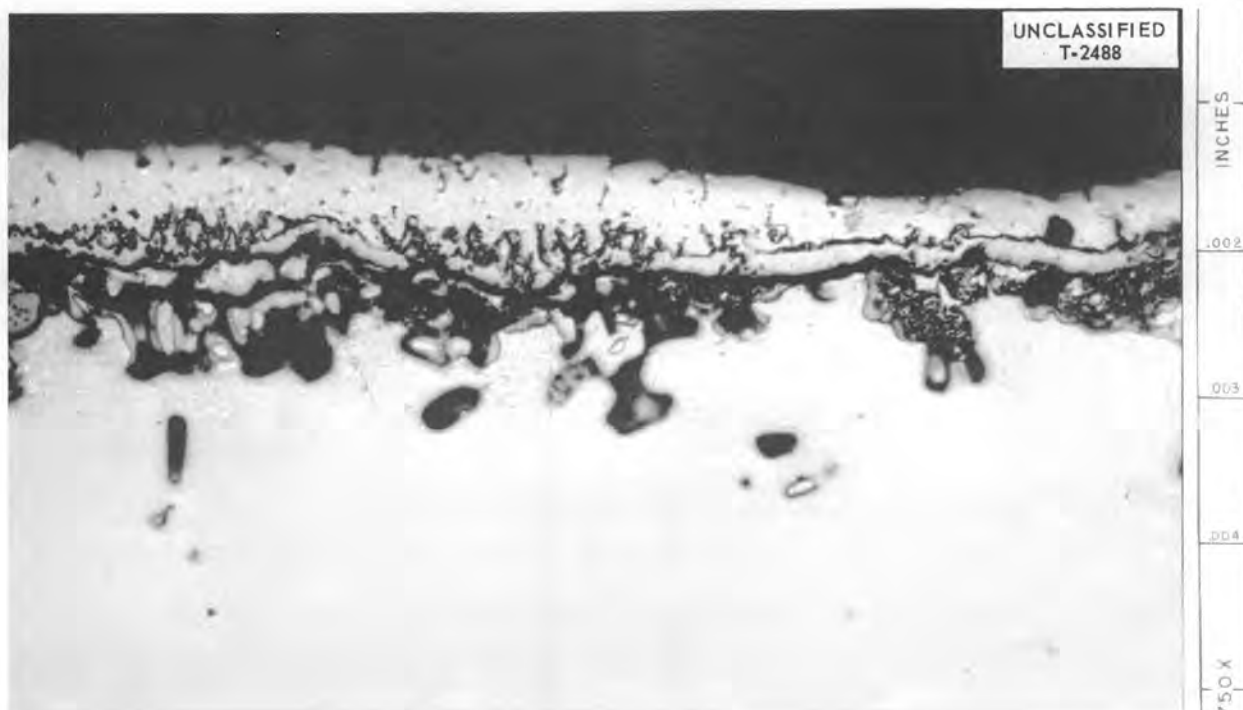
Fig. 11. Hot Leg of Inconel Loop After Circulating Molten Fluorides with Small Addition of Titanium Hydride. 750X. (Secret with caption)

Titanium hydride was similarly added to loop 250. The addition of 0.5% titanium hydride decreased the corrosion to a maximum penetration of 0.0025 in. but produced a thin metallic layer, identified by R. M. Steele by x-ray diffraction as Ni_3Ti . Under a high magnification (750X) it was revealed that the layer was actually made up of several phases imposed one upon another, as can be seen in Fig. 11, a photomicrograph of the hot leg of loop 250. A similar layer was also found in the cold leg.

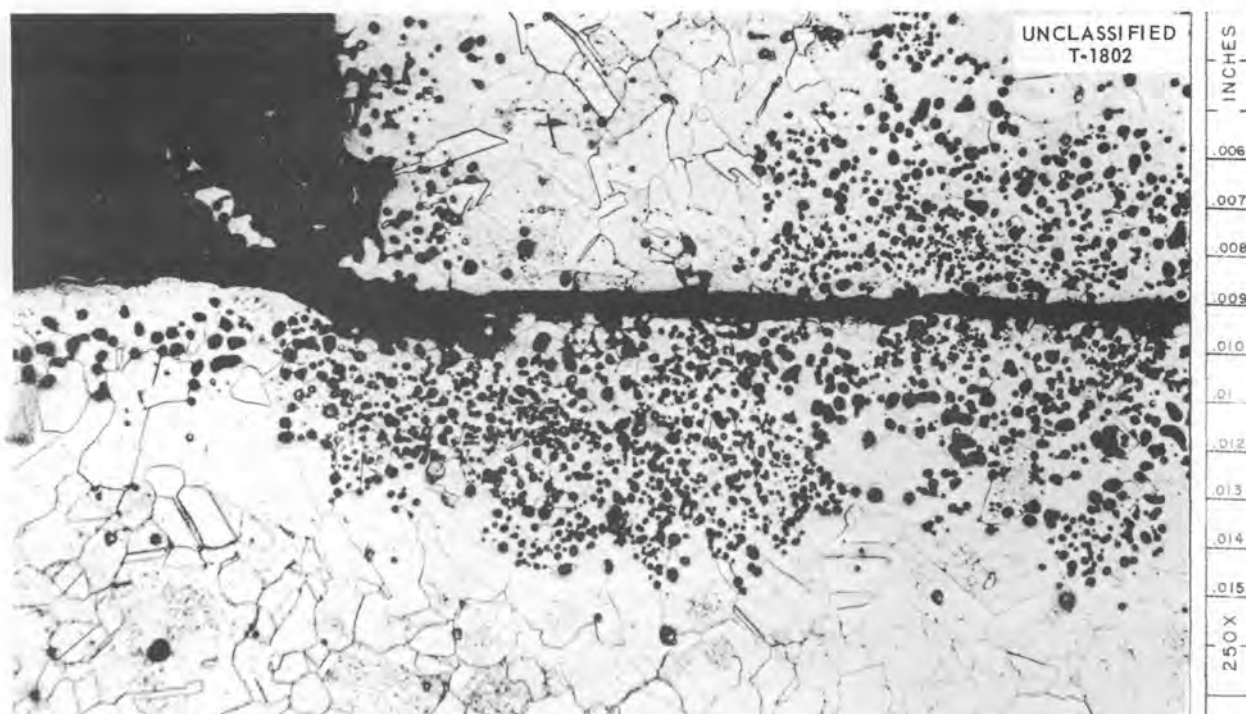
Fig. 13. Increase in Attack in a Crevice of an Inconel Loop. 250X.

As an additional check on crevice corrosion, the top welds from standard loops 219 and 229 were examined. The welding techniques used had resulted in an incomplete weld penetration, and hence crevices were present on the inside of the loops. The increase in corrosion in such a crevice is apparent from Fig. 13, a photomicrograph of the top weld of loop 219. The maximum penetration of the wall in this area was 0.003 in., while in the crevice the attack was 0.006 in. deep and several times as intense. Similar results were obtained with loop 229.

These results indicated that crevice corrosion by the fused fluorides was not a serious problem. The most likely explanation for the small increase in corrosion found in the crevices is that the cleaning was inadequate. Some oxidation had taken place during welding, and the oxides were not removed during cleaning. Helium was used as a backup gas during welding, but purging of
