INTERGRANULAR CRACKING OF INOR-8 IN THE MSRE

H. E. McCoy
B. McNabb

ORNL-4829
UC-25 — Metals, Ceramics, and Materials

NOVEMBER 1972

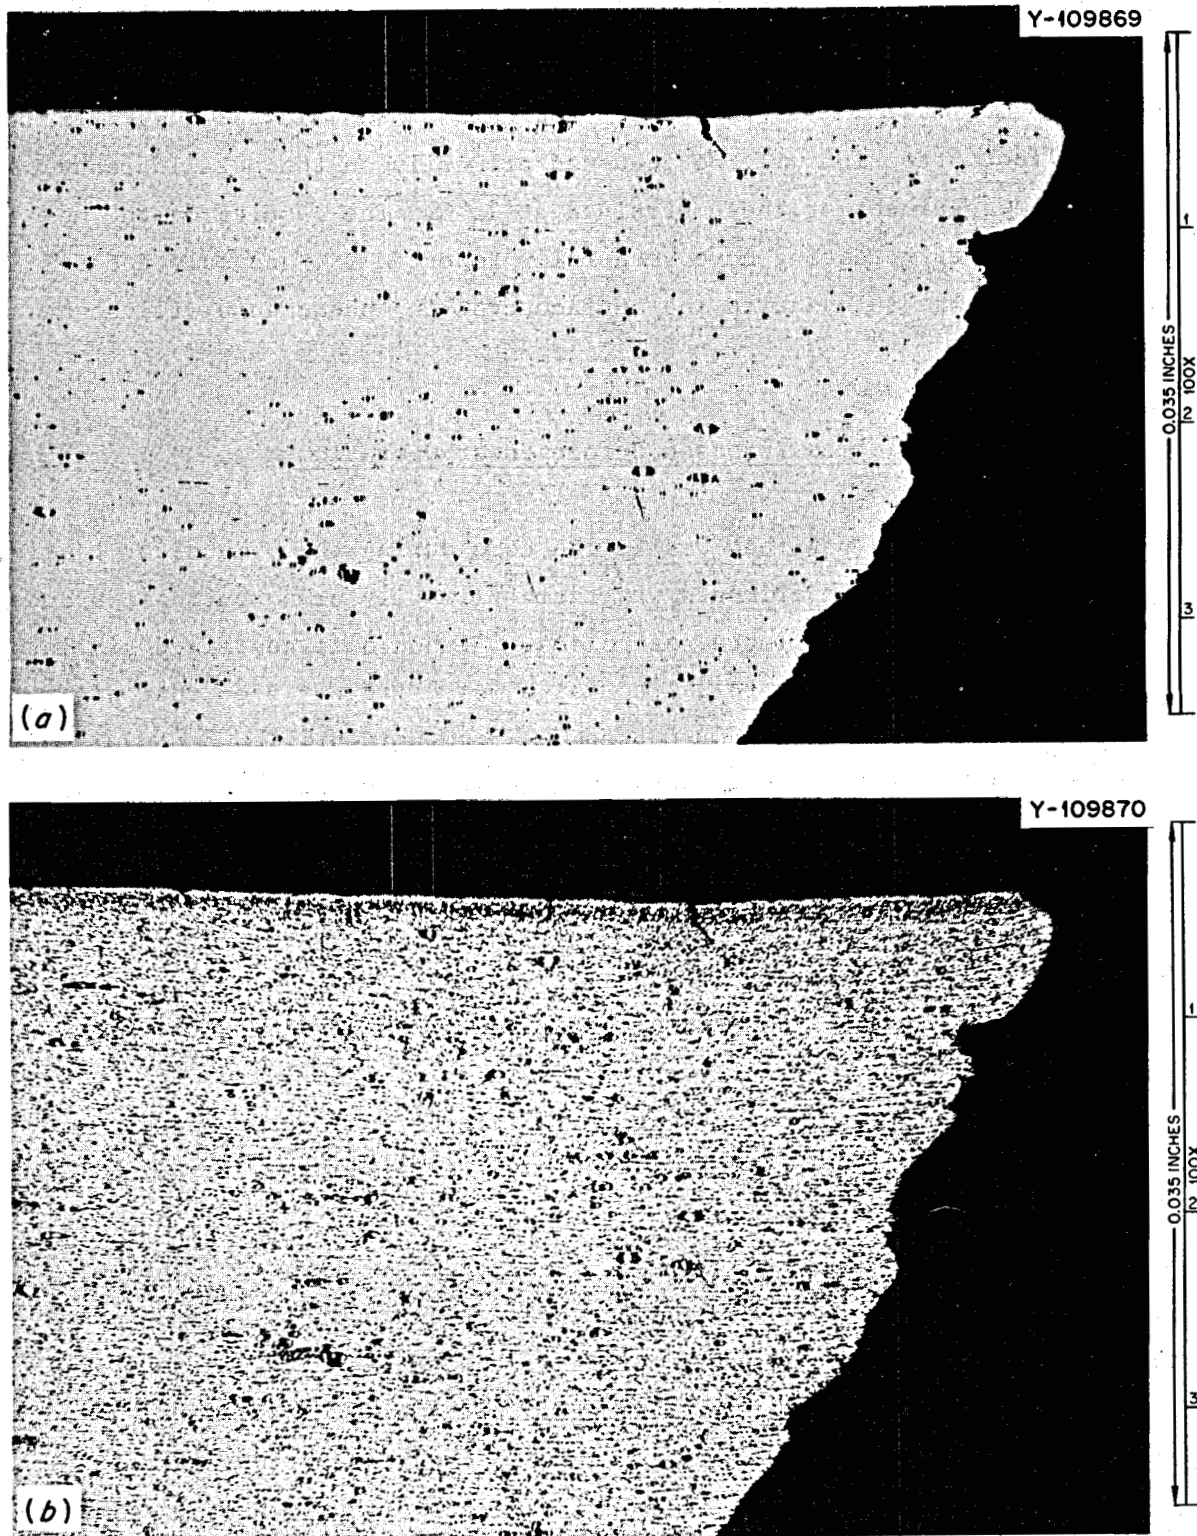
The only visible change in the specimens as a result of their exposure was that the originally shiny specimens of INOR-8 had developed a bright gray-white matte surface.¹⁵ The microstructure of one of the specimens after it was fractured at 25°C is shown in Fig. 7. No grain-boundary cracks are visible. The 1-mil surface layer that etched more darkly caused some concern at first. However, as will be brought out later, the modified surface layer was present on control specimens as well as on those exposed in the core and, on a series of specimens, showed no systematic variation with exposure time. Further work showed that it was likely cold-work from machining causing carbides to precipitate more readily near the surface. (See later discussion of possible connection to surface cracking.)

Fig. 7. Microstructure of INOR-8 Sample Held Above 500°C for 3306 hr During the "Zero-power" Run of the MSRE. (Fuel was in system 1090 hr.) (a) As polished. (b) Etched with glyceria regia. The material is cold worked, and the grains are not delineated by etching.

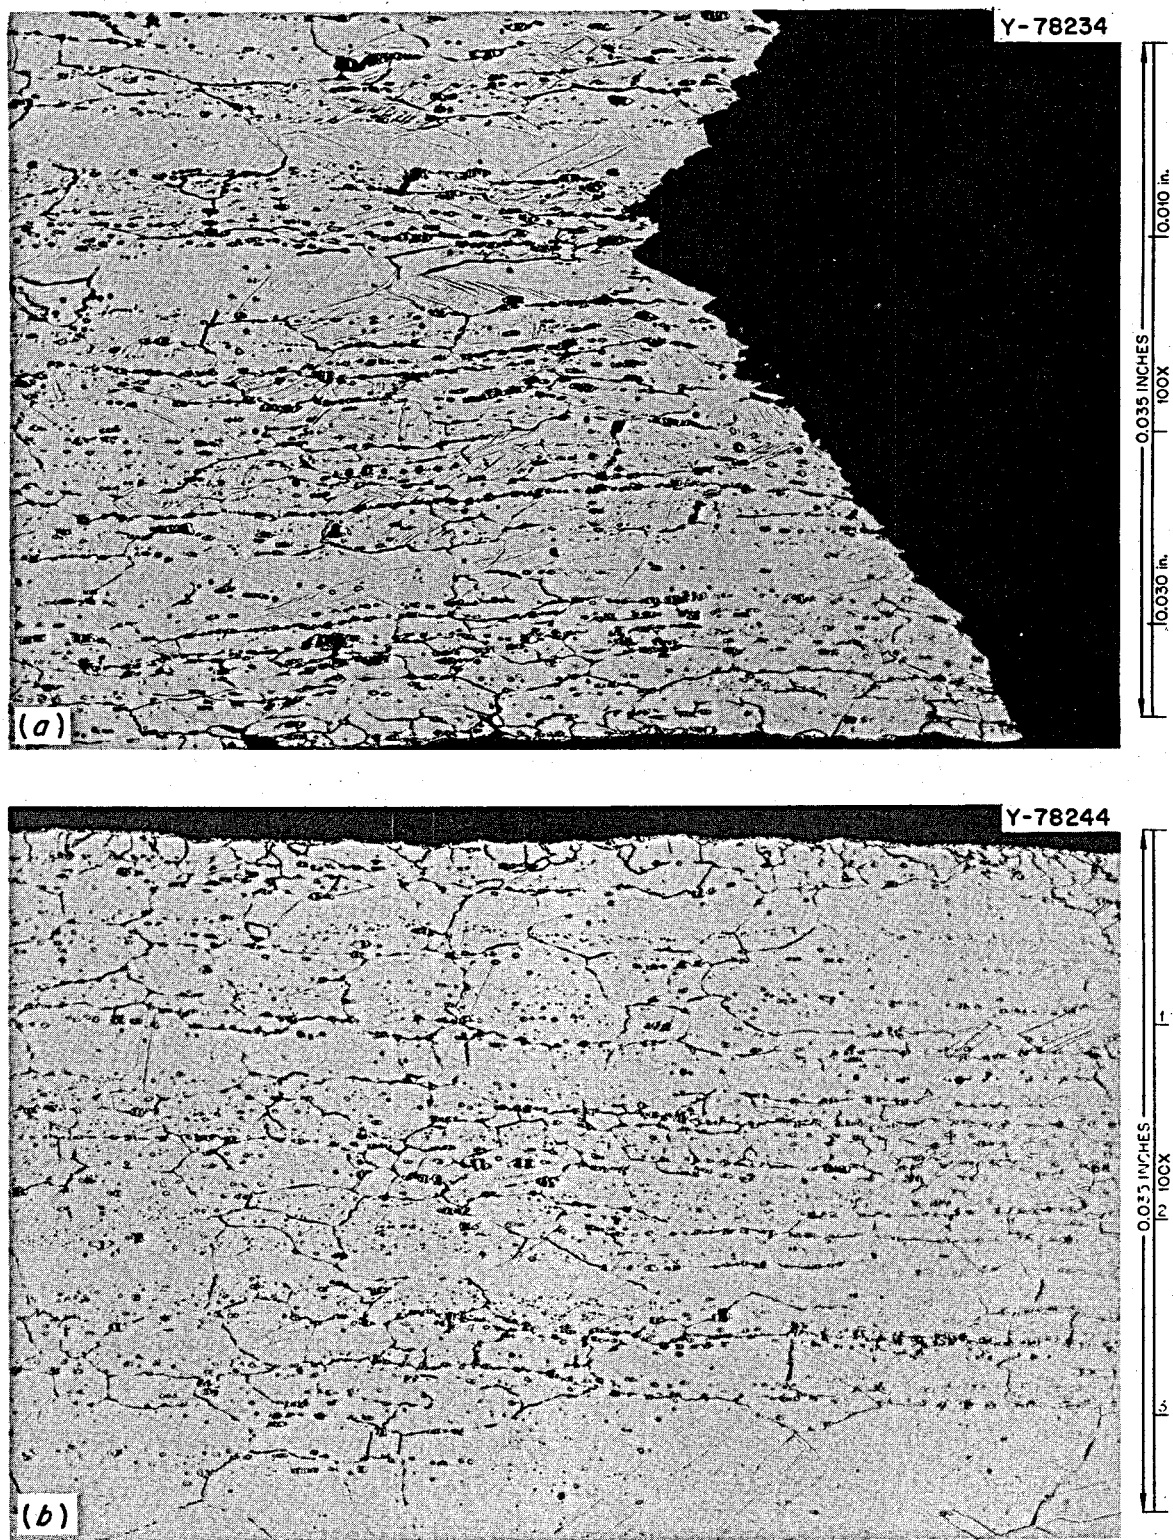
Metallography of specimens broken in tension at 25°C revealed differences in the nature of the fractures in core and control specimens. These differences are believed to be another manifestation of carbide precipitation. Figures 8 and 9 show specimens of heat 5081 from the control facility and from the core. The fracture in the control specimen (Fig. 8) is typical of transgranular shear-type failure (cup-cone appearance). In contrast, the fracture of the core specimen (Fig. 9) is largely intergranular. Heat 5085 specimens are shown in Figs. 10 and 11. The fracture in the 5085 control specimen is mixed transgranular and intergranular, with the elongated grains attesting to the large amount of strain. The fracture in the 5085 core specimen is largely intergranular with numerous intergranular cracks in the microstructure.

Fig. 8. Photomicrographs of Control Specimen AC-8 from Heat 5081. Tested at 25°C and at a Strain Rate of 0.05/min. (a) Fracture. (b) Edge of specimen about 1/4 in. from fracture. Etchant: glyceria regia.

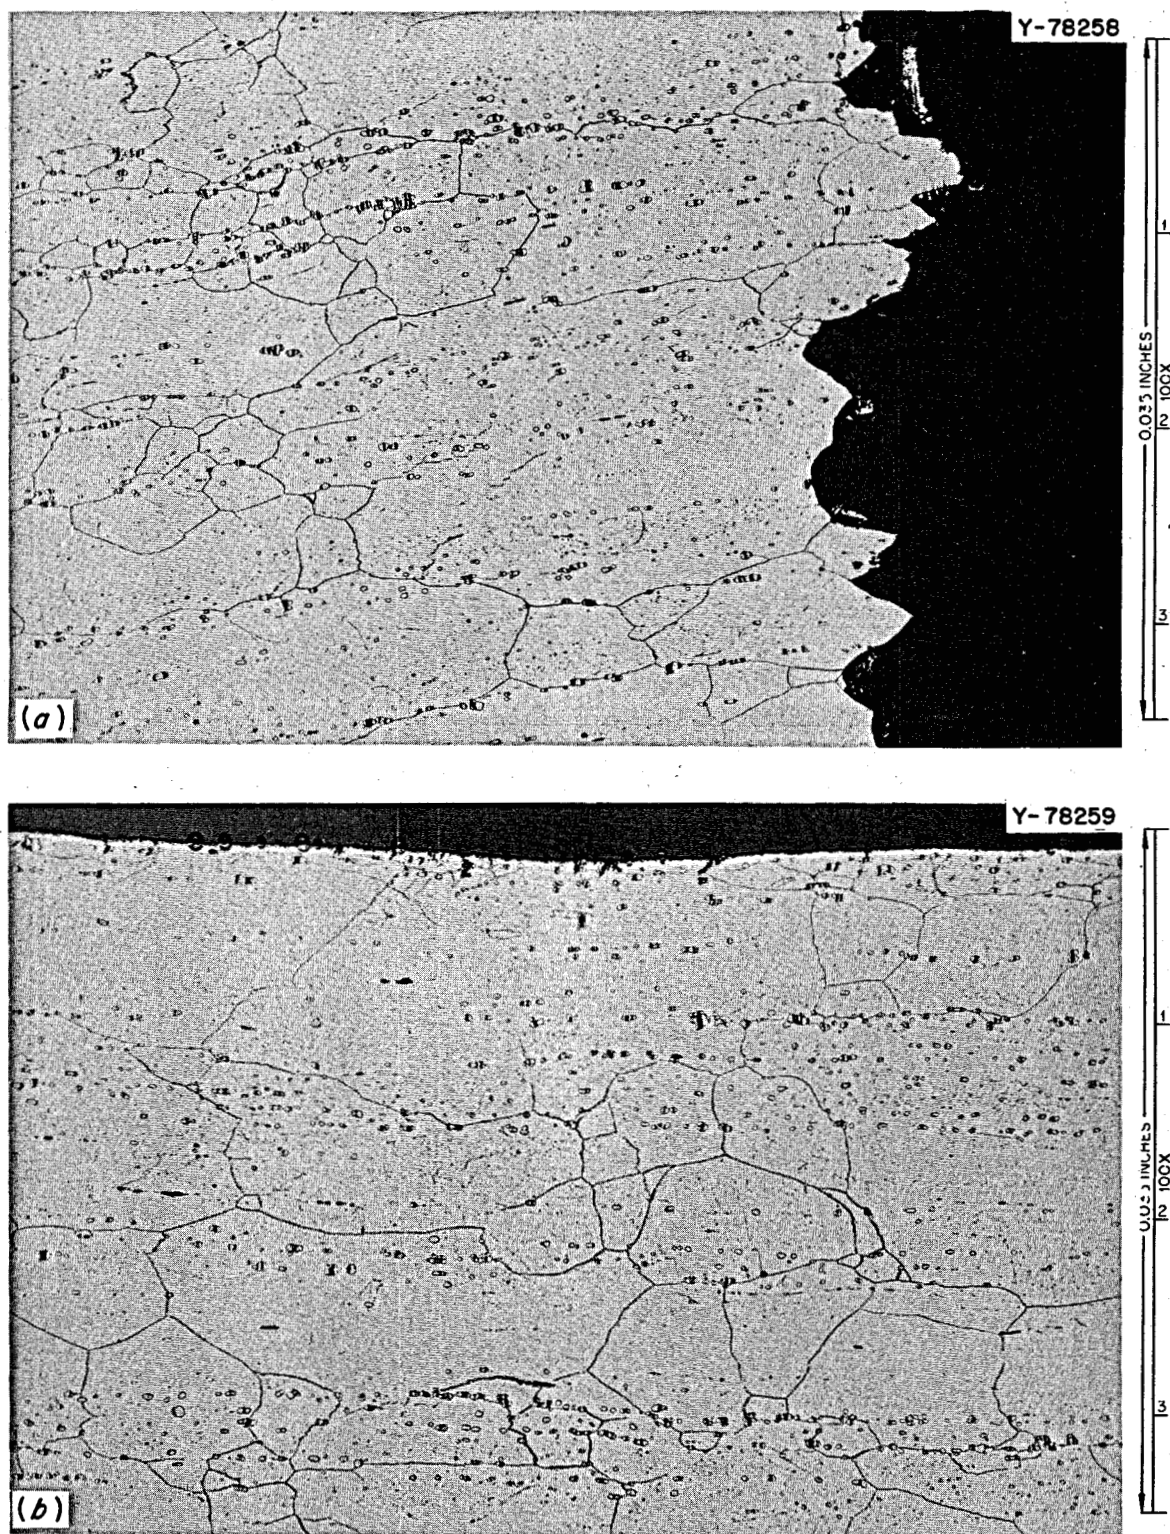
Fig. 10. Photomicrographs of Control Specimen DC-24 from Heat 5085 Tested at 25°C and at a Strain Rate of 0.05/min. (a) Fracture. (b) Edge of specimen about 1/4 in. from fracture. Etchant: glyceria regia.

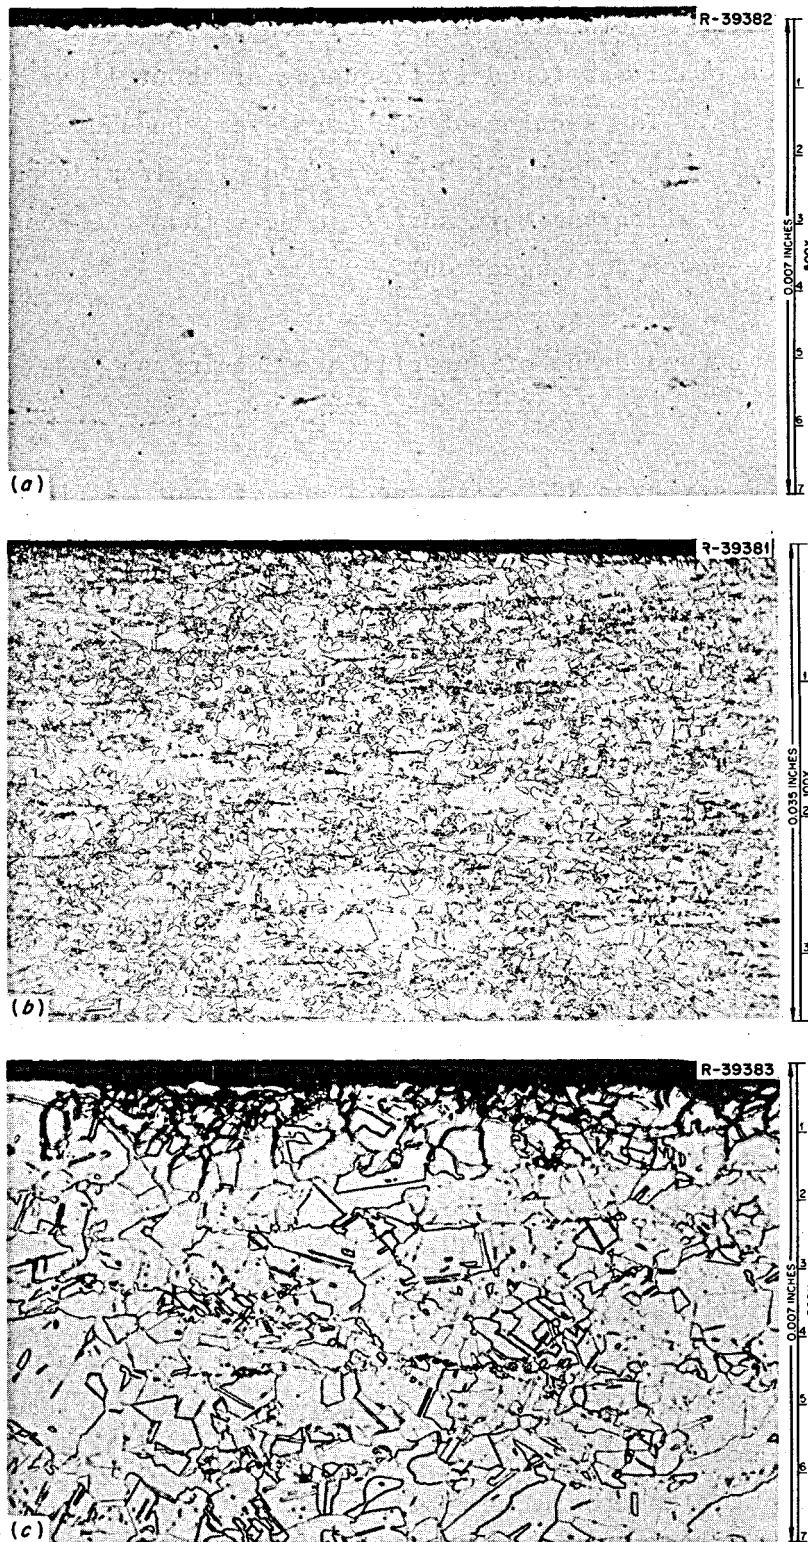
Visual inspection showed the core specimens to be very slightly discolored but otherwise apparently unaffected. Photomicrographs of specimens (unstrained) after exposure are shown in Figs. 13 and 14. (The unusually fine grain size is due to the fabrication history of the specimens, which included 100-hr anneals at 870°C.) The as-polished views of specimens of both heats show some evidence of grain boundary modifications to a depth of 1 to 2 mils, and both show some tendency to etch more readily near the surface.

Fig. 13. Photomicrographs of Zirconium-Modified INOR-8 (Heat 21554) Removed from the MSRE after 5554 hr above 500°C. Edge exposed to flowing salt. (a) As polished. 500x. (b) Etchant: aqua regia. 100x. (c) Etchant: aqua regia. 500x. Reduced 30%.

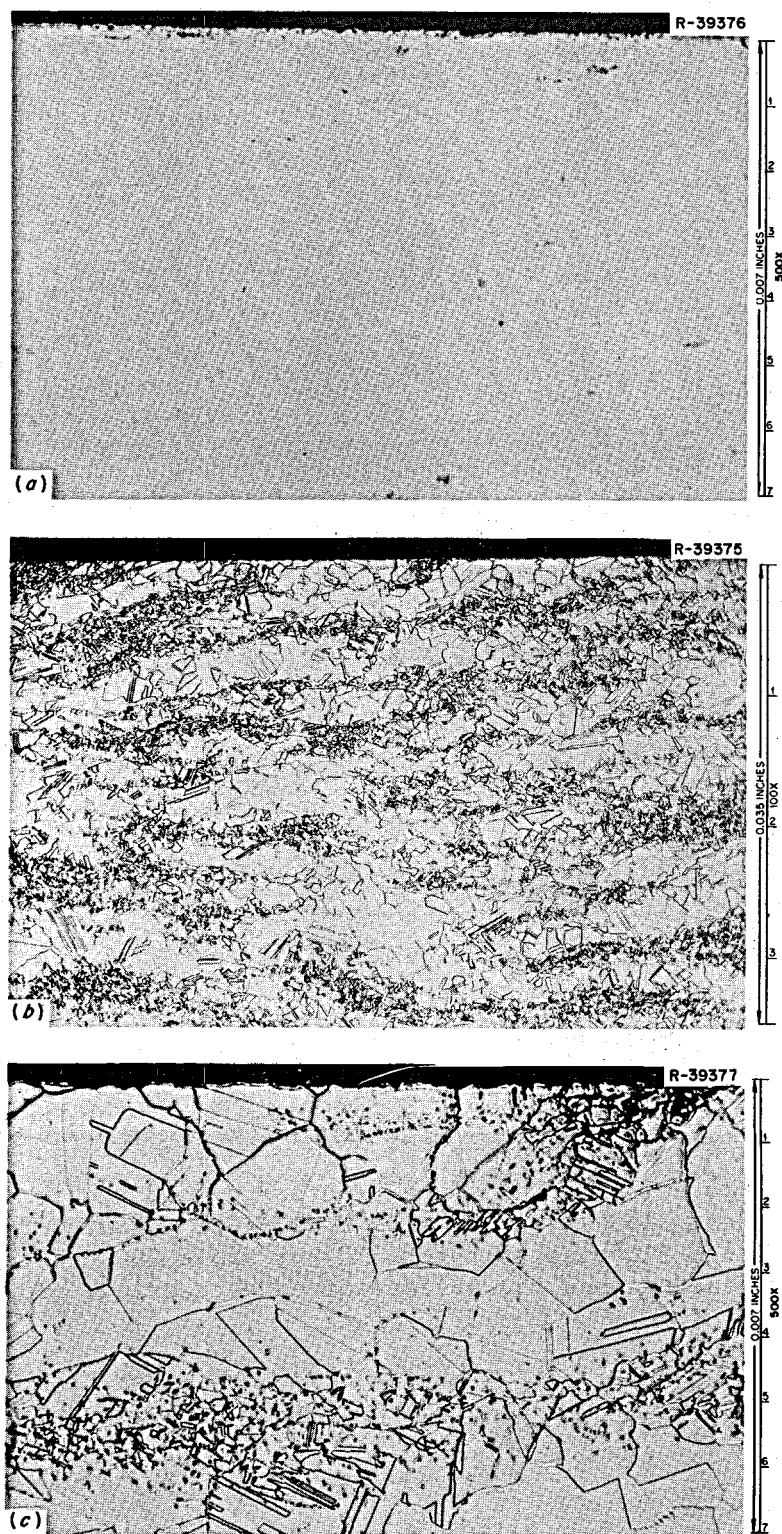
Fig. 14. Photomicrographs of Titanium-Modified INOR-8 (Heat 21545) Removed from the MSRE After 5554 hr above 500°C. Edge exposed to flowing salt. (a) As polished. 500x. (b) Etchant: aqua regia. 100x. (c) Etchant: aqua regia. 500x. Reduced 33%.

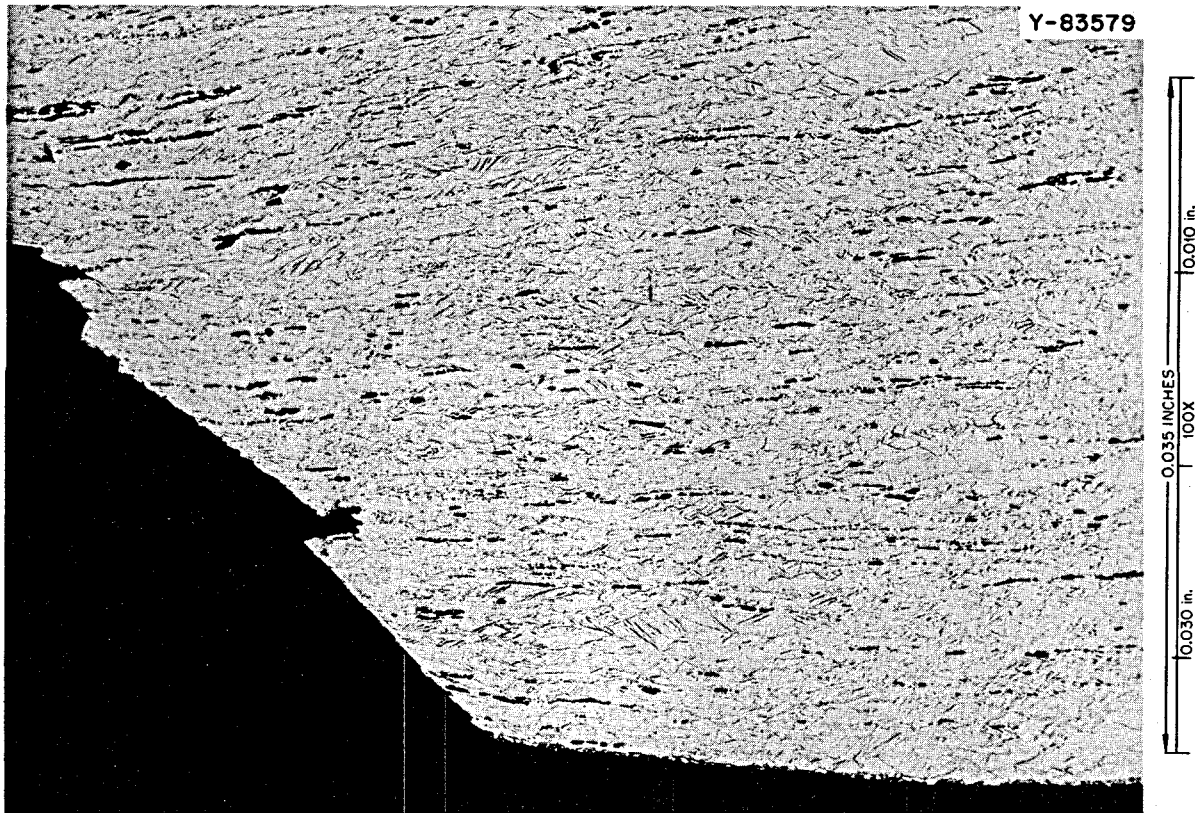
Core specimens of both heats tested to failure in tension developed numerous intergranular cracks along the surfaces, while control specimens tested similarly showed few or no surface cracks. The difference is illustrated in Figs. 15-18. Figure 15 and 16 are control and core specimens respectively of heat 21554. In the core specimen surfaces nearly every grain boundary is cracked to a consistent depth of about 2 mils. In the control specimen there is no evidence of intergranular edge cracking. Figures 17 and 18 show the same thing for heat 21545.

Fig. 15. Photomicrograph of the Fracture of a Zirconium-Modified INOR-8 Sample (Heat 21554) Tested at 25°C at a Strain Rate of 0.05/min. Exposed to a static fluoride salt for 5554 hr above 500°C before testing. Note the shear fracture and the absence of edge cracking. 100x. Etchant. glyceria regia.

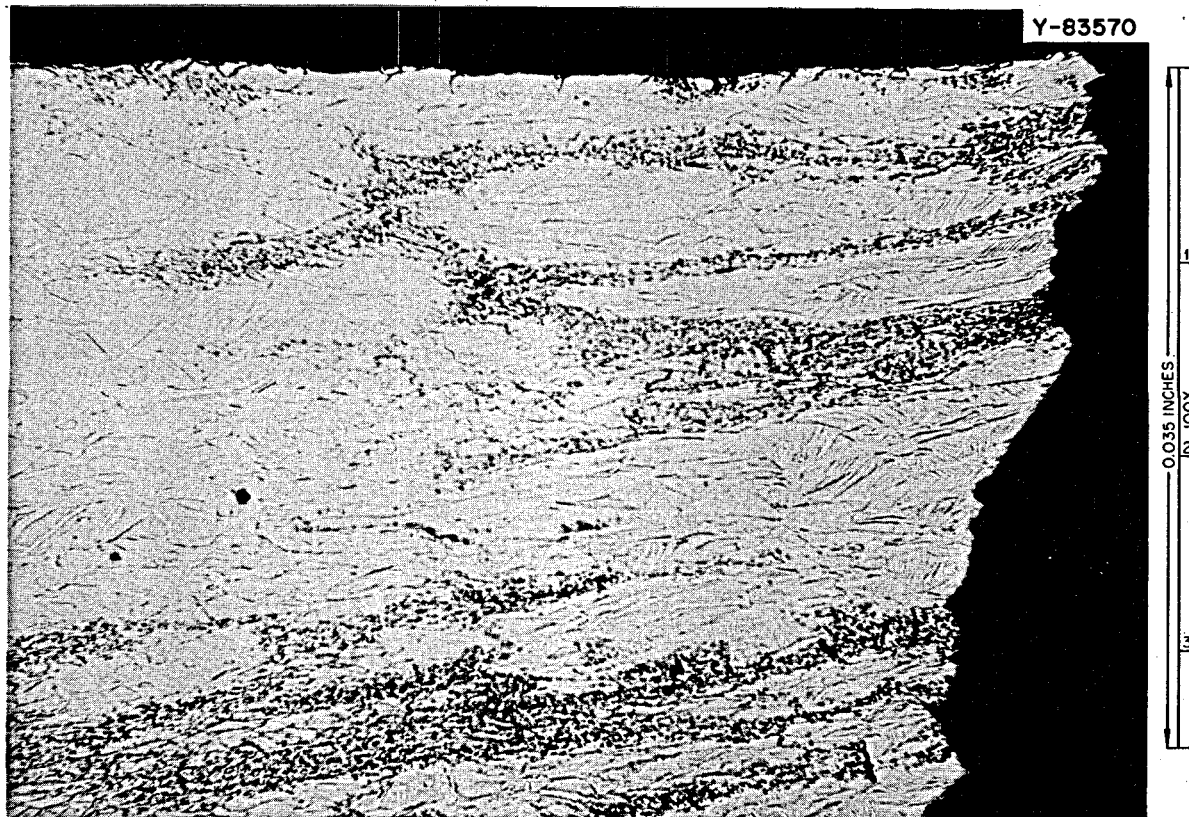
Fig. 17.. Photomicrograph of the Fracture of a Titanium-Modified INOR-8 Surveillance Sample (Heat 21545) Tested at 25°C at a Strain Rate of 0.05/min. Exposed to a static fluoride salt for 5554 hr above 500°C before testing. Note the shear fracture and the absence of edge cracking. 100x. Etchant: glyceria regia.

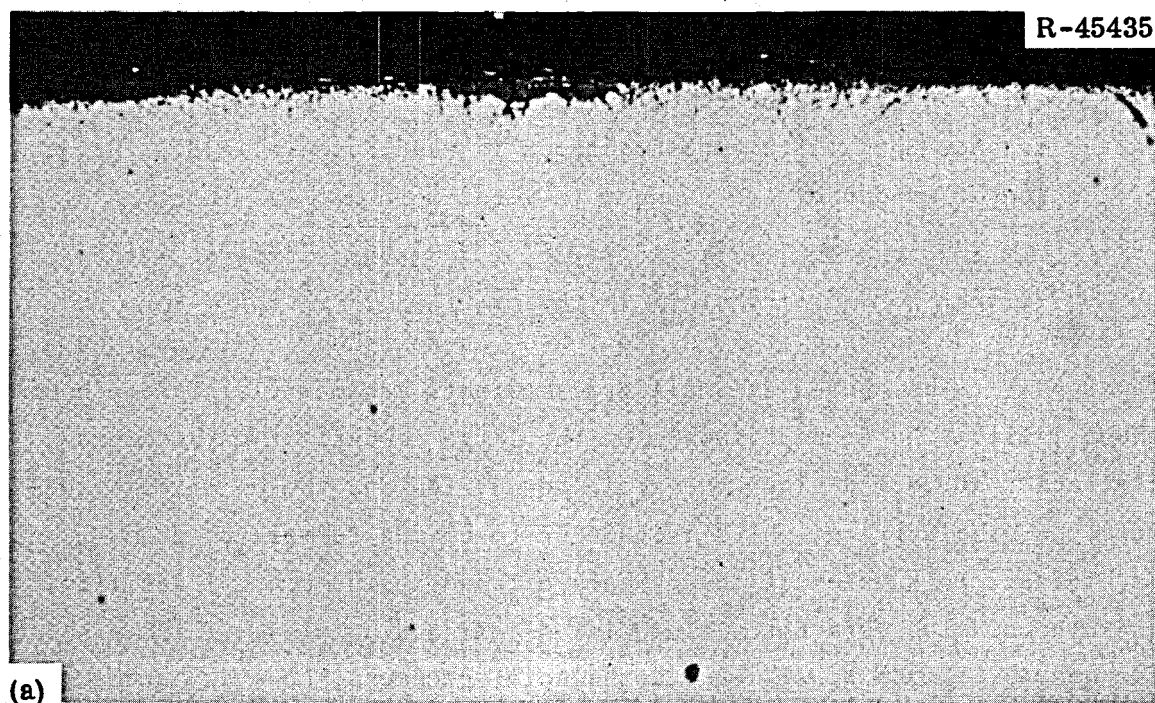
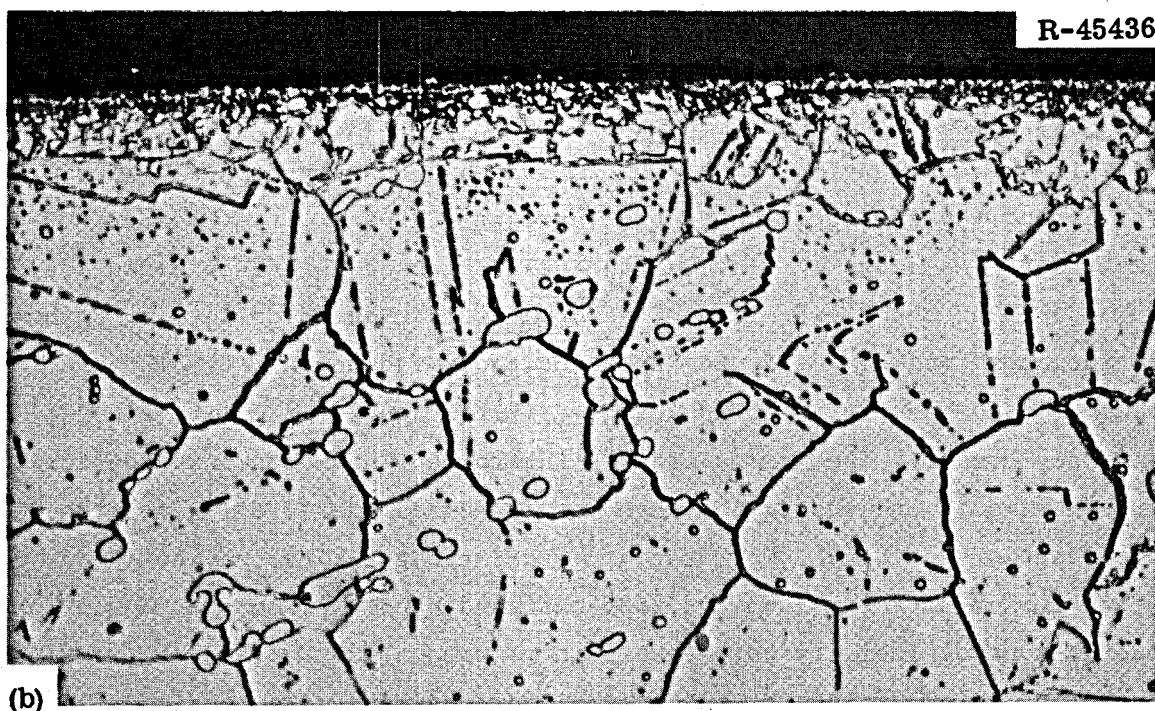
Stringers RR2, with the standard heats, had been exposed 2 to 4 times as long as the standard alloy specimens in the first group. (The factor depends upon which exposure index is used; see Table 3.) Effects of the longer exposure were evident in metallographic examinations of unstrained specimens. Figures 19 and 20 are of specimens of heats 5065 and 5085 exposed on stringer RR2 in the core. Some of the grain boundaries near the surface are visible in the as-polished condition, and a few appear to be opened as small cracks with a maximum visible depth of about 1 mil. The etched views show the large amounts of carbide precipitate that formed along the grain boundaries and the modified structure near the surface, which is thought to be due to working from machining. In samples of these heats exposed in the control facility, grain boundaries were not visible in as-polished samples. This is shown for heat 5065 in Fig. 21. As in the core specimens, however, etching brought out the carbide precipitate and the modified structure near the surface. The microstructure of control specimens of heat 5085 was quite similar.

Fig. 19. Photomicrographs of INOR-8 (Heat 5065) Surveillance Specimens Exposed to Fuel Salt for 11,933 hr above 500°C, 500x. Shallow reaction layer is seen near surface. (a) Unetched. (b) Etched (glyceric acid).

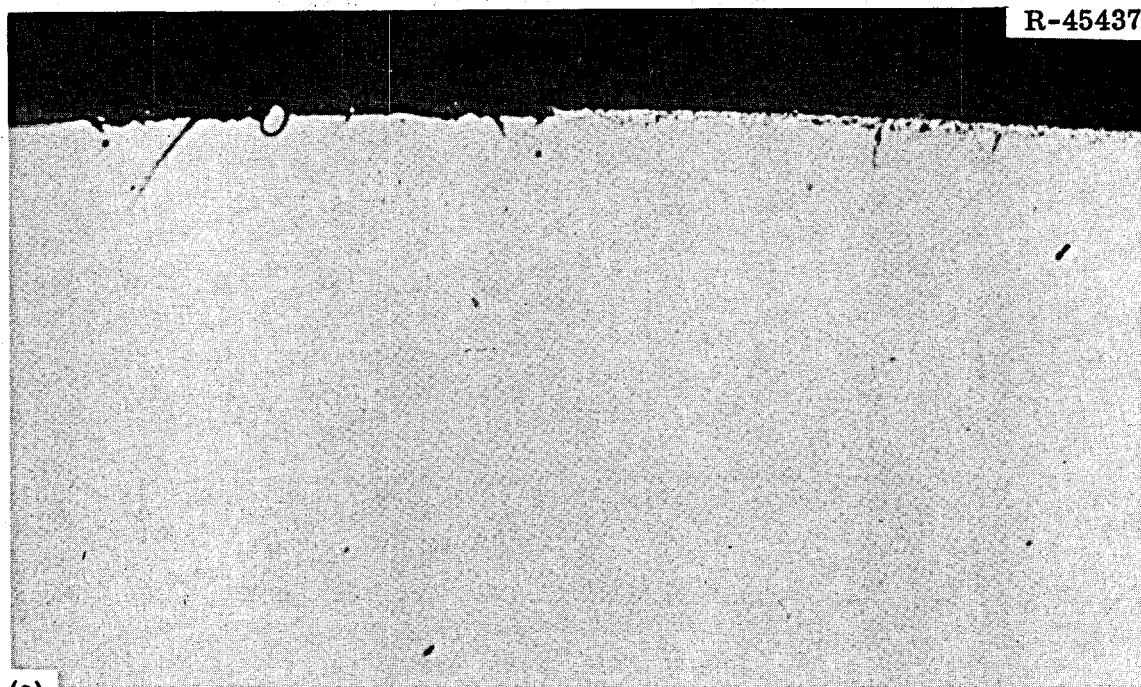
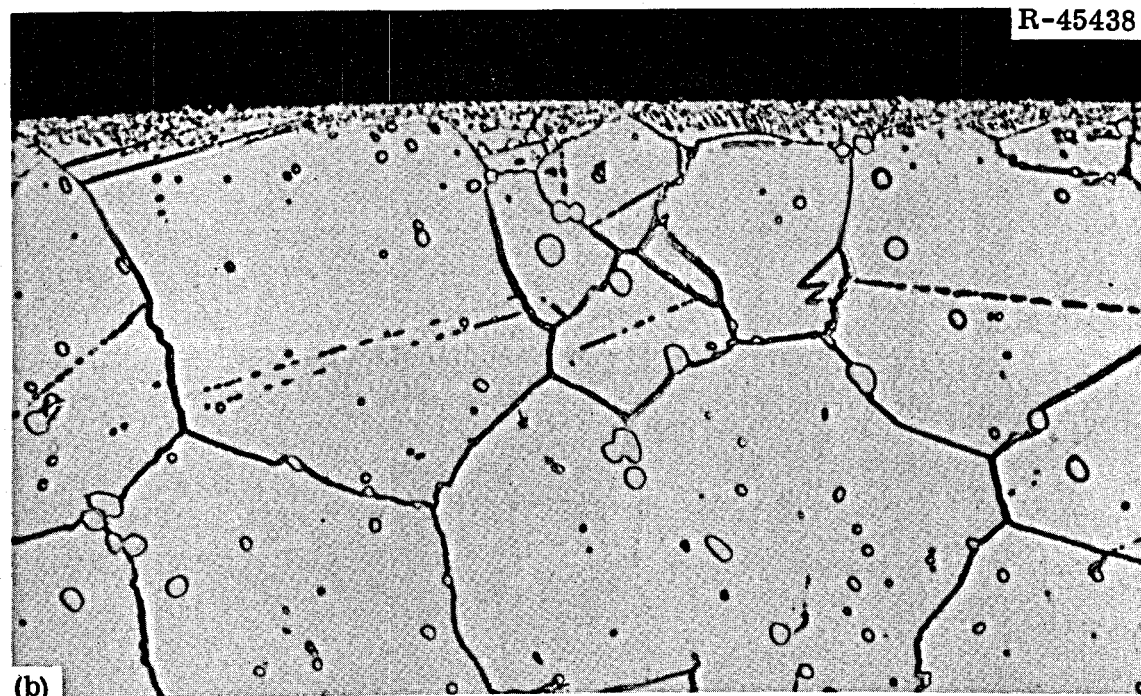
Fig. 20. Photomicrographs of INOR-8 (Heat 5085) Surveillance Specimens Exposed to Fuel Salt for 11,933 hr above 500°C. 500x. Shallow reaction layer is seen near surface. (a) Unetched. (b) Etched (glyceria regia).

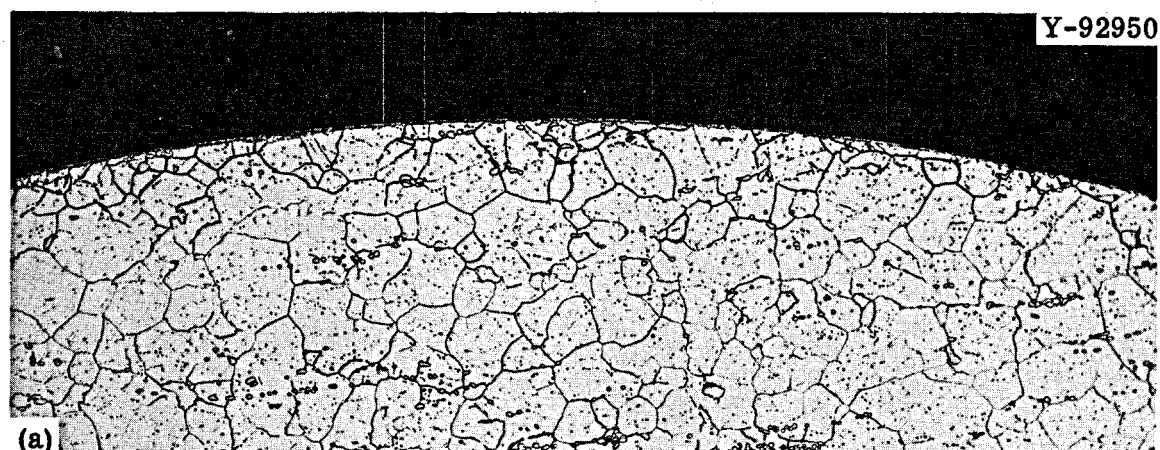
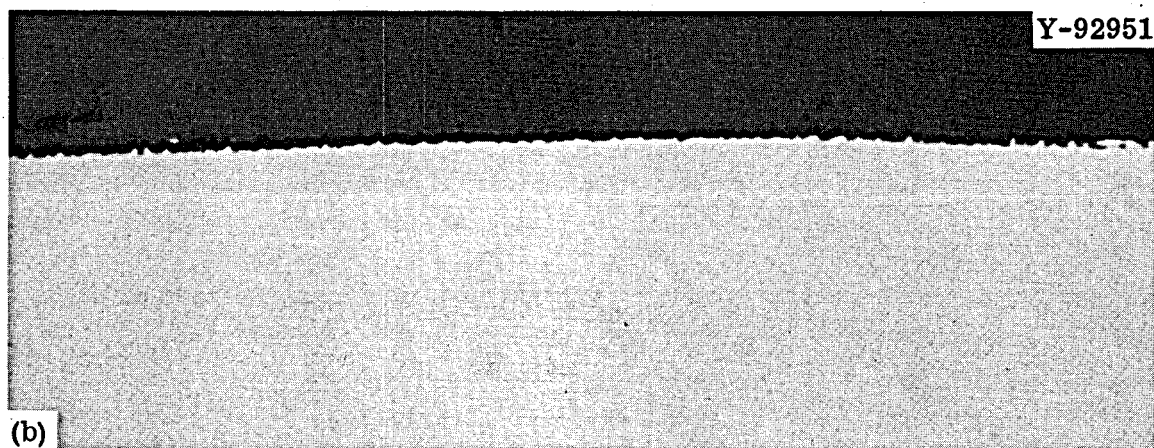
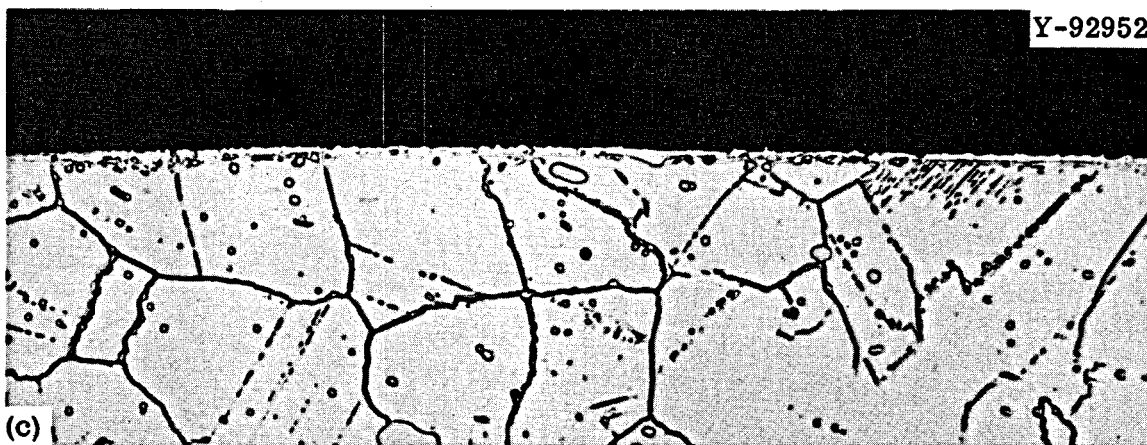
Fig. 21. Photomicrographs of INOR-8 (Heat 5065) Surveillance Control Specimens Exposed to Static Barren Fuel Salt for 11,933 hr above 900°C. Note the shallow reaction layer near the surface. (a) Etched. 100x. (b) As polished. 500x. (c) Etched. 500x. Etchant: glyceria regia.

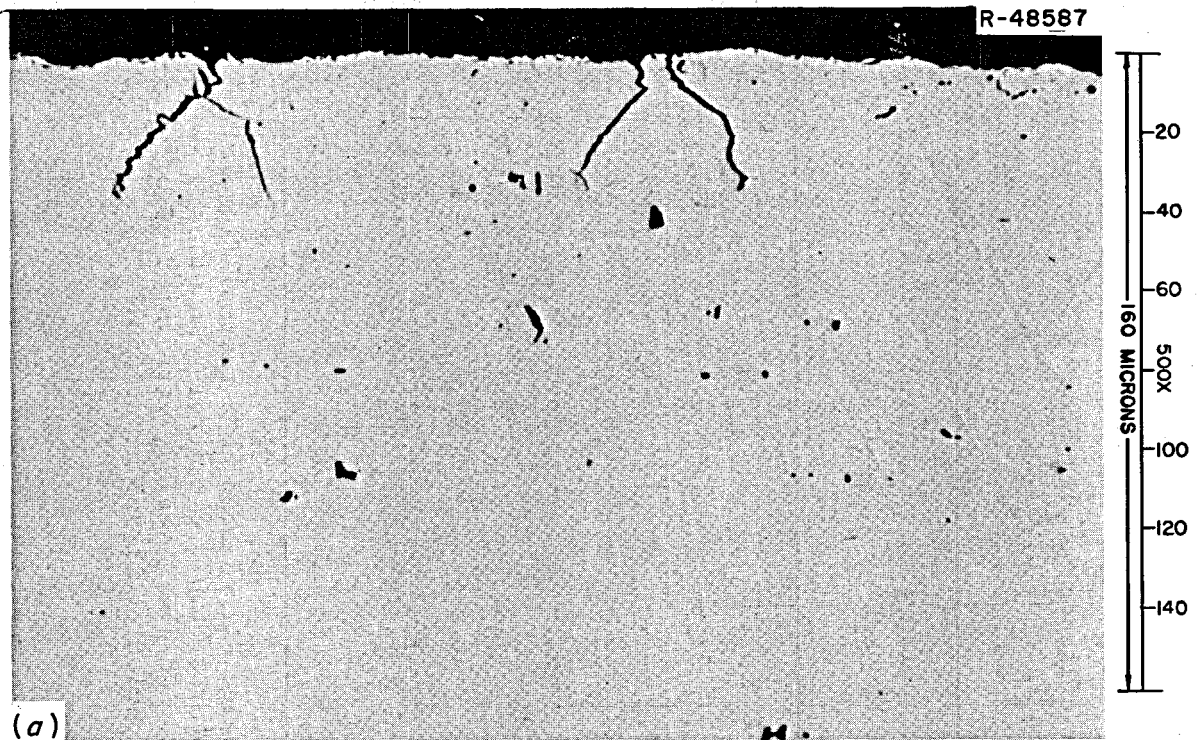
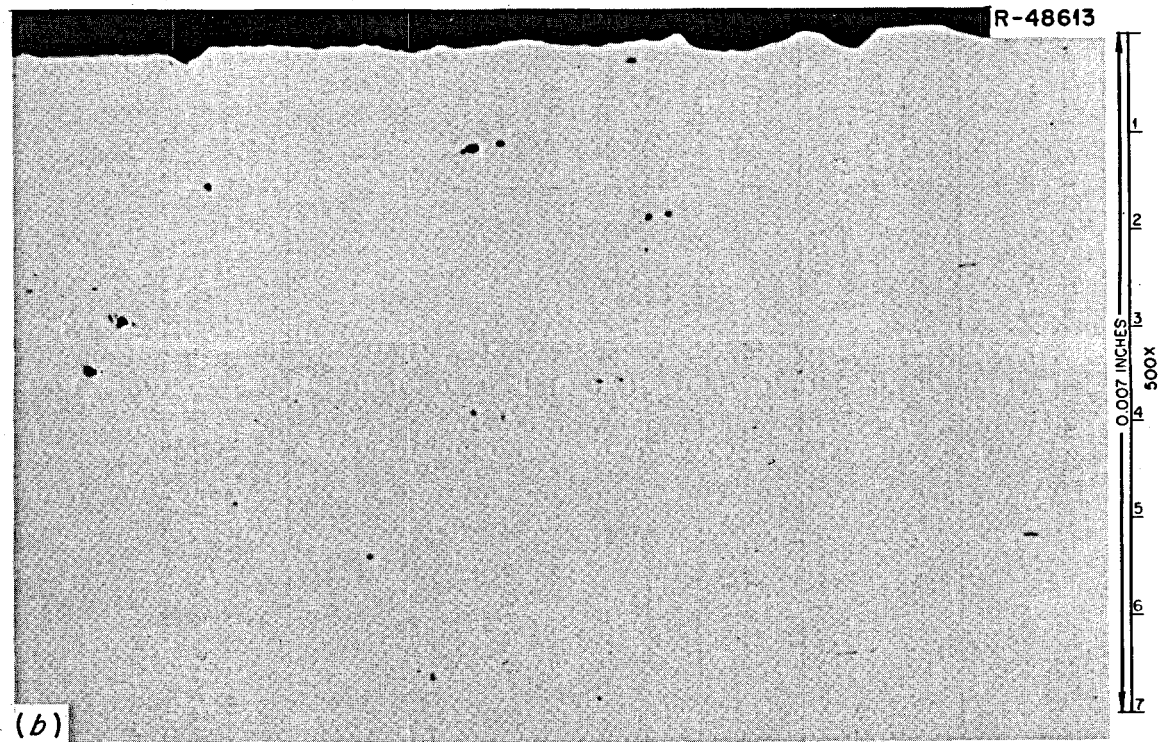
Cracking at the surface of unstrained material was even more evident in the examination of the straps that bound stringer RR2. These straps and those around the control stringer CR2 were of standard INOR-8 heat 5055. As shown in Fig. 22, the strap exposed in the core had cracks to a depth of about 1.5 mils. Cracks were distributed uniformly, both on surfaces exposed to flowing salt and those facing the graphite specimens. In contrast, the straps exposed in the control facility did not show any cracks. The straps after being formed, had been annealed for 1 hr at 1180°C and should not have been stressed thereafter since they expanded more at high temperature than did the graphite they enclosed.

Fig. 22. Photomicrographs of INOR-8 (Heat 5055) after Exposure to (a) the MSRE Core and (b) the MSRE Control Facility for 11,933 hr above 500°C. This material was used for straps for the surveillance assembly. As polished. 500x.

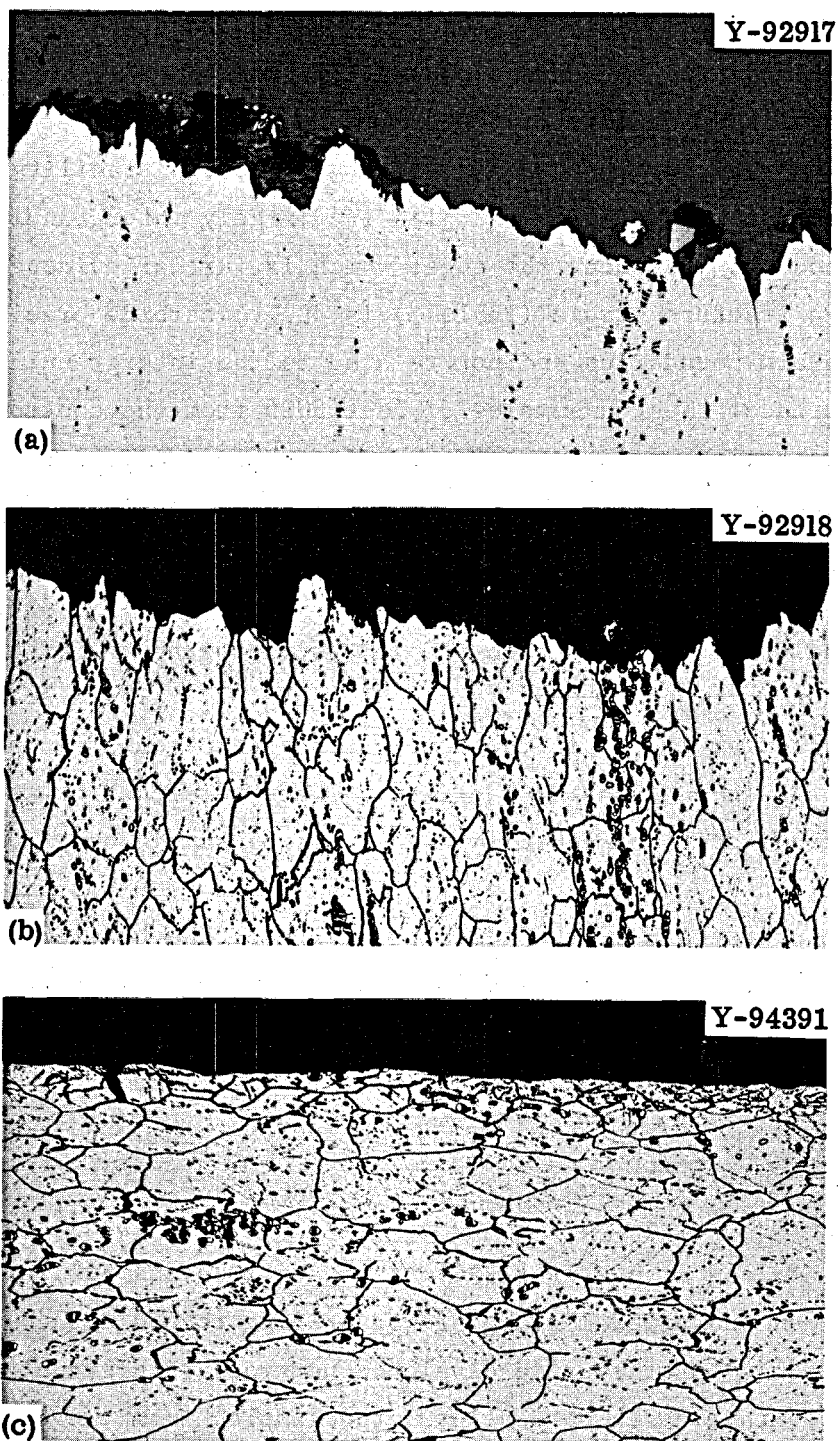
Microstructures of stressed samples of heat 5065 from the control facility and from the core are shown in Figs. 23 and 24, respectively. Numerous intergranular edge cracks are found in the sample from the core (Fig. 24) and very few in the sample from the control facility (Fig. 23). The fractures of both of these samples are largely intergranular at all locations and not just near the edge, which is further evidence that the reduction in fracture strain (Table 5) is due to carbide precipitation along the grain boundaries and not related to the intergranular cracking near the surface. Tested samples of heat 5085 from the control facility and the core are shown in Figs. 25 and 26, respectively. The as-polished views in the latter figure show some of the large carbide particles that fractured during testing.

Fig. 23. Photomicrographs of a INOR-8 (Heat 5065) Sample Exposed to Static Barren Fuel Salt for 11,933 hr above 500°C and Then Tested at 25°C and a Strain Rate of 0.05/min. 100×. (a) Fracture, as polished. (b) Fracture, etched. (c) Edge of stressed portion, etched. Etchant: glyceria regia.

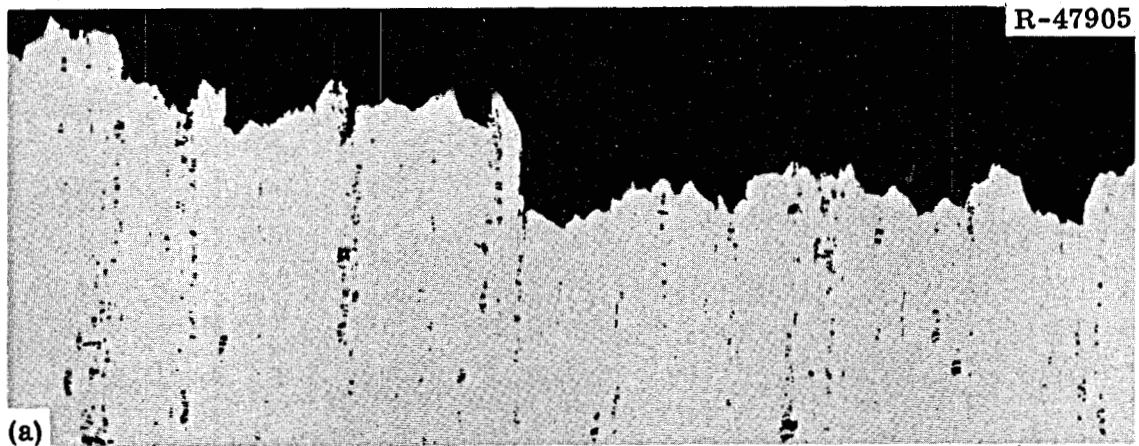
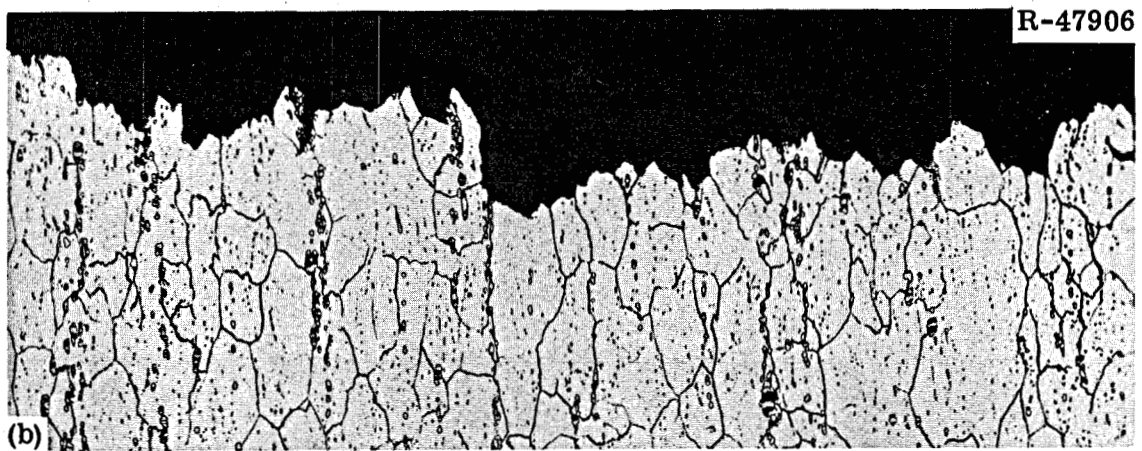
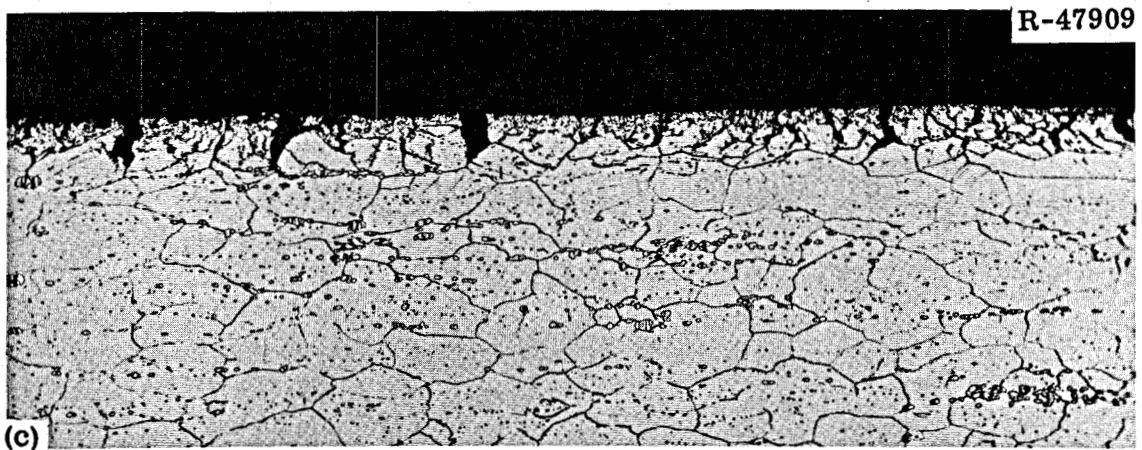
Fig. 24. Photomicrographs of INOR-8 (Heat 5065) Sample Exposed to Fluoride Salt in the MSRE for 11,933 hr above 500°C and Then Tested at 25°C and a Strain Rate of 0.05/min. Thermal fluence was 9.4×10^{20} neutrons/cm². 100x. (a) Fracture, as polished. (b) Fracture, etched. (c) Edge of stressed portion. Etchant: aqua regia.

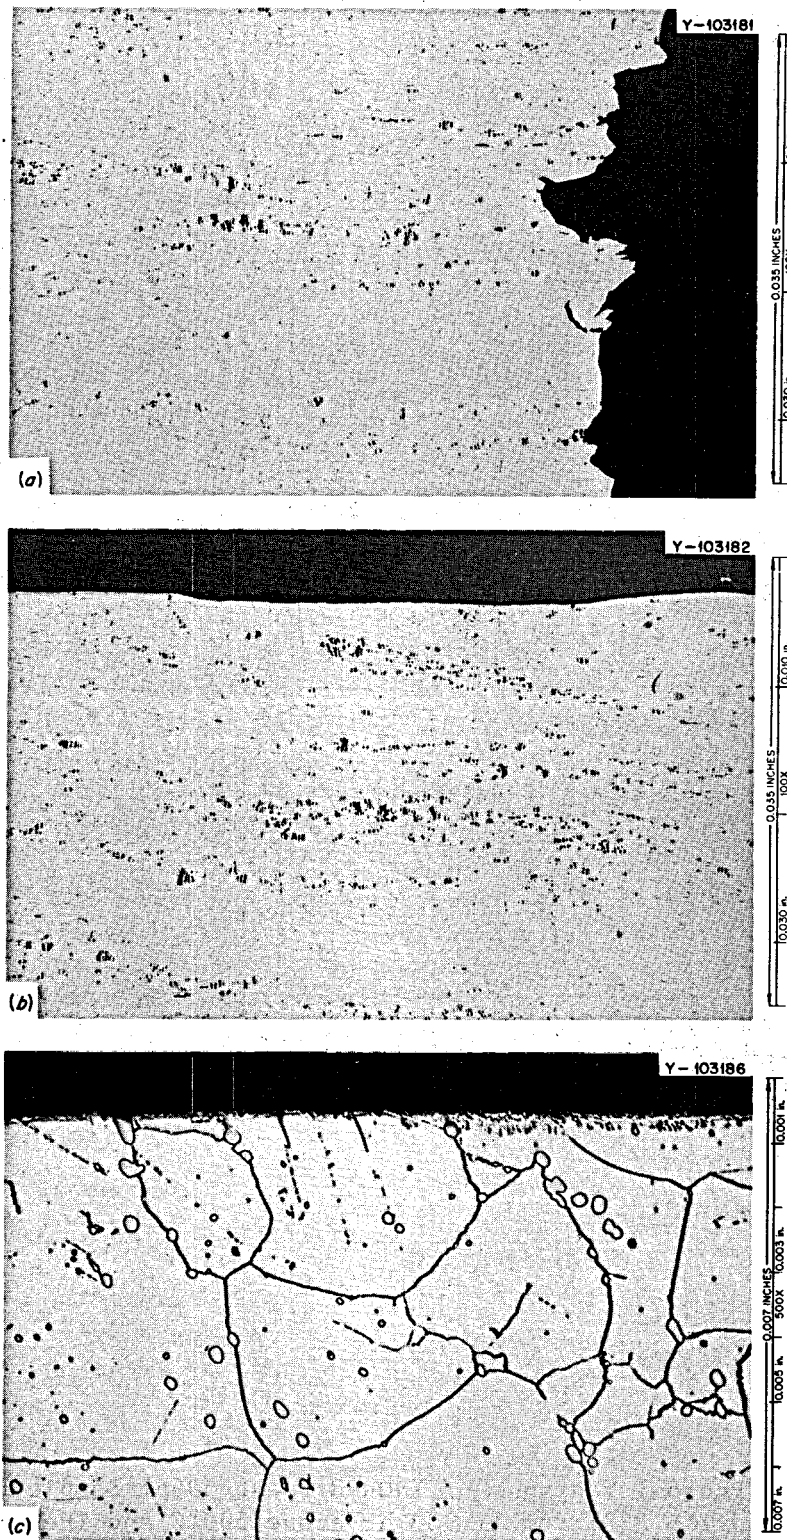
Fig. 25. Photomicrographs of INOR-8 (Heat 5085) Specimen Exposed to Depleted Static Fuel Salt for 11,933 hr at 650° and Strained at 25°C. (a) Fracture, as polished, (b) typical edge of gage section, as polished, (c) typical unstressed edge, etched with glyceria regia.
