INTERGRANULAR CRACKING OF INOR-8 IN THE MSRE

H. E. McCoy
B. McNabb

ORNL-4829
UC-25 — Metals, Ceramics, and Materials

NOVEMBER 1972

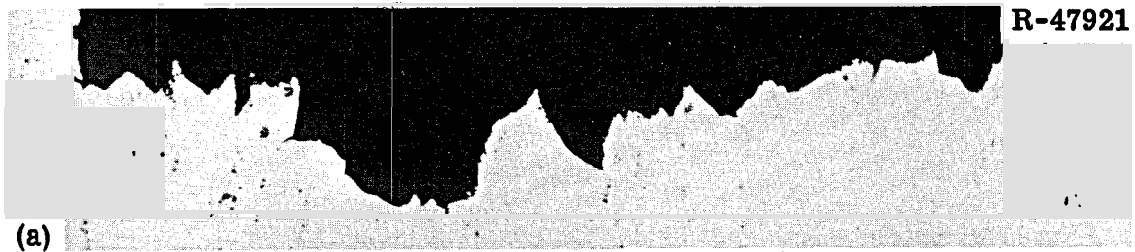
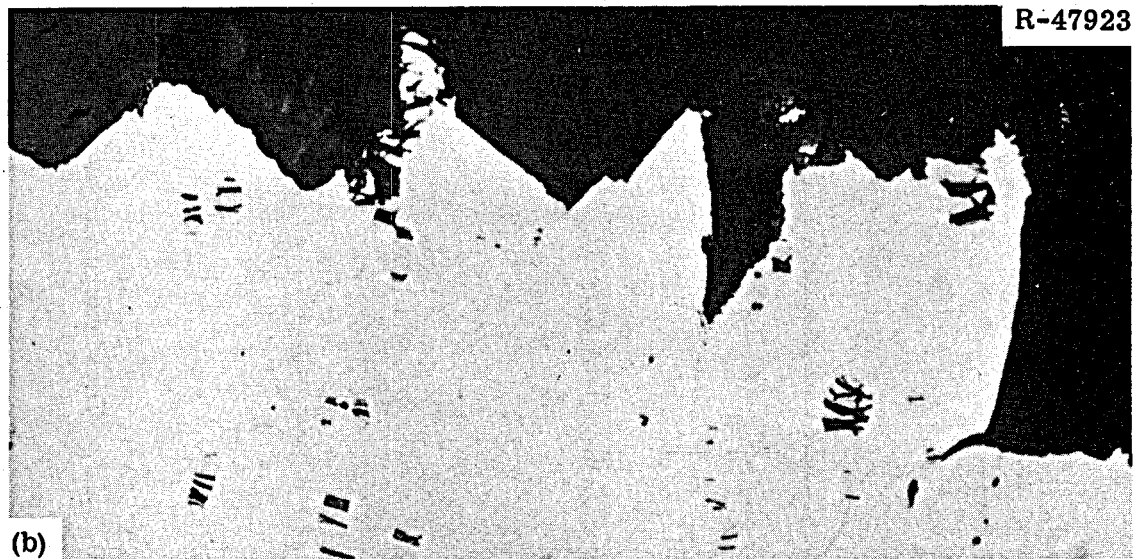
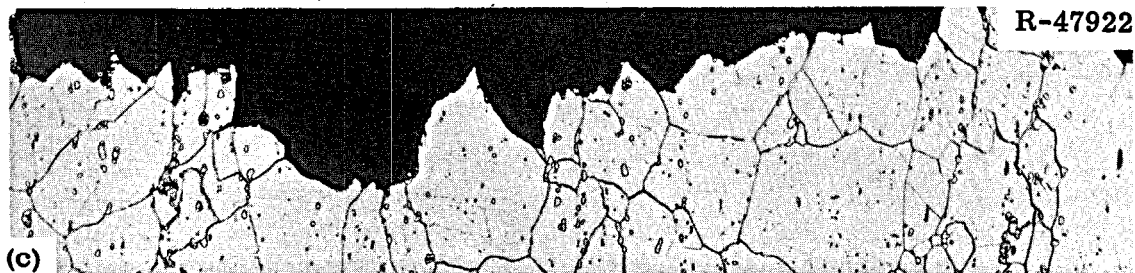
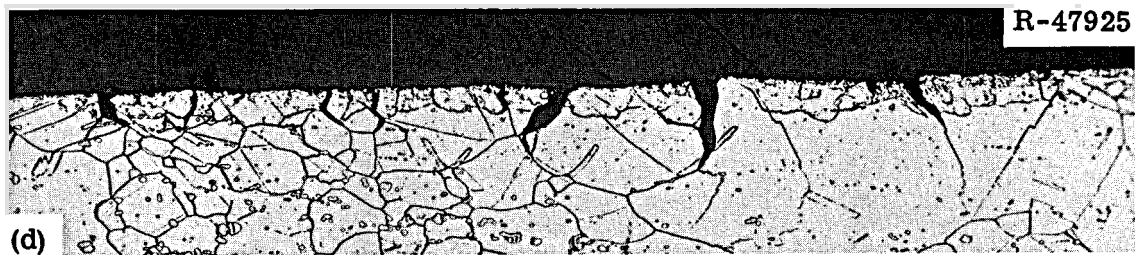
Fig. 26. Photomicrographs of INOR-8 (Heat 5085) Sample Exposed to Fluoride Salt in the MSRE for 11,933 hr above 500°C and then Tested at 25°C. Thermal fluence was 9.4×10^{20} neutrons/cm². (a) Fracture, as polished. 100x. (b) Fracture, as polished. 500x. (c) Fracture, etched. 100x. (d) Edge of stressed portion, etched. 100x. Etchant: aqua regia.

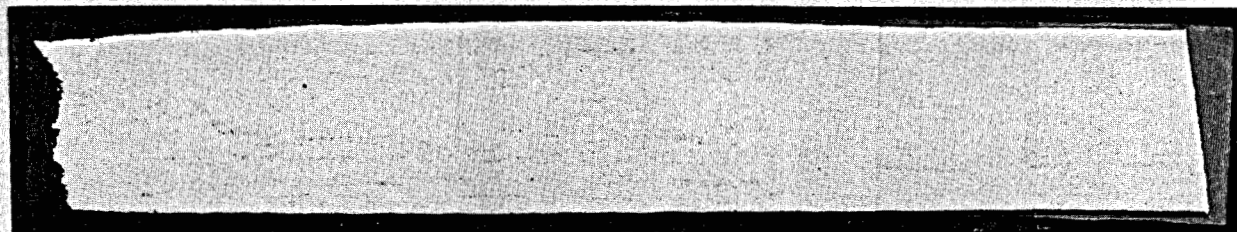
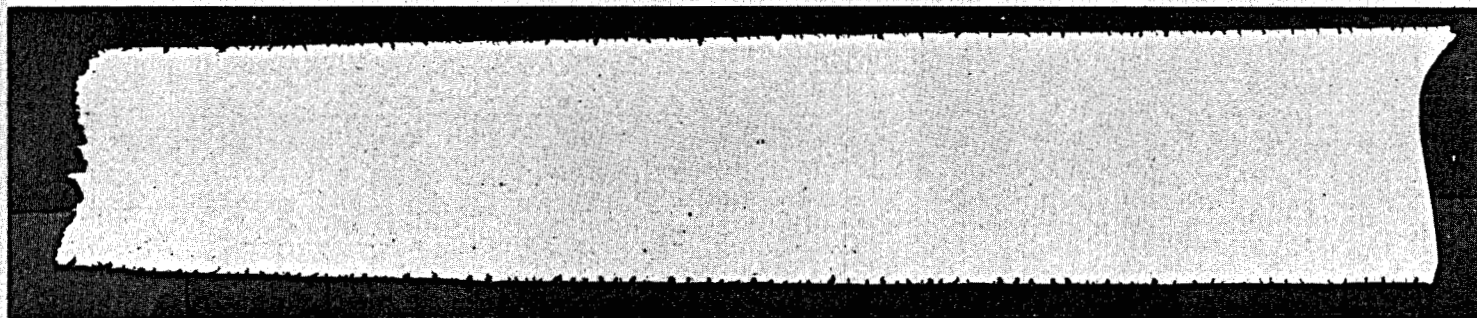
The samples that were fractured at 25°C were repolished at a later date, one-half of each fractured sample was photographed. The composite microstructures for heat 5065 are shown in Fig. 27. There are obviously more intergranular cracks in the sample exposed to the core than in the sample exposed in the control facility. There were 3 cracks per inch with an average depth of 1.0 mil in the control sample and 230 cracks per inch with an average depth of 1.8 mils in the sample from the core. A composite photograph of the tested portions of the heat 5085 sample is shown in Fig. 28. There were 134 cracks per inch along the edge of the sample from the core with an average depth of 1.9 mils. None were visible along the edge of the control specimen.

Fig. 27. Sections of Heat 5065 Tested at 25°C After Exposure to Fuel Salt for 11,933 hr above 500°C. Diameters of specimens are about 0.1 in. The fractures are on the left end.

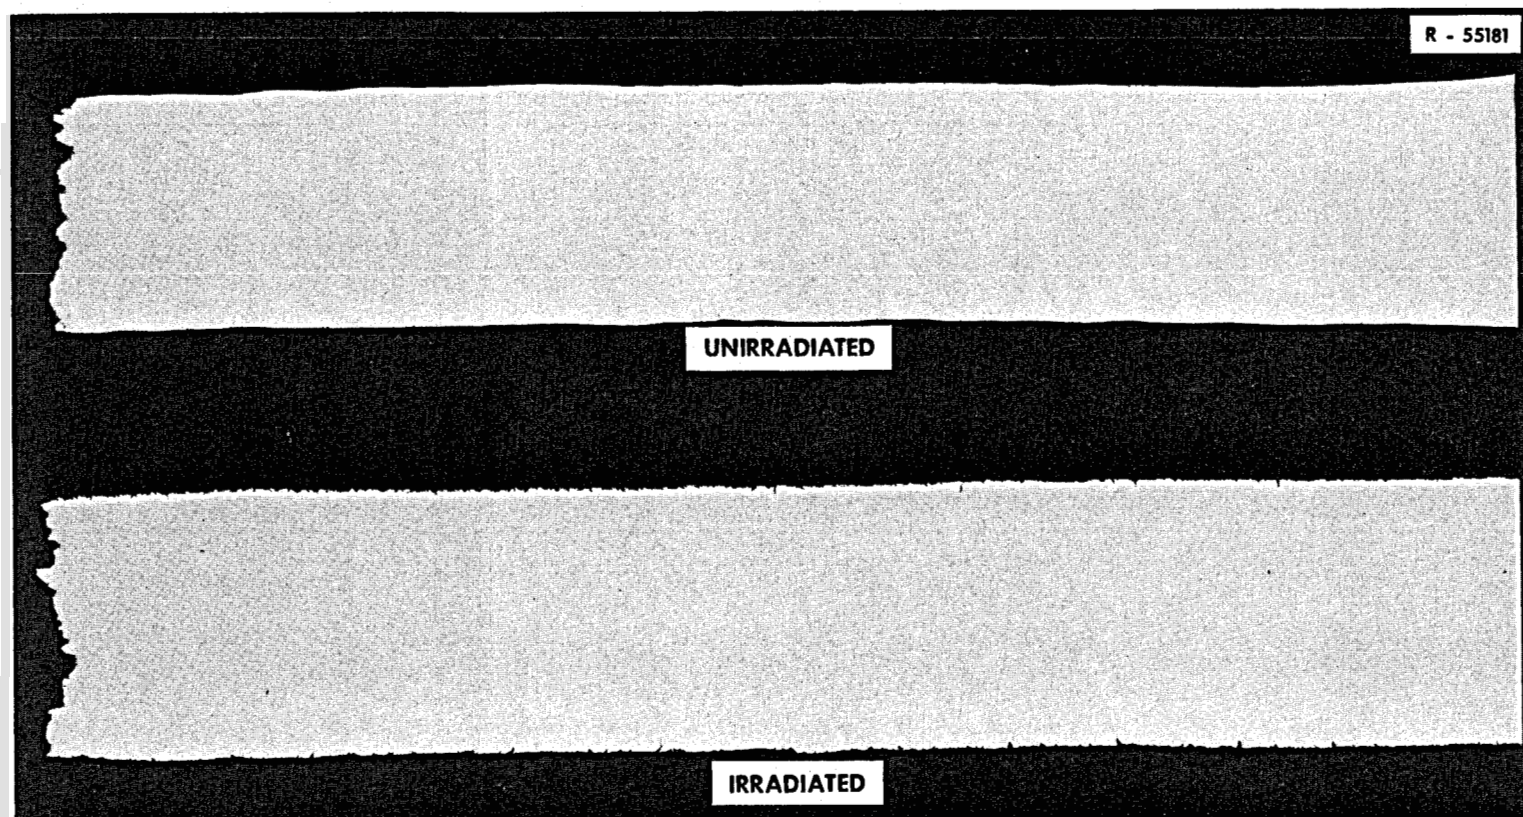
Fig. 28. Photomicrographs of INOR-8 Specimens Strained to Fracture After 11,933 hr above 500°C. The upper sample was in the control facility and the lower sample was in the MSRE core. The sample diameter is about 0.1 in.

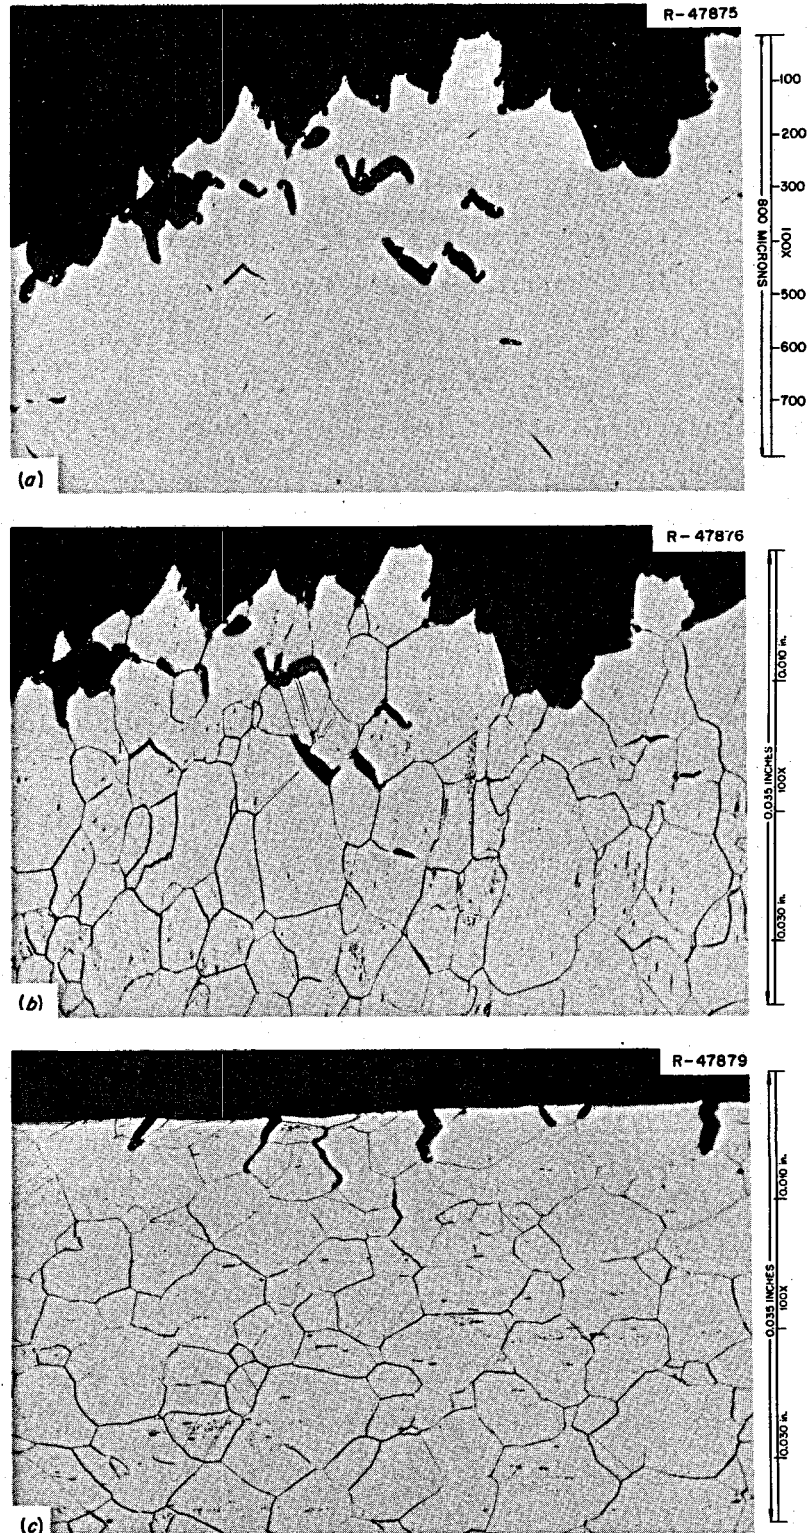
Stringer RS3 with the specimens of modified alloy had been exposed about half as long as stringer RR2 with heats 5065 and 5085. The modified alloy specimens deformed more before fracturing than did the standard alloy specimens, but they also developed numerous intergranular edge cracks. As with the standard alloys, the samples from the control facility did not show edge cracks.

Fig. 30. Photomicrographs of Alloy 67-502 Sample Exposed to Fluoride Salt in the MSRE for 6379 hr Above 500°C and then Tested at 25°C. 100x. (a) Fracture, as polished. (b) Fracture, etched. (c) Edge of stressed portion, etched. Etchant: aqua regia. Reduced 33%.

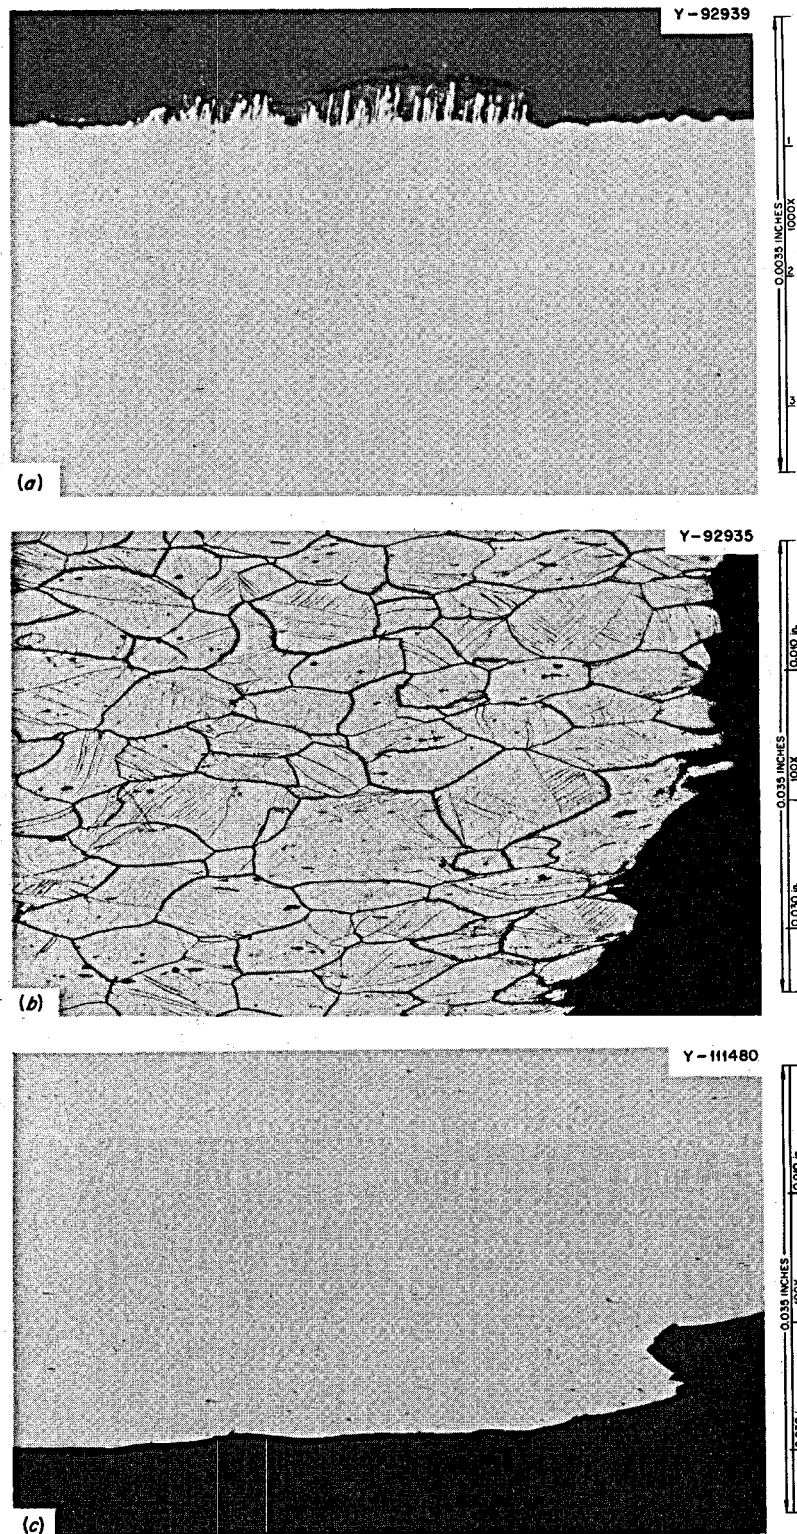
Photomicrographs of samples of heat 67-504 tested at 25°C after exposure in the control facility and in the core are shown in Figs. 31 and 32. This heat modified with 0.50% Hf, contained 0.07% Fe. As shown in Fig. 31, iron deposited on the surface of this heat as it did on 67-502. This sample, from the control facility, deformed 55% before failing with a mixed inter- and transgranular fracture. There were no intergranular edge cracks. The sample exposed in the core deformed 52% before fracture. The fracture was primarily transgranular but there were frequent edge cracks (Fig. 32). Most boundaries were cracked, but the cracks extended only to a depth of about 2 mils in the fields that were photographed.

Fig. 31. Photomicrographs of Alloy 67-504 (see Table 1) Exposed to Depleted Fuel Salt for 6379 hr Above 500°C and Tested at 25°C. (a) Edge of unstressed portion, (b) Fracture, (c) Edge of stressed portion. Figs (a) and (c) as-polished and Fig. (b) etched with glyceria regia. Reduced 33.5%.

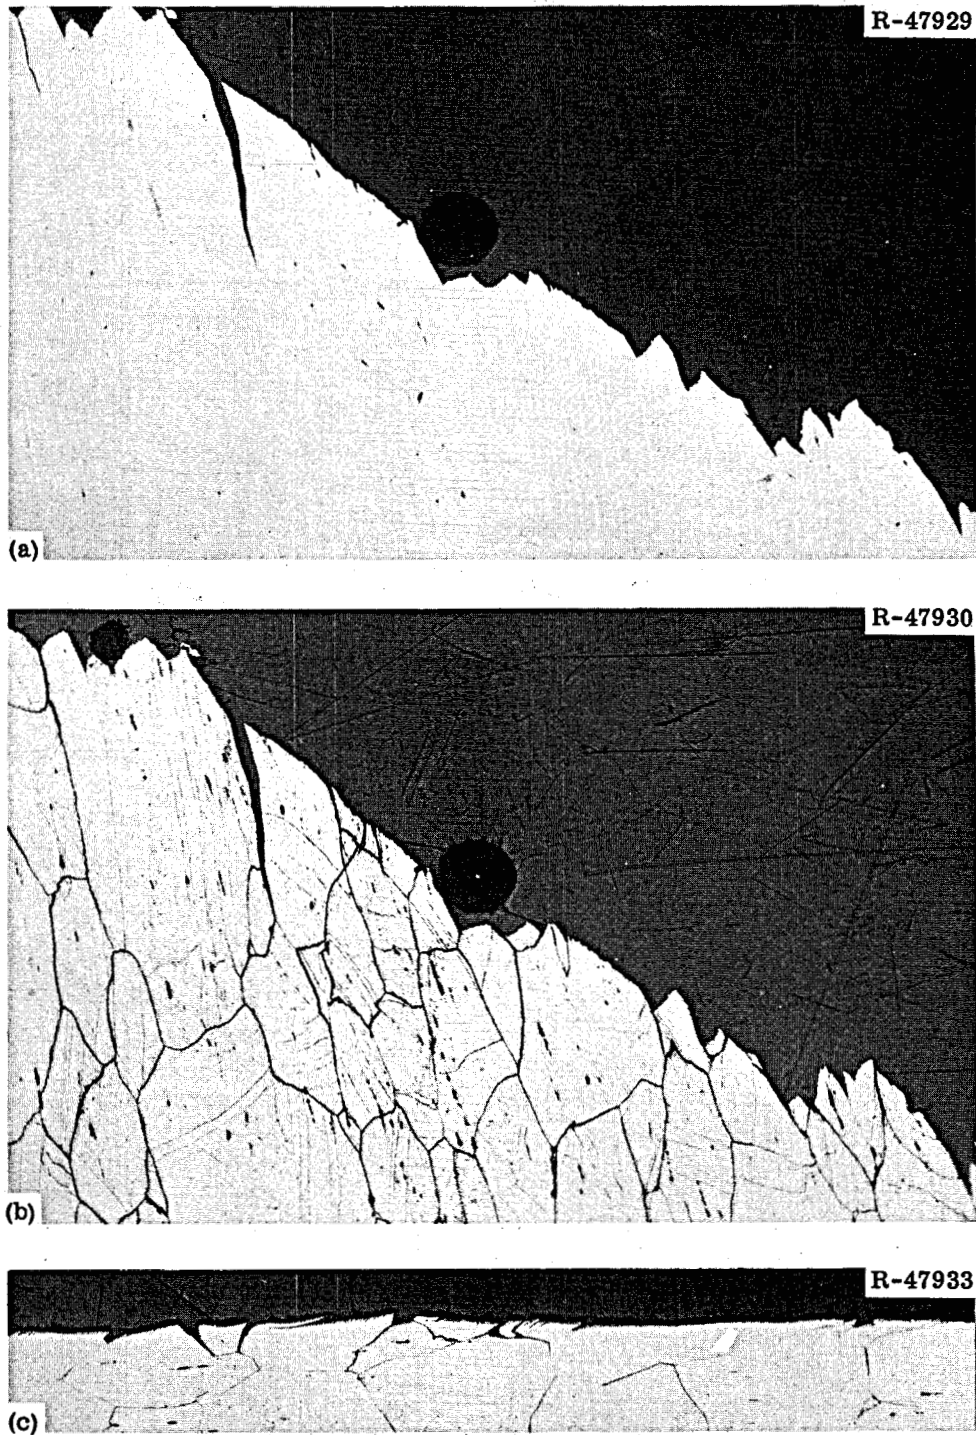
Fig. 32. Photomicrographs of INOR-8 (Heat 67-504) Sample Exposed to Fluoride Salt in the MSRE for 6379 hr Above 500°C and Tested at 25°C. 100x. (a) Fracture, as polished. (b) Fracture, etched. (c) Edge of Stressed portion, etched. Etchant: aqua regia. Reduced 14%.

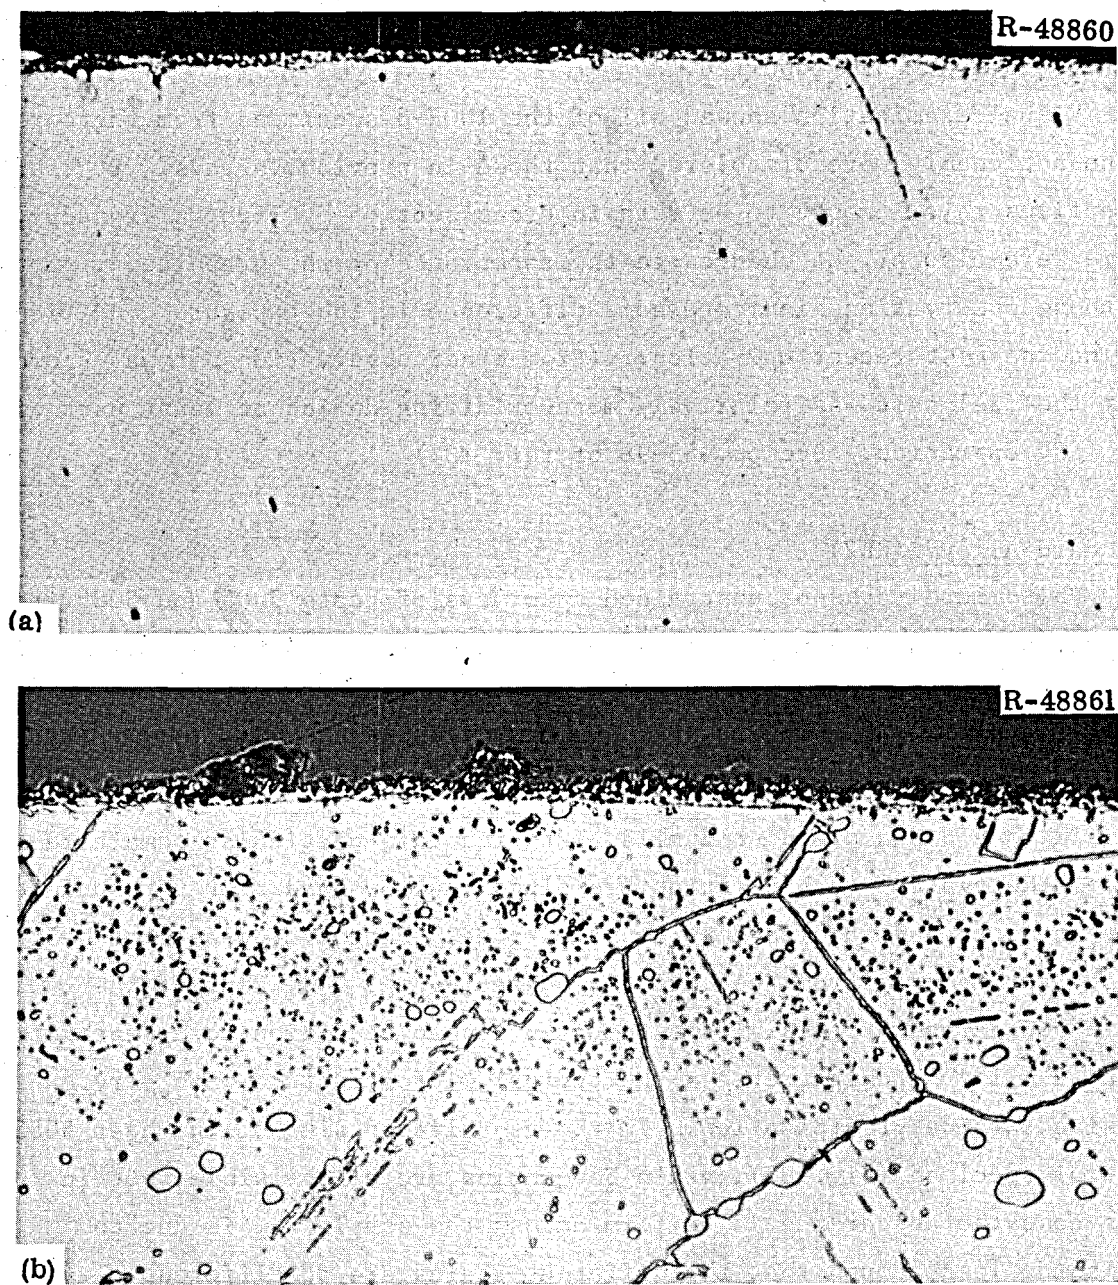
Photomicrographs of unstrained specimens of heats 5065 and 5085 from RL2 revealed many grain boundaries near the surfaces that were visible in the as-polished condition. The view of a specimen of heat 5065 in the as-polished condition, (Fig. 33) shows a thin surface layer (believed to be the cause of the visible discoloration) and some grain boundaries visible to a depth of about 2 mils. Etching this particular sample revealed the typical carbide structure plus a narrow band near the surface that seems to have a high density of carbide. Photomicrographs of heat 5085 after removal from the core are shown in Fig. 34. Many of the grain boundaries are visible in the as-polished condition to a depth of about 2 mils. Etching reveals the typical microstructure with very extensive carbide precipitation. In the as-polished view of the heat 5065 control specimen (Fig. 35), grain boundaries are also visible, but in this case the appearance is uniform across the sample and is due to polishing long enough that the different grains are at different elevations. Etching reveals the shallow surface modification and the typical carbide structure. The heat 5085 specimen from the control facility, shown in Fig. 36, was also slightly overpolished so that the grains are visible in the as-polished condition. Etching revealed the typical microstructure and the shallow surface modification.

Fig. 33. Typical Photomicrographs of INOR-8 (Heat 5065) Exposed to the MSRE Core for 19,136 hr Above 500°C. (a) As polished. (b) Etchant: aqua regia. 500x.

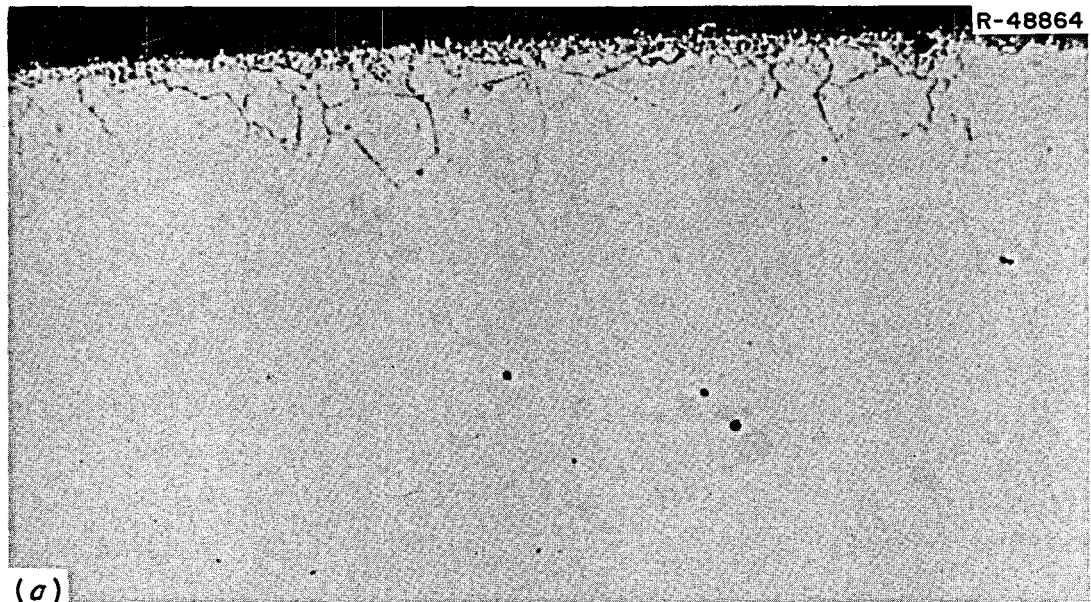
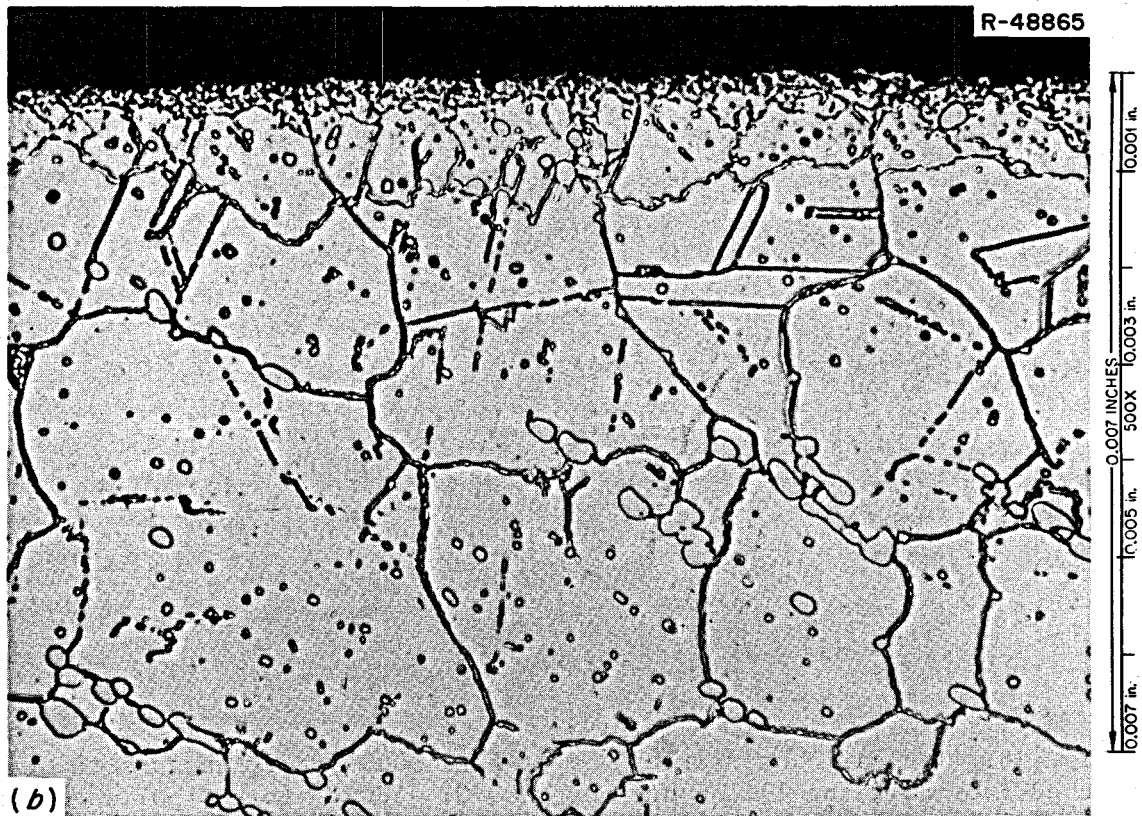
Fig. 34. Typical Photomicrographs of INOR-8 (Heat 5085) Exposed to the MSRE Core for 19,136 hr Above 500°C. (a) As polished. (b) Etchant: glyceria regia. 500x.

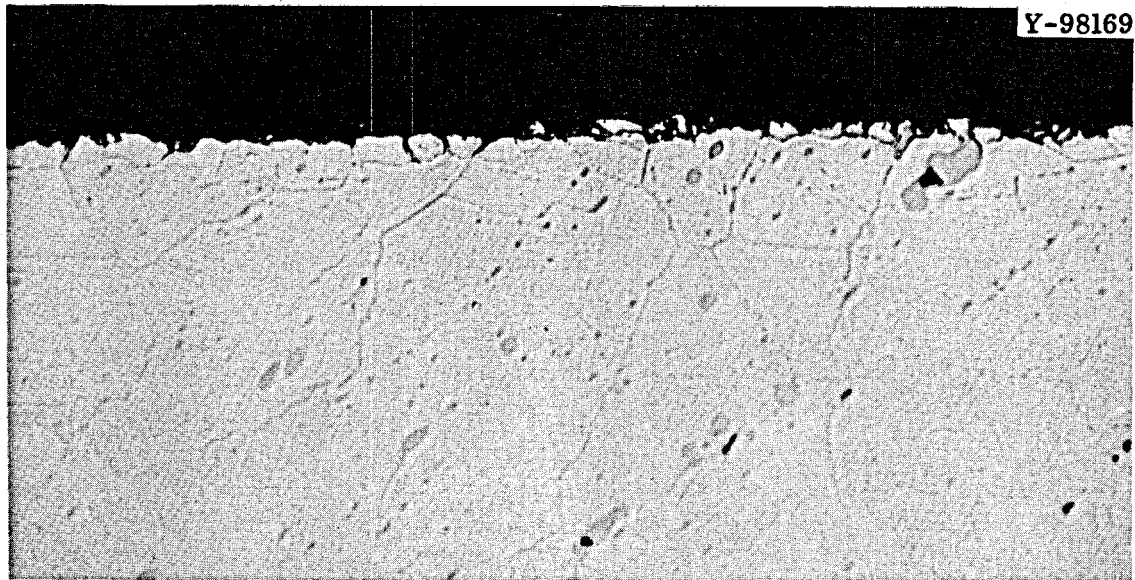
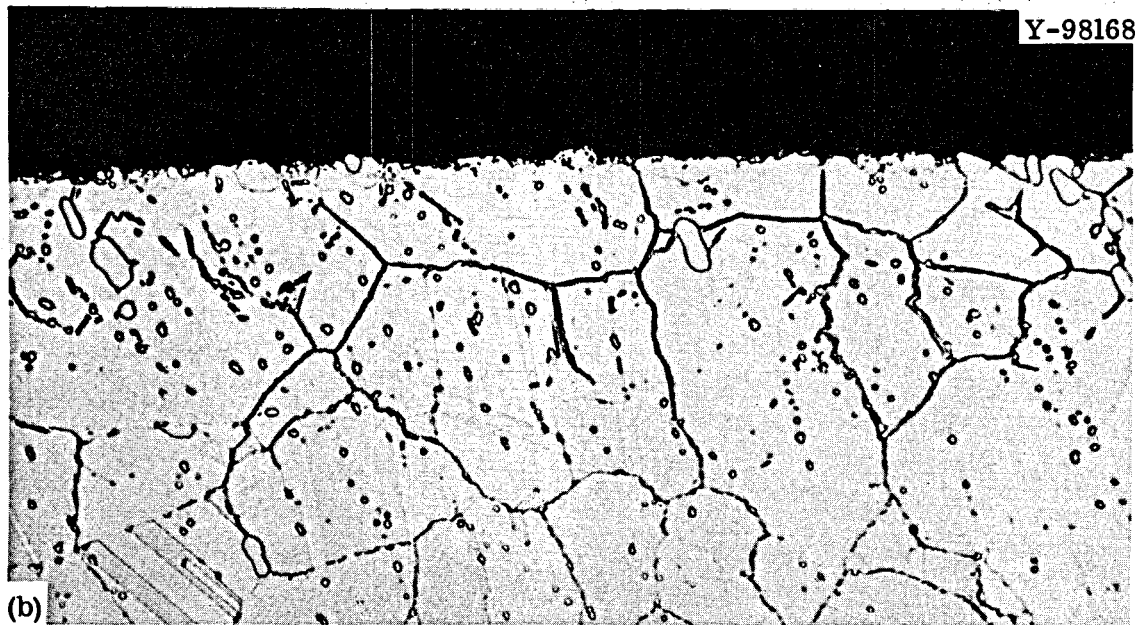
Fig. 35. Typical Photomicrographs of Heat 5065 After Exposure to Static Unenriched Fuel Salt for 19,136 hr Above 500°C. 500x. (a) As polished. (b) Etchant: glyceria regia.

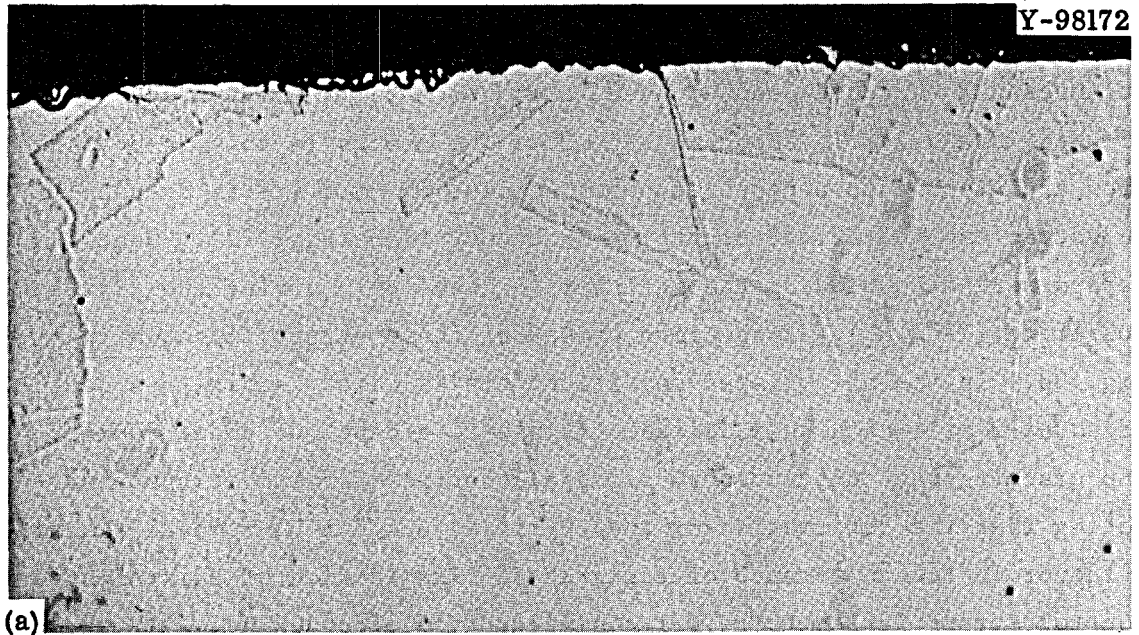
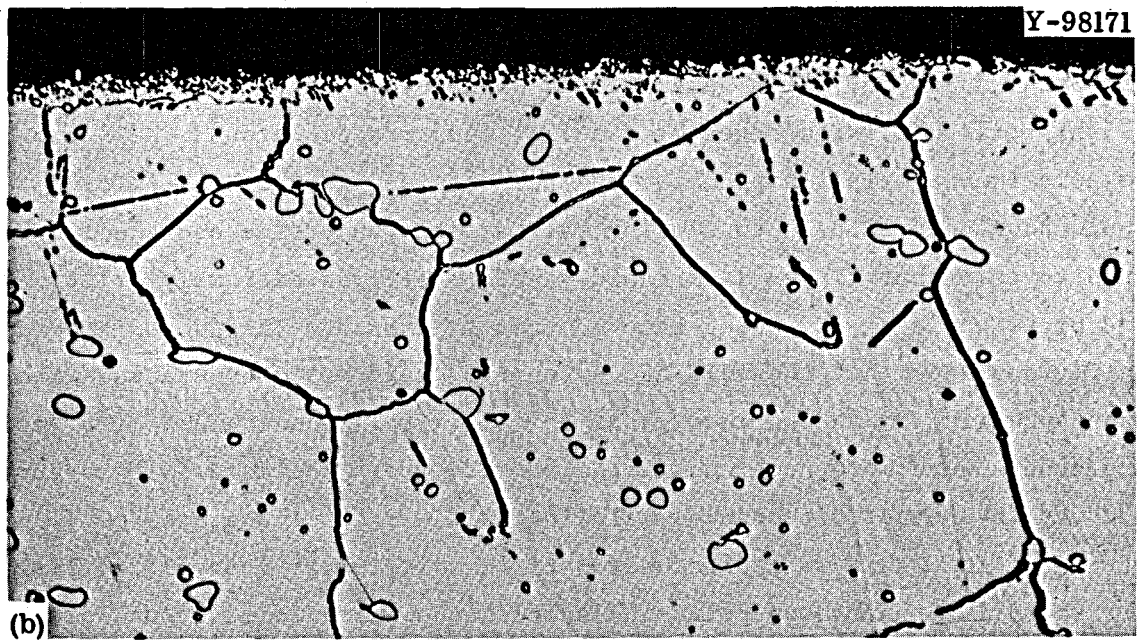
Fig. 36. Typical Photomicrographs of Heat 5085 After Exposure to Static Unenriched Fuel Salt for 19,136 hr above 500°C. 500x. (a) As polished. (b) Etchant: glyceria regia.

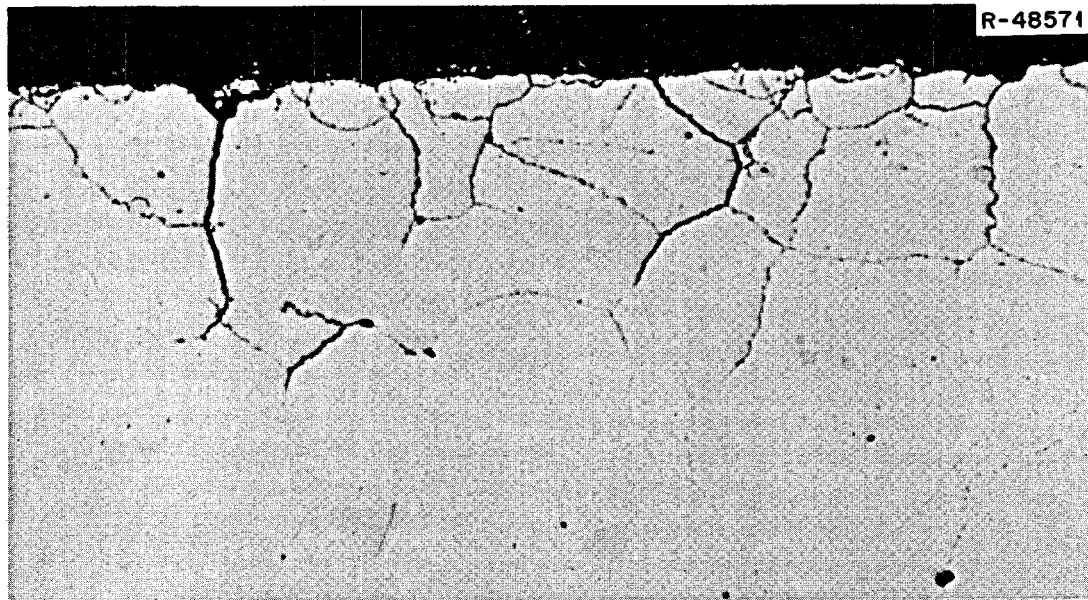
As in the previous set of core specimens, the straps of heat 5055 showed more cracks in the nominally unstrained condition than did the tensile specimens on the same stringer. A section of a strap from stringer RL2 that had been exposed, along with the specimens shown in Figures 33 and 34, is shown in Fig. 37. The cracks in this as-polished view are visible to a depth of about 3 mils, about twice as deep as in the strap exposed 12,000 hr during ^{235}U operation (Fig. 22). Heat 5055 straps were also used on the stringers exposed only during the ^{233}U operation (7200 hr). A specimen of one of these straps is shown in Fig. 38. In the as-polished condition, cracks were visible to a depth of about 1 mil; etching made them visible to a depth of about 3 mils. The cracking was quite uniform along all surfaces of the straps, indicating that the deformation of the 20-mil straps during removal was not a factor in the appearance of the cracks. Examination of unirradiated control straps failed to reveal a similar type of cracking.

Fig. 37. Typical Microstructure of INOR-8 (Heat 5055) After Exposure to the MSRE Core for 19,136 hr Above 500°C. This material was used for straps for the surveillance assembly. As polished. 500x.

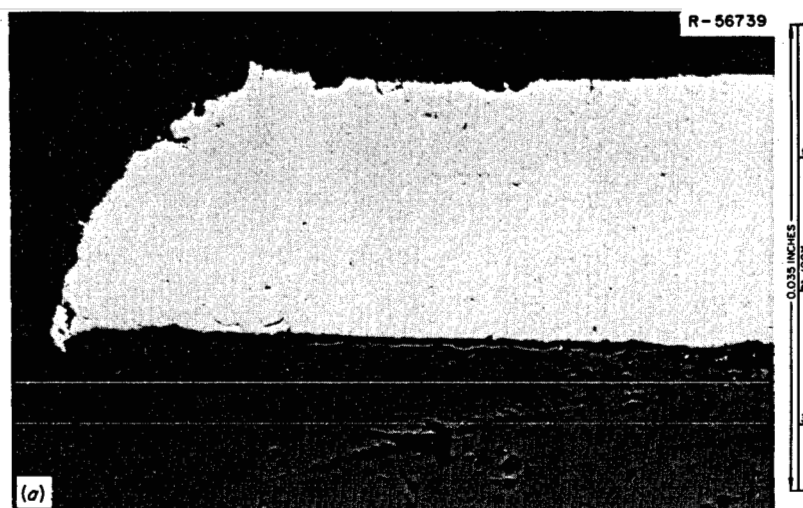
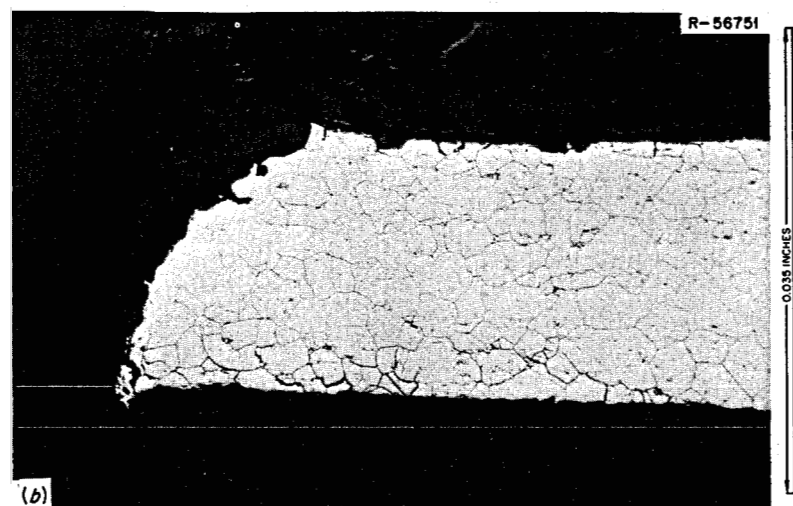
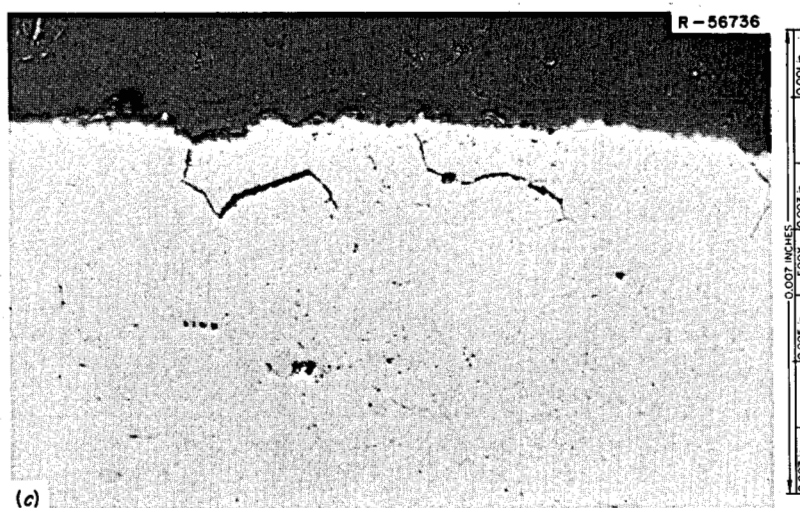
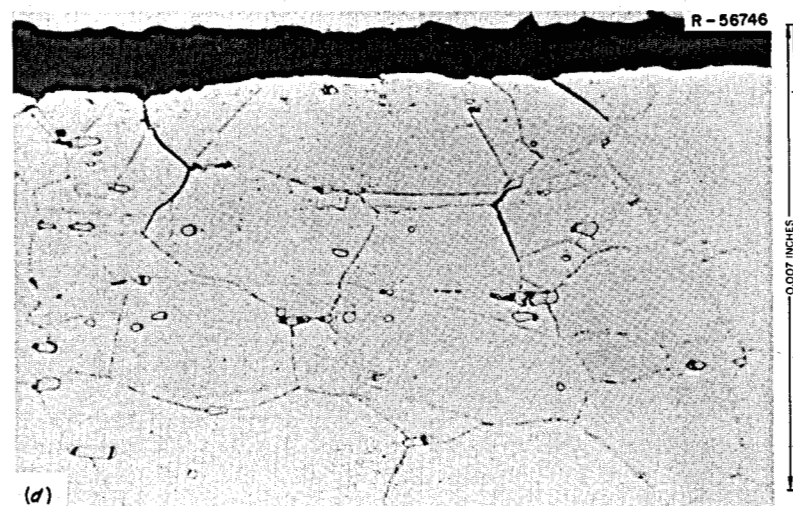
One other interesting specimen that showed extensive cracking was a piece of thin INOR-8 sheet (heat 5075) that had been attached to the strap shown in Fig. 38. The sheet had been rolled to 4 mils and annealed 0.5 hr at 1180°C. The edges of the foil were wrapped around the strap to hold the material in place. Thus the outside surface of the foil would have been exposed to flowing salt and the underside and the folded ends to salt that flowed less rapidly. The foil was extremely brittle and broke while it was being removed from the strap. The photomicrographs in Fig. 39 show that the foil had extensive grain boundary cracks, with many appearing to extend throughout the 4 mil thickness. In some areas the cracks were more numerous on the outside where the material was curved and was in contact with rapidly flowing salt. Photomicrographs of a strap and foil that were exposed to static salt in the control facility are shown in Figs. 40 and 41. The samples showed no evidence of intergranular cracking.

Fig. 38. Photomicrographs of INOR-8 (Heat 5055) Strap Exposed to the MSRE Core 7203 hr above 500°C. (a) As-polished view near cut (b) Etched view near cut (c) As polished view of outside edge (d) Etched view of outside edge. Etchant: Lactic acid, HNO_3 , HCl . Reduced 32%.

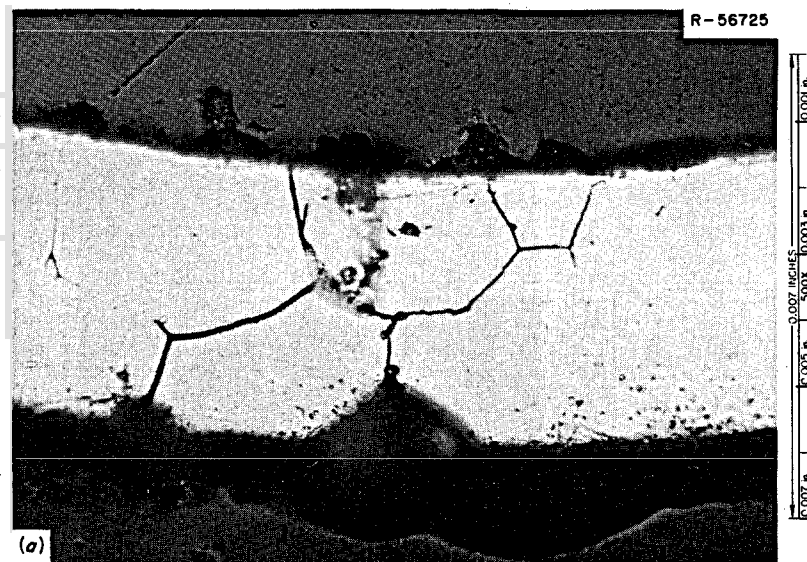
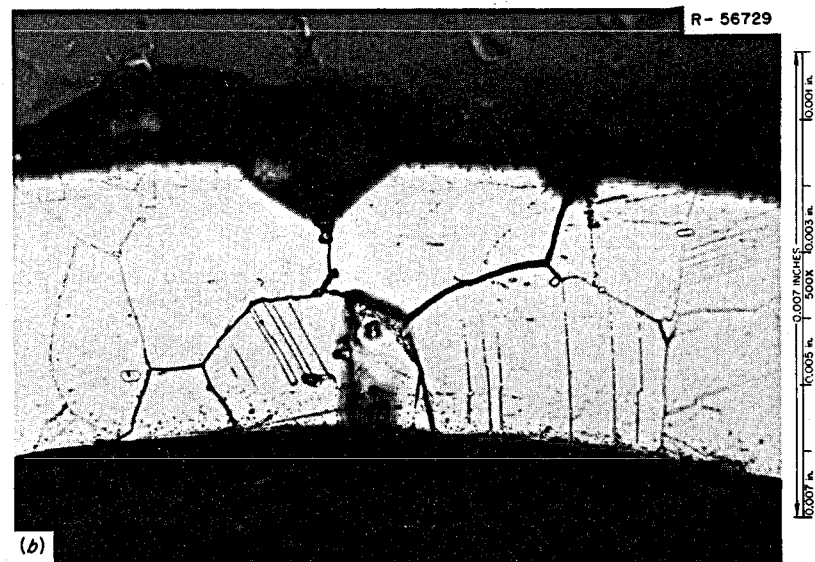
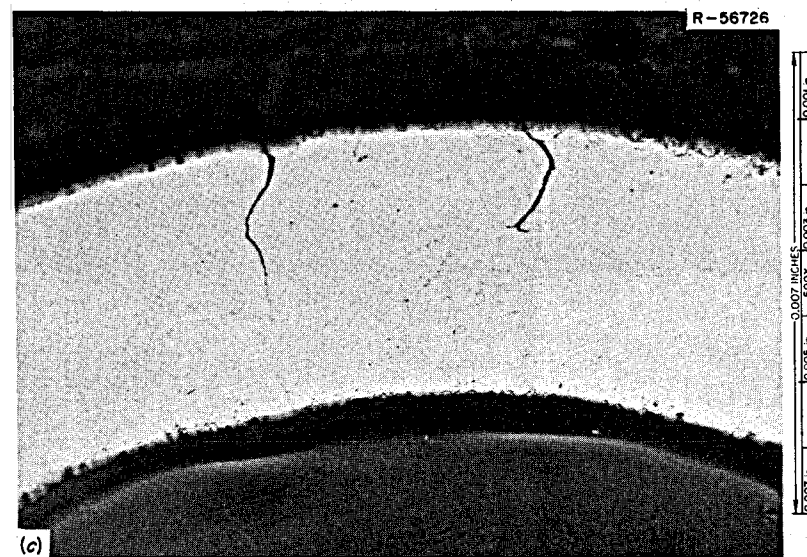
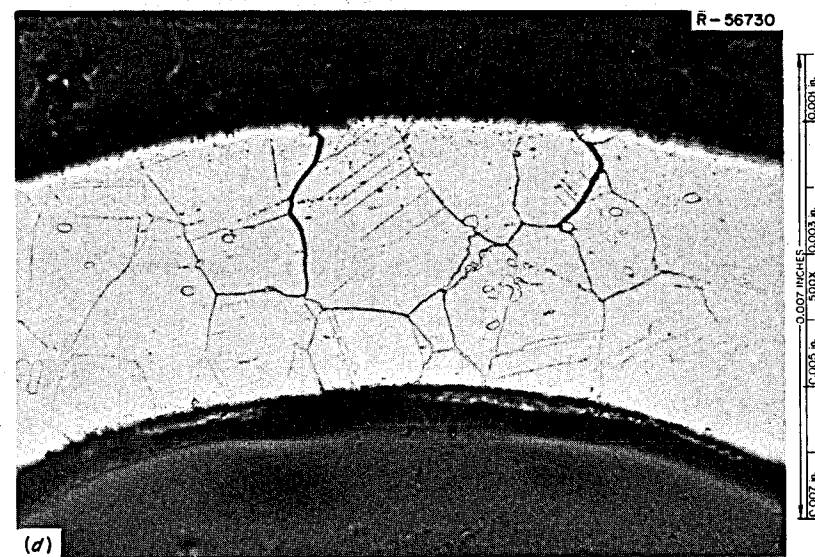
Fig. 39. Photomicrographs of Two Specimens From a Thin INOR-8 (Heat 5075) Foil that was Attached to the Strap Shown in the Previous Figure. The curvature was caused by forming before being inserted into the MSRE. (a) As polished (b) Etched (c) As polished (d) Etched. Etchant: Lactic acid, HNO_3 , HCl . Reduced 32%.

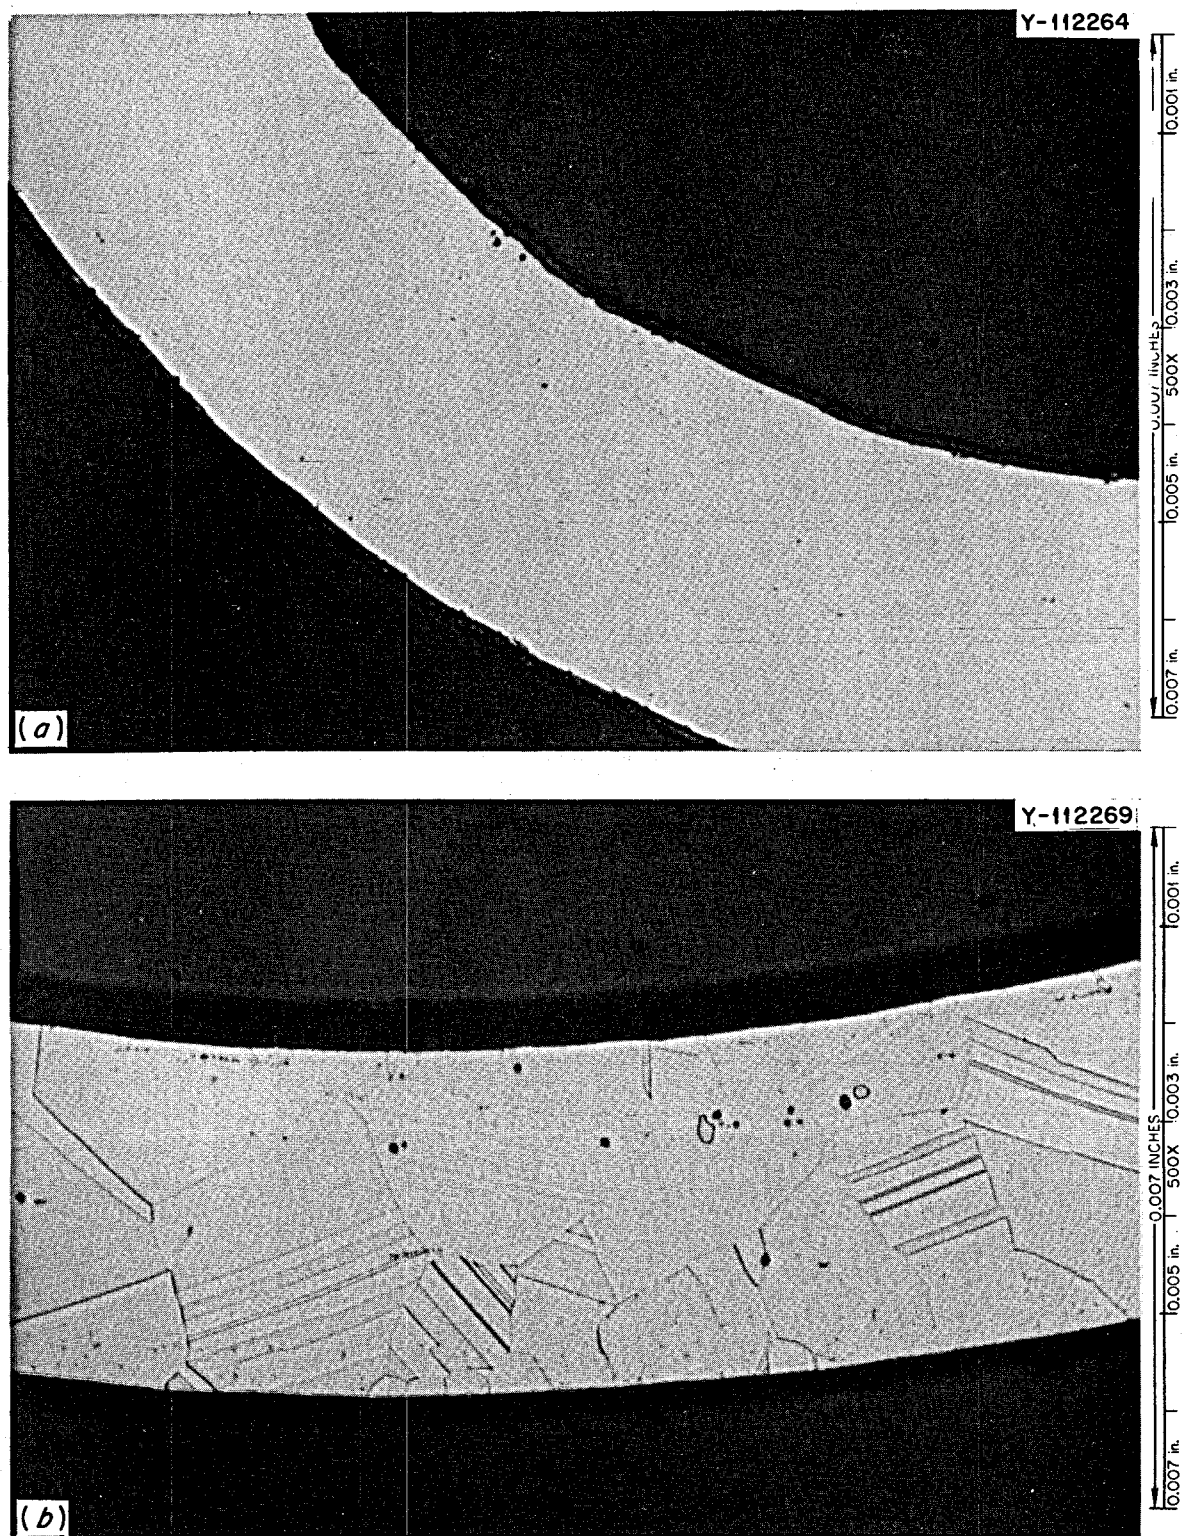
Fig. 41. Photomicrographs of a Thin INOR-8 (Heat 5075) Foil that was attached to the strap shown in the Previous Figure. (a) As Polished, (b) Etched with glyceria regia. 500x.

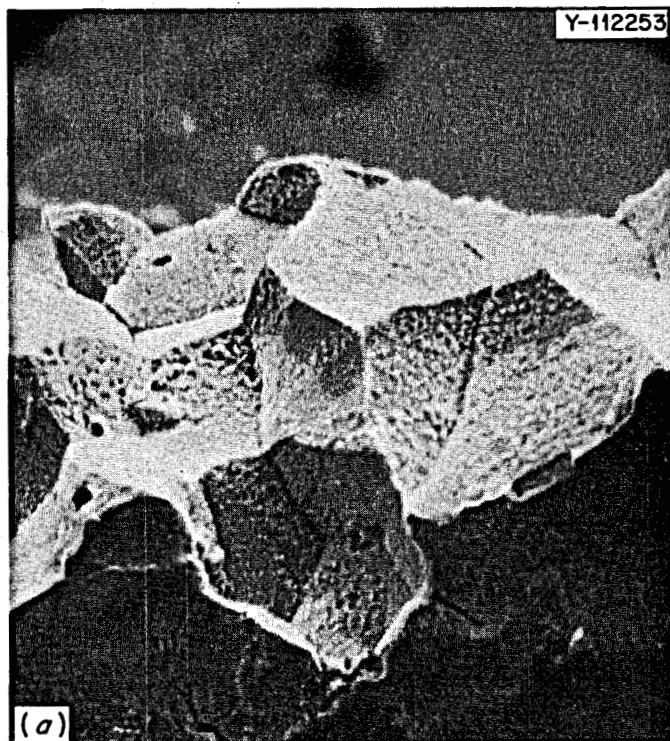
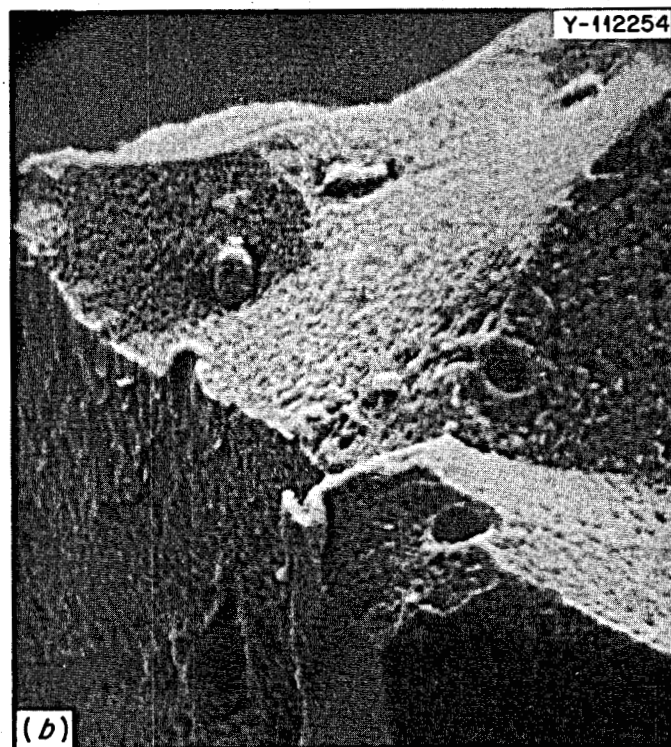
A fracture surface of the foil from the MSRE was examined by the scanning electron microscope (SEM) and Auger spectroscopy. The fracture is shown in Fig. 42 and is intergranular. The SEM with a dispersive x-ray analytical system indicated the presence only of the elements normally

Fig. 42. Scanning Electron Micrograph of INOR-8 (Heat 5075) Foil Exposed to the MSRE Core for 7203 hr Above 500°C. (a) Topographical view of fracture showing the surfaces of the fractured grain boundaries. 500x. (b) 1000x.

found in INOR-8. Auger electron spectroscopy indicated that Te, S, and Mo were concentrated in the boundaries. Definite confirmation of the presence of these elements was difficult because many of the spectra overlapped.
