INTERGRANULAR CRACKING OF INOR-8 IN THE MSRE

H. E. McCoy
B. McNabb

ORNL-4829
UC-25 — Metals, Ceramics, and Materials

NOVEMBER 1972

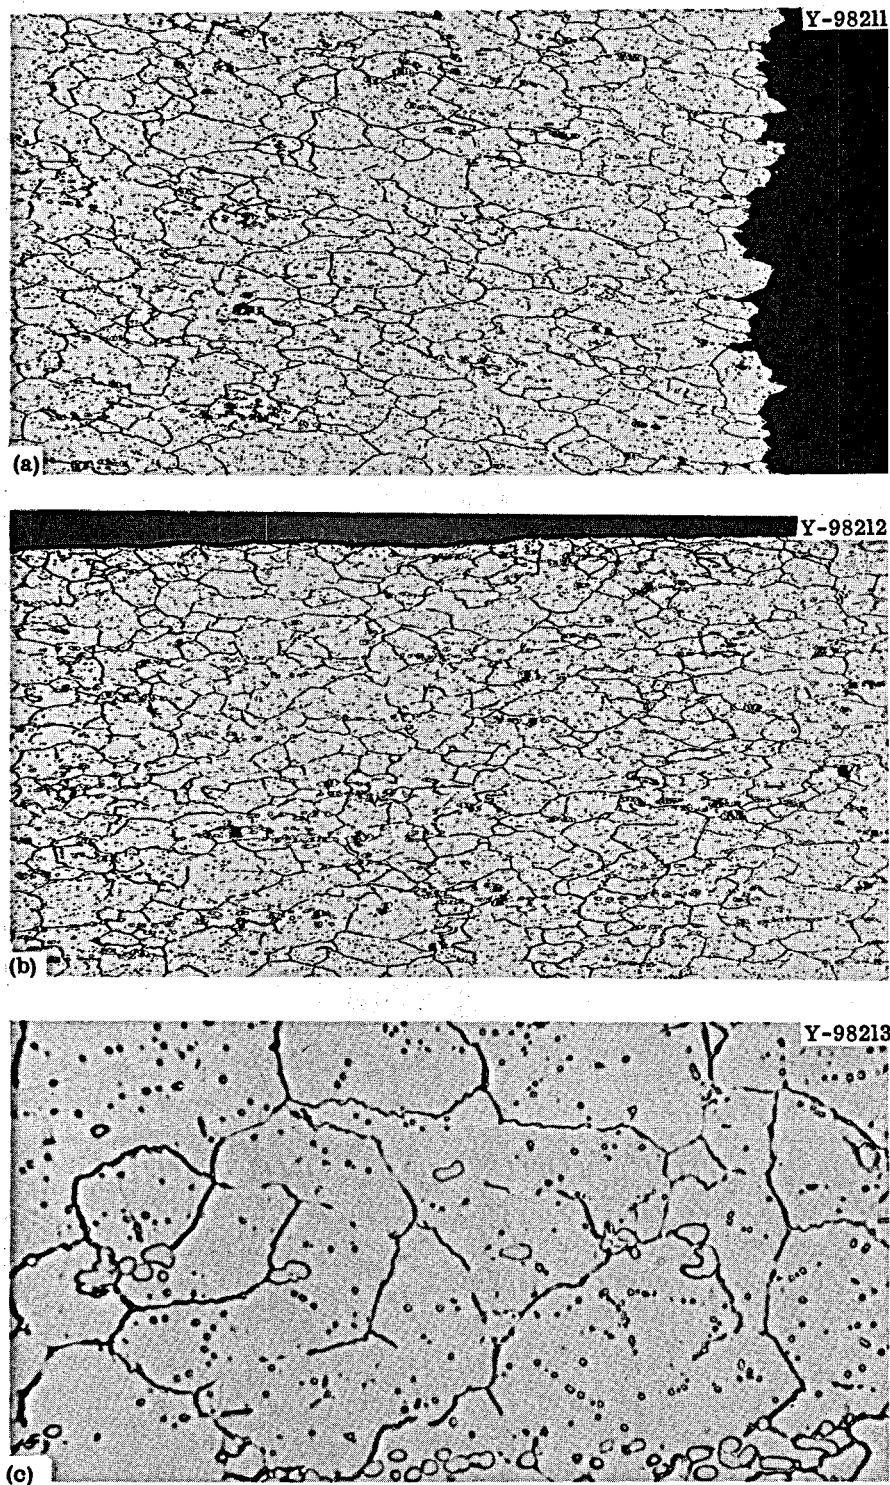
The control sample of heat 5065, whose microstructure is shown in Fig. 43, deformed 50% before fracture. The fracture is mixed intergranular and transgranular and no cracks formed along the edge away from the immediate vicinity of the fracture. The microstructure of a heat 5065 sample from the core is shown in Fig. 44. This sample deformed 43% and had a mixed fracture. Numerous intergranular cracks to a depth of about 5 mils formed along the gage length. Samples of heat 5085 from the control facility and the core are shown in Figures 45 and 46. The control sample failed after 41% strain with a mixed fracture. No intergranular cracks were visible in the field shown in Fig. 45. The sample of heat 5085 from the core that was tested at 25°C failed after much less strain (22%). As shown in Fig. 46, the fracture is mixed, and numerous intergranular cracks formed along the surfaces to a depth of 5 mils.

Fig. 43. Typical Photomicrographs of INOR-8 (Heat 5065) Sample Tested at 25°C After Being Exposed to Static Unenriched Fuel Salt for 19,136 hr above 500°C. Etchant: glyceria regia. (a) Fracture. 100x. (b) Edge near fracture. 100x. (c) Representative unstressed structure. 500x. Reduced 22%.

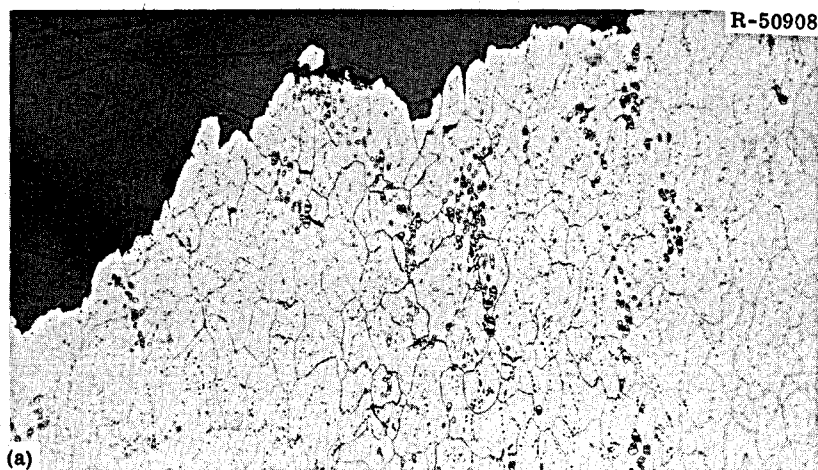
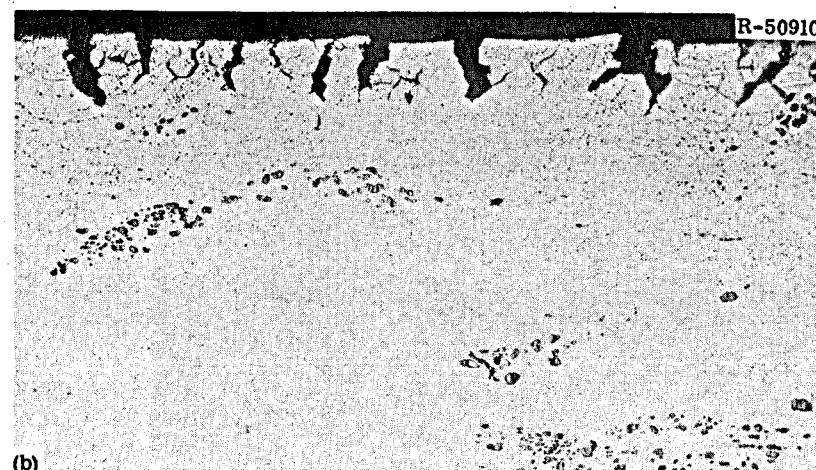
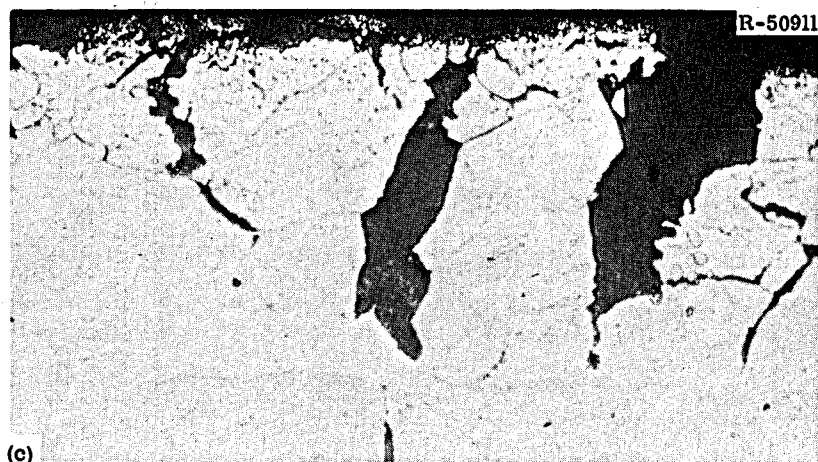
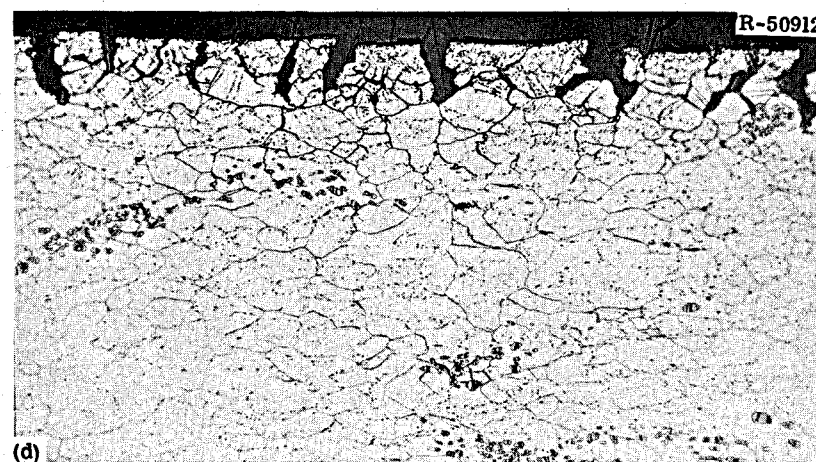
Fig. 44. Photomicrographs of INOR-8 (Heat 5065) Sample Tested at 25°C After Being Exposed to the MSRE Core for 19,136 hr Above 500°C and Irradiated to a Thermal Fluence of 1.5×10^{21} neutrons/cm². (a) Fracture, etched. 100x. (b) Edge, as polished. 100x. (c) Edge, as polished. 500x. (d) Edge, etched. 100x. Etchant: glyceria regia. Reduced 26%.

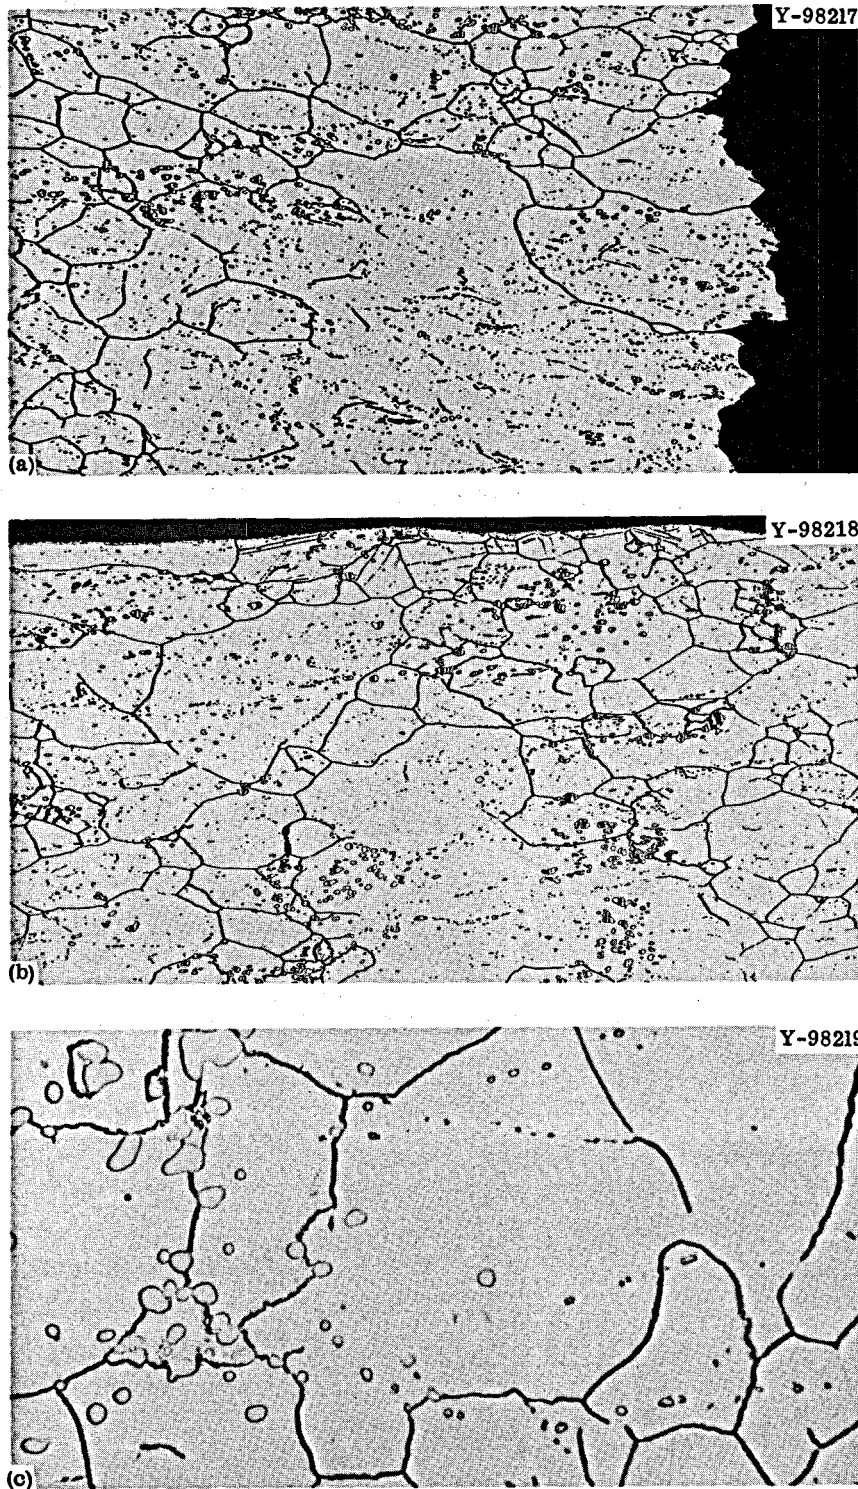
Fig. 45. Typical Photomicrographs of INOR 8 (Heat 5085) Sample Tested at 25°C After Being Exposed to Static Unenriched Fuel Salt for 19,136 hr Above 500°C. (a) Fracture, etched. 100x. (b) Edge near fracture, etched. 100x. (c) Representative unstressed structure, etched. 500x. Etchant: glyceria regia. Reduced 24.5%.

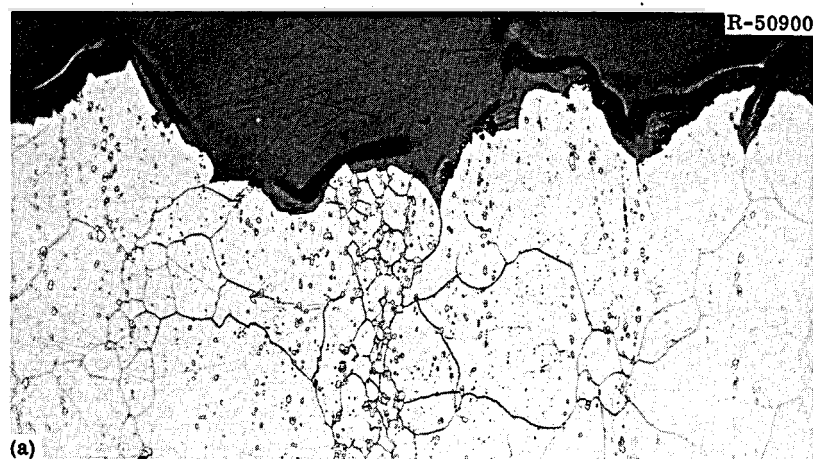
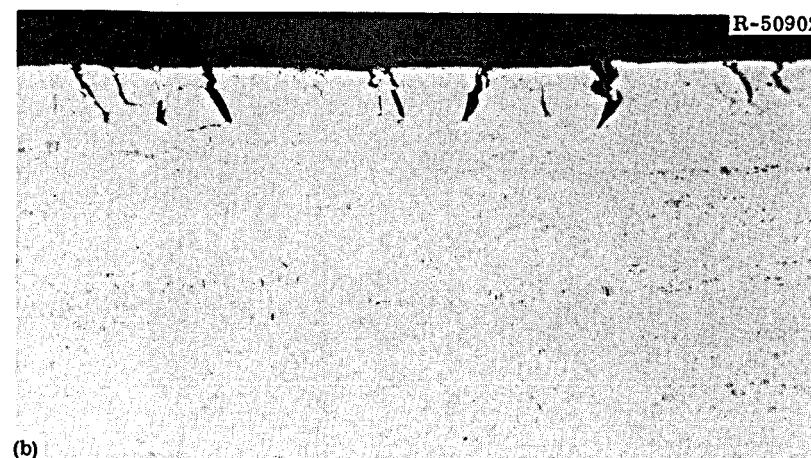
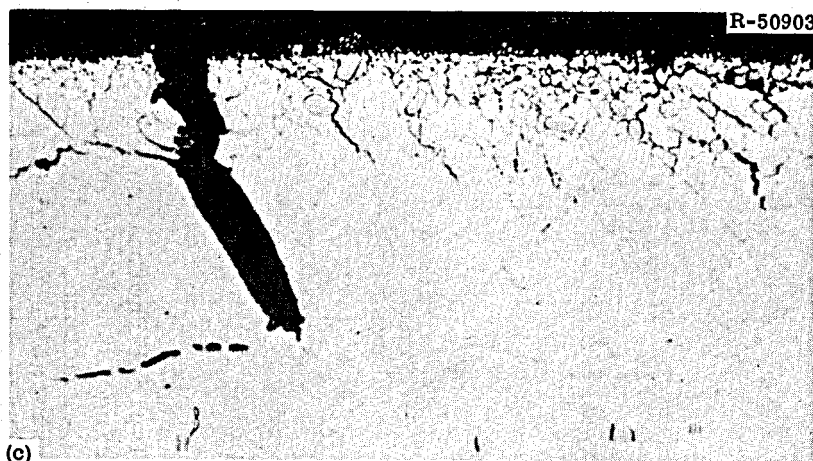
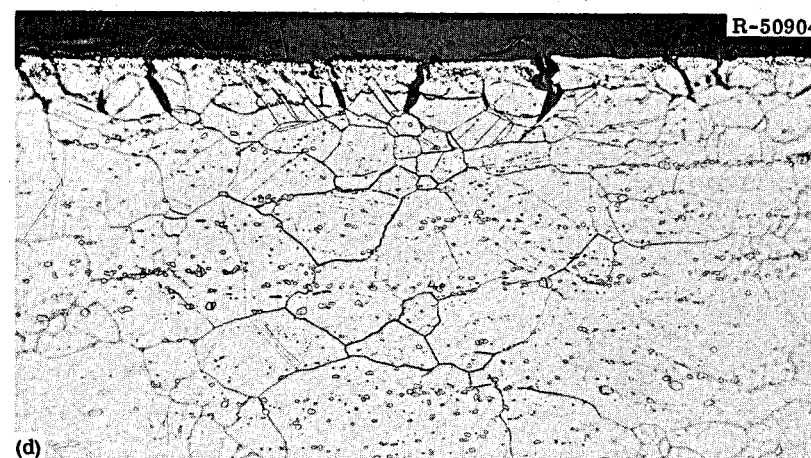
Fig. 46. Photomicrographs of INOR-8 (Heat 5085) Sample Tested at 25°C After Being Exposed to the MSRE Core for 19,136 hr Above 500°C and Irradiated to a Thermal Fluence of 1.5×10^{21} neutrons/cm². (a) Fracture, etched. 100x. (b) Edge, as polished. 100x. (c) Edge, as polished. 500x. (d) Edge, etched. 100x. Etchant: glyceria regia. Reduced 27%.

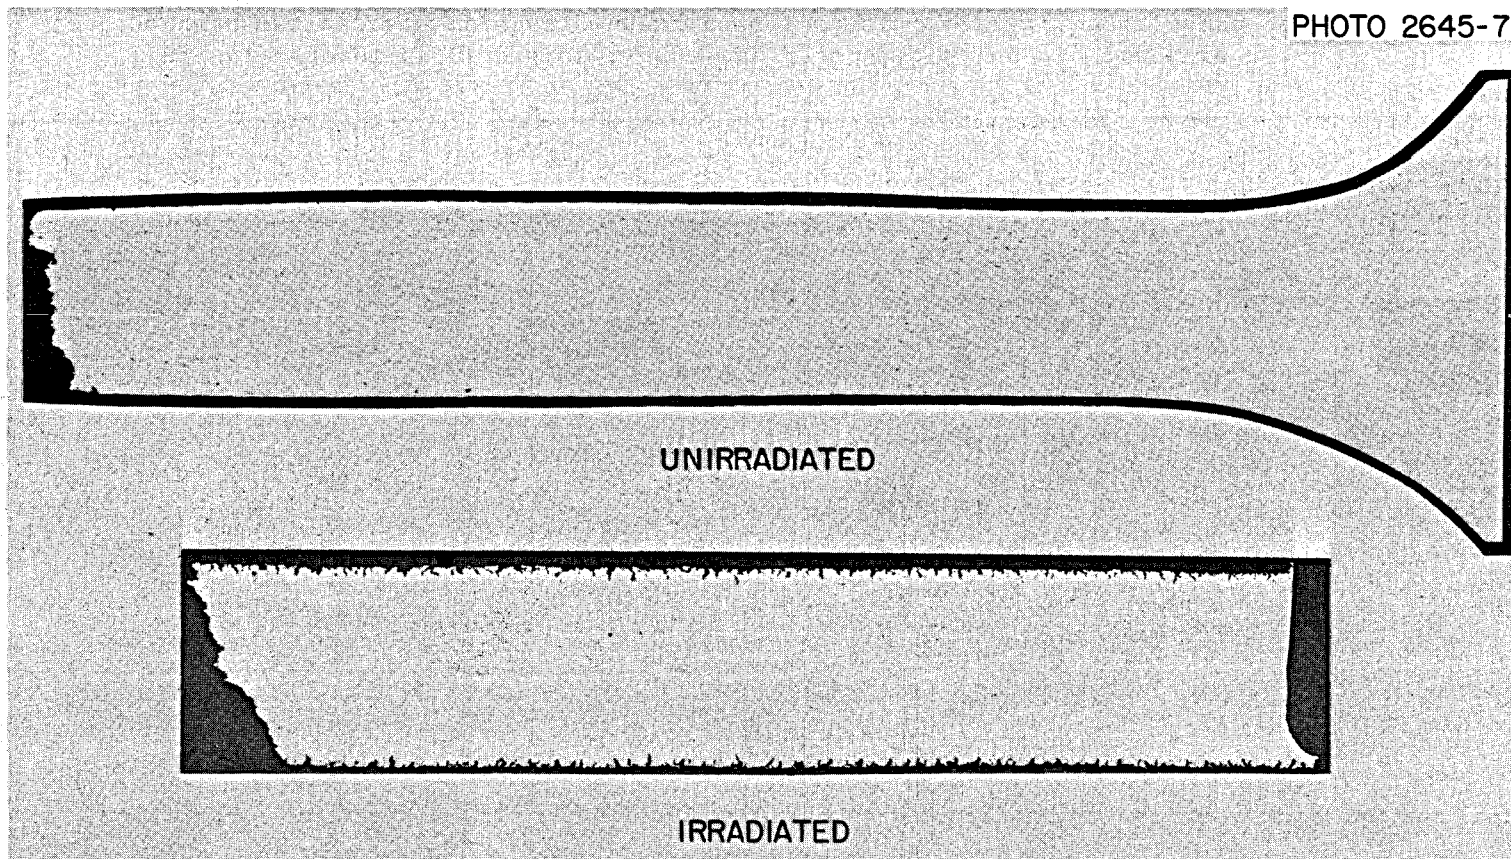
PHOTO 2645-71

Composite photographs of sections of the broken control and surveillance samples of heats 5065 and 5085 were made for overall viewing. These are Figures 47 and 48. These pictures show very clearly that the intergranular cracks are more frequent and deeper in the specimens exposed in the core than in the control samples. The photograph of the heat 5085 core sample also shows that very small strains are sufficient to make the cracks visible. The sample had a 3/16-in. radius at the

Fig. 47. Photomicrographs of INOR-8 (Heat 5065) Strained to Fracture at 25°C. Top specimen was exposed to static unenriched fuel salt for 19,136 hr above 500°C and the lower specimen was exposed to the MSRE core for the same time. The diameters are about 0.1 in.

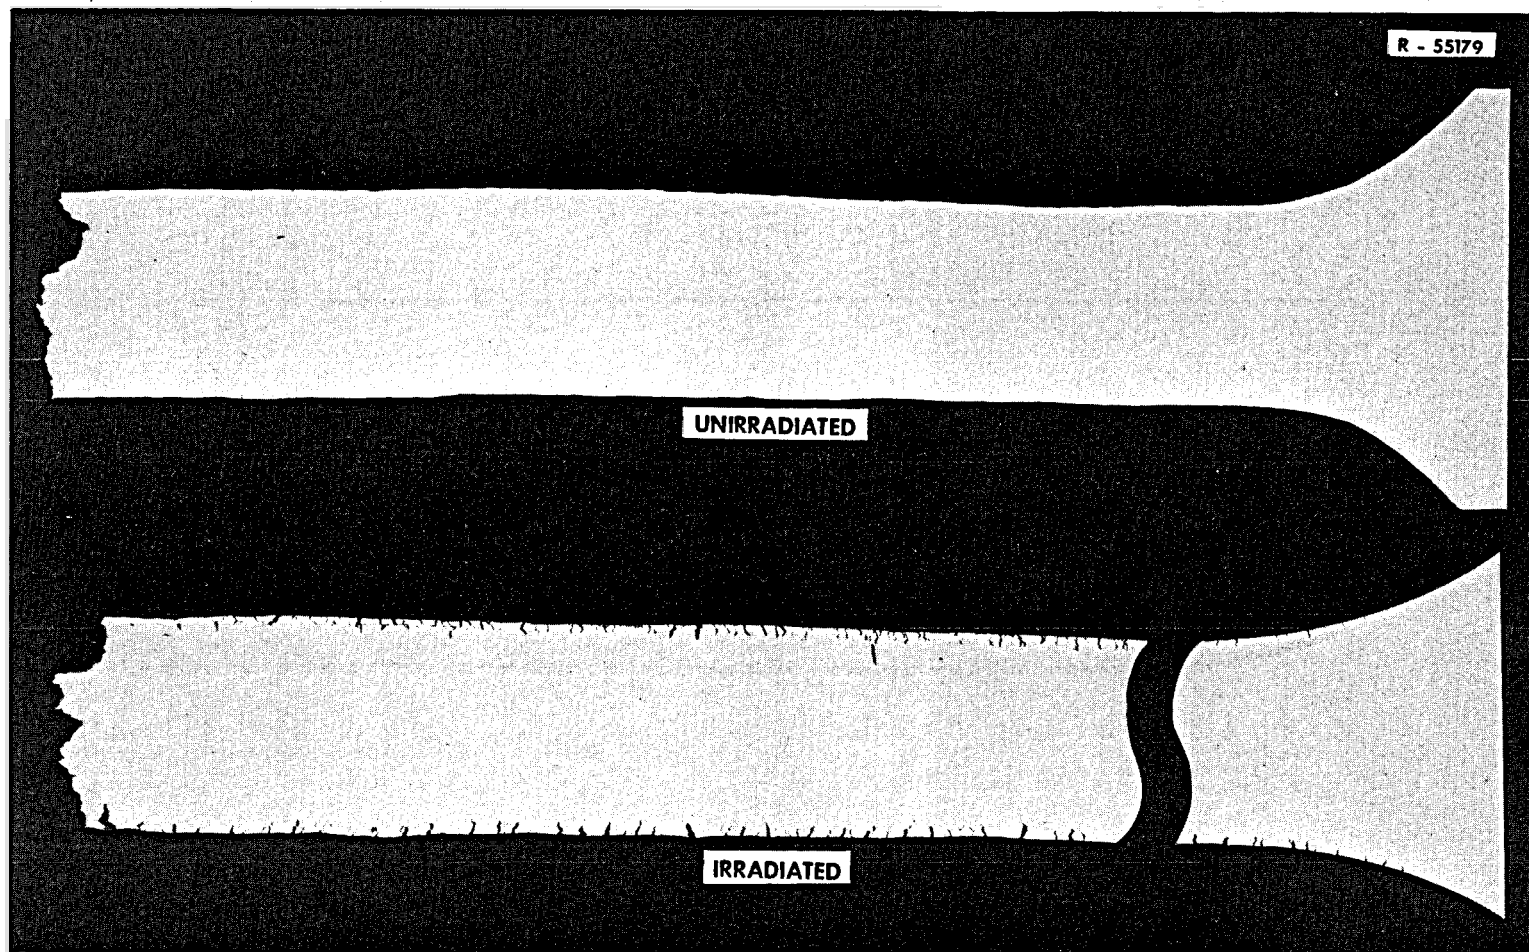
Fig. 48. Photomicrographs of INOR-8 (Heat 5085) Strained to Fracture at 25°C. The top specimen was exposed to static unenriched fuel salt for 19,136 hr above 500°C and the lower specimen was exposed to the MSRE core for the same time. The diameters are about 0.1 in.

end of the gage section and the diameter increased rapidly from 1/8 in. to 1/4 in. Thus the stress, and hence the strain, decreased rapidly along this radius. Note in Fig. 48 that the cracks continue a large distance along the radius, into the region of low strain.

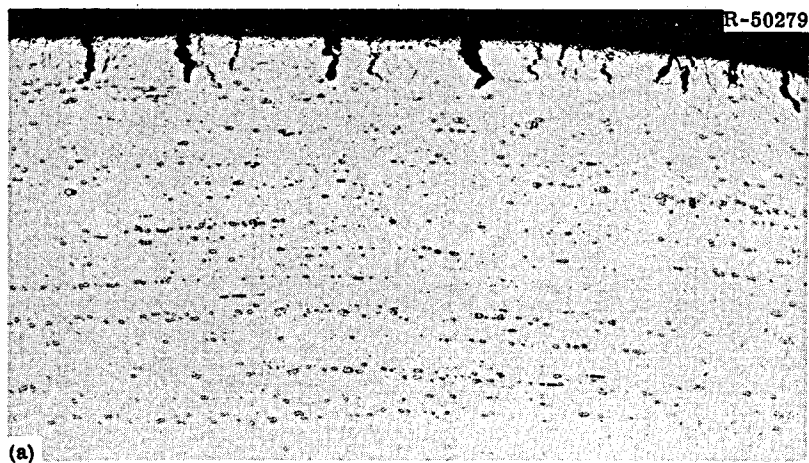
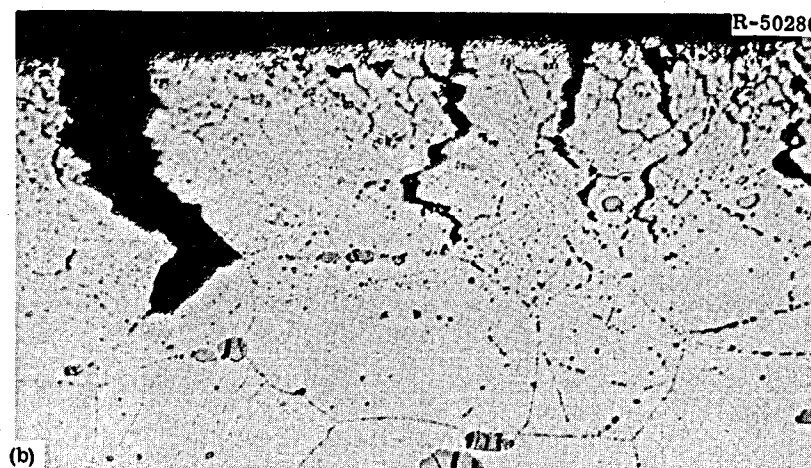
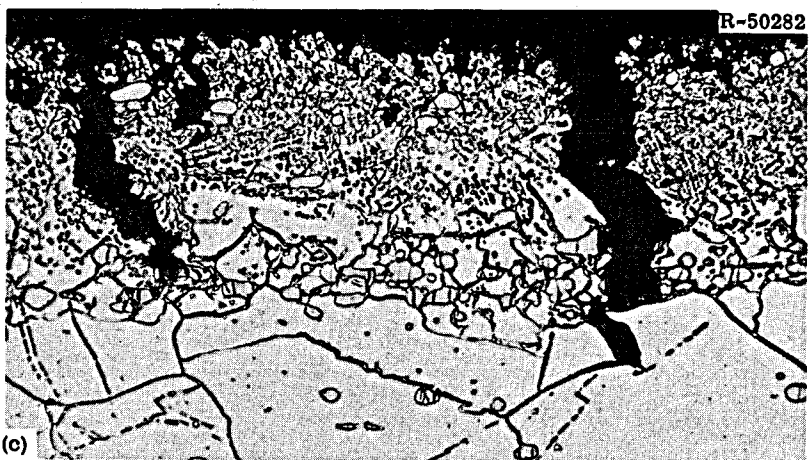
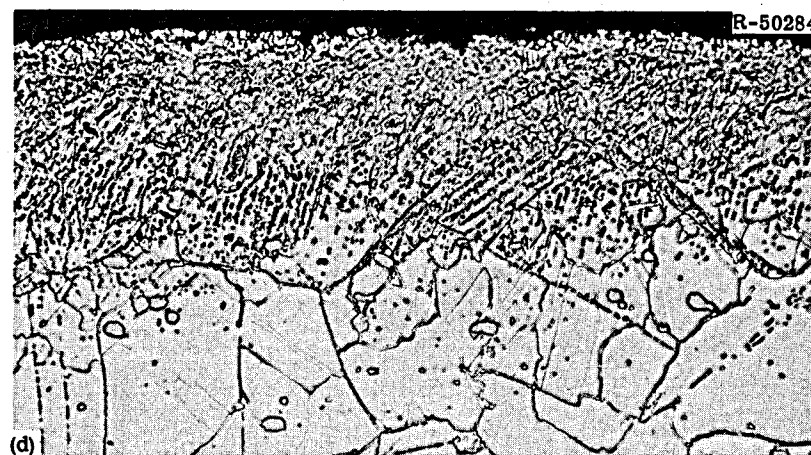
An additional experiment was made with a core sample of heat 5085 that had been cut too short for mechanical property testing. The remaining segment was bent about 30° in a vise, then was sectioned and examined metallographically. The resulting photomicrographs are shown in Fig. 49. The tension side had intergranular cracks to a depth of about 4 mils, but no cracks were evident on the compression side. Both the tension and compression sides etched abnormally near the surface because of the modification thought to be due to cold working.

Fig. 49. Typical Photomicrographs of INOR-8 (Heat 5085) Sample Exposed to the MSRE Core for 19,136 hr Above 500°C. The sample was bent in a vise. (a) As polished, tension side. 100x. (b) As polished, tension side. 500x. (c) Etched, tension side. 500x. (d) Etched, compression side. 500x. Etchant: aqua regia. Reduced 27%.

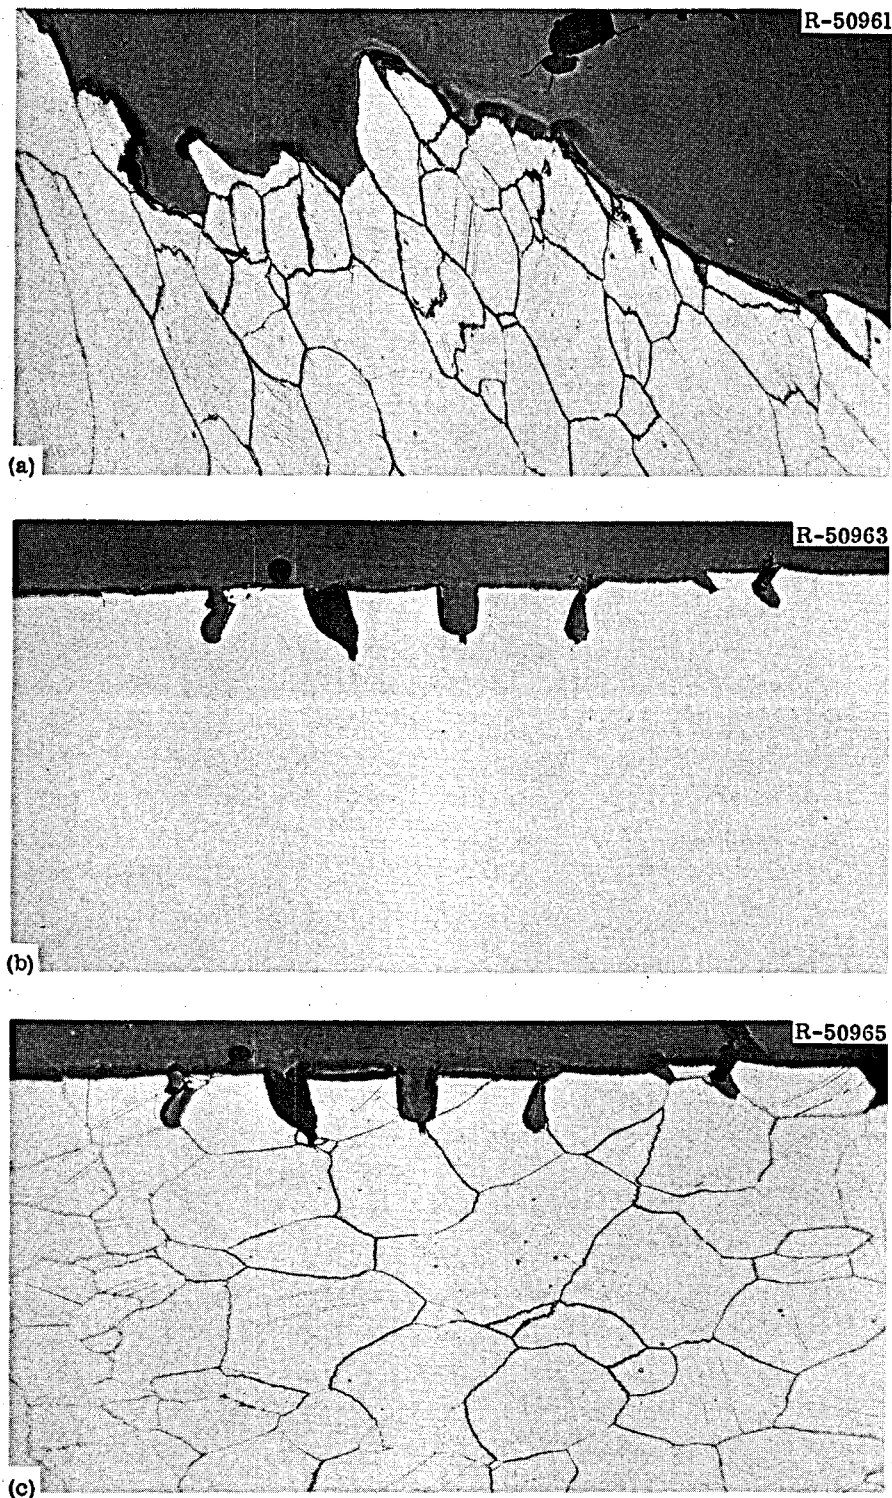
The specimens on stringers RR3 and RS4 were of two different heats of titanium-modified alloy: heat 7320, containing 0.65% Ti, and heat 67-551, containing 1.1% Ti. The 7200-hr exposure of these specimens had been entirely during the ^{233}U operation, in which the initial oxidation state was relatively high. The specimens were discolored and had much the same appearance as the standard heats. The samples were subjected to various mechanical property tests and some were examined metallographically. The microstructure of heat 7320 after exposure in the control facility and testing at 25°C is shown in Fig. 50. The sample deformed 50% before fracturing in a mixed mode. No edge cracks were visible. A similar sample that was exposed to the fuel salt is shown in Fig. 51. It failed after deforming 45%. Edge cracks were present along almost every grain boundary to a depth of 3 to 5 mils. Note that many of these cracks proceed to where the cracking grain boundary intersects another boundary. Note also that the crack tips are quite blunt indicating that they formed early during deformation and were simply spread by further deformation and did not propagate. Similar metallographic observations were made on heat 67-551. Control and core specimens deformed almost equal amounts before fracturing (52% and 51%). No edge cracks were observed in the sample from the control facility (Fig. 52), but numerous intergranular cracks were evident in the sample from the core (Fig. 53).

Fig. 51. Photomicrographs of a Modified INOR-8 (Heat 7320) Sample Tested at 25°C After Being Exposed to the MSRE Core for 7203 hr Above 500°C and Irradiated to a Fluence of 5.1×10^{20} neutrons/cm². (a) Fracture, etched, 100×. (b) Edge, as polished. 100×. (c) Edge, Etched. 100×. Etchant: glyceria regia. Reduced 22%.

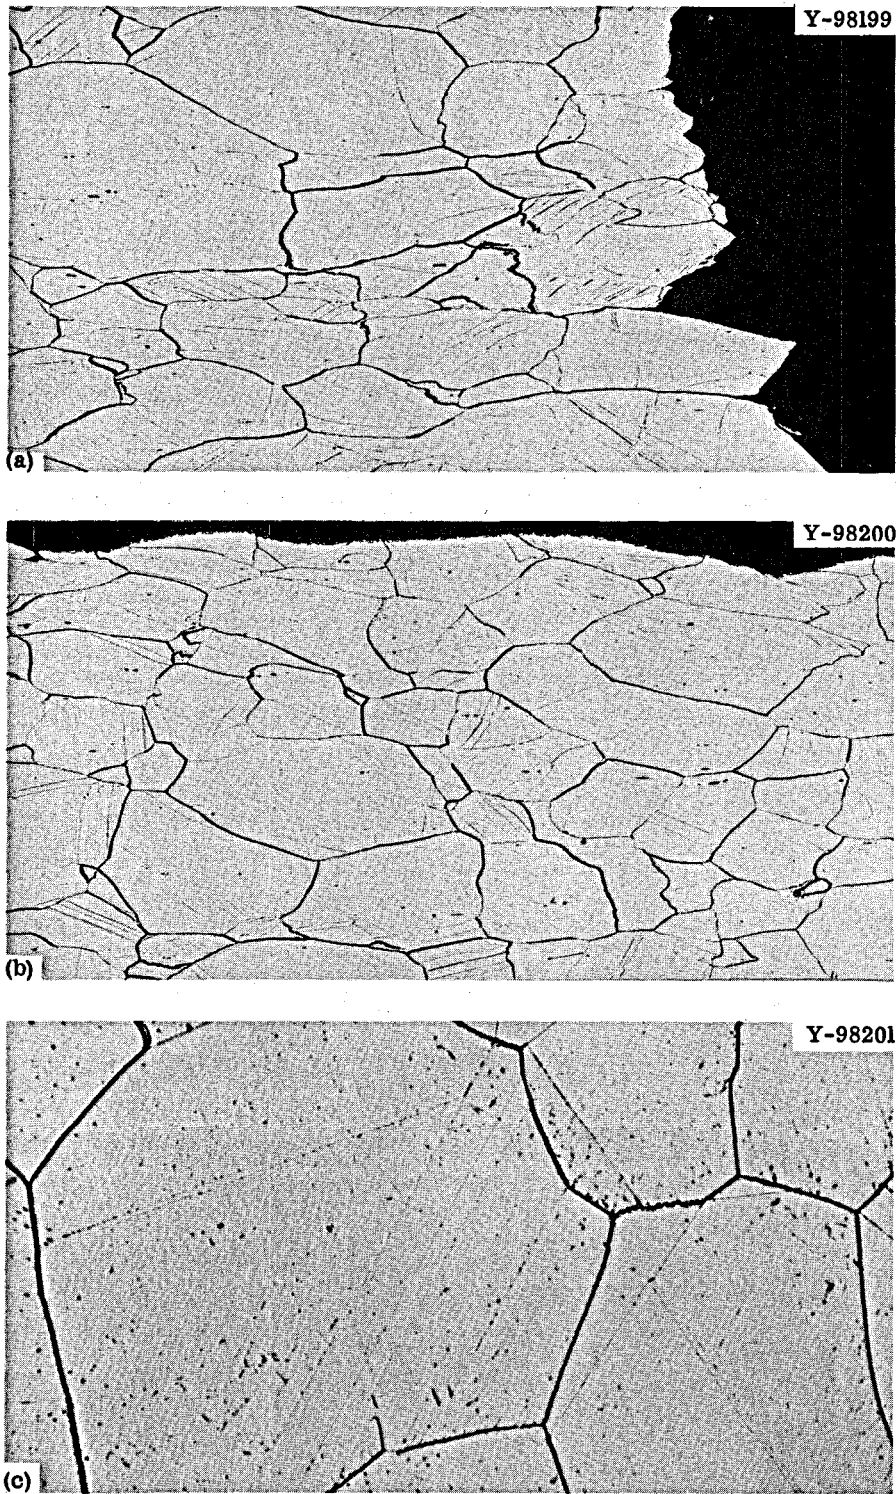
Fig. 52. Photomicrographs of a Modified INOR-8 (Heat 67-551) Sample Tested at 25°C After Being Exposed to Static Unenriched Fuel Salt for 7203 hr Above 500°C. (a) Fracture. 100x. (b) Edge. 100x. (c) Typical unstressed microstructure. 500x. Etchant: glyceria regia. Reduced 20.5%.

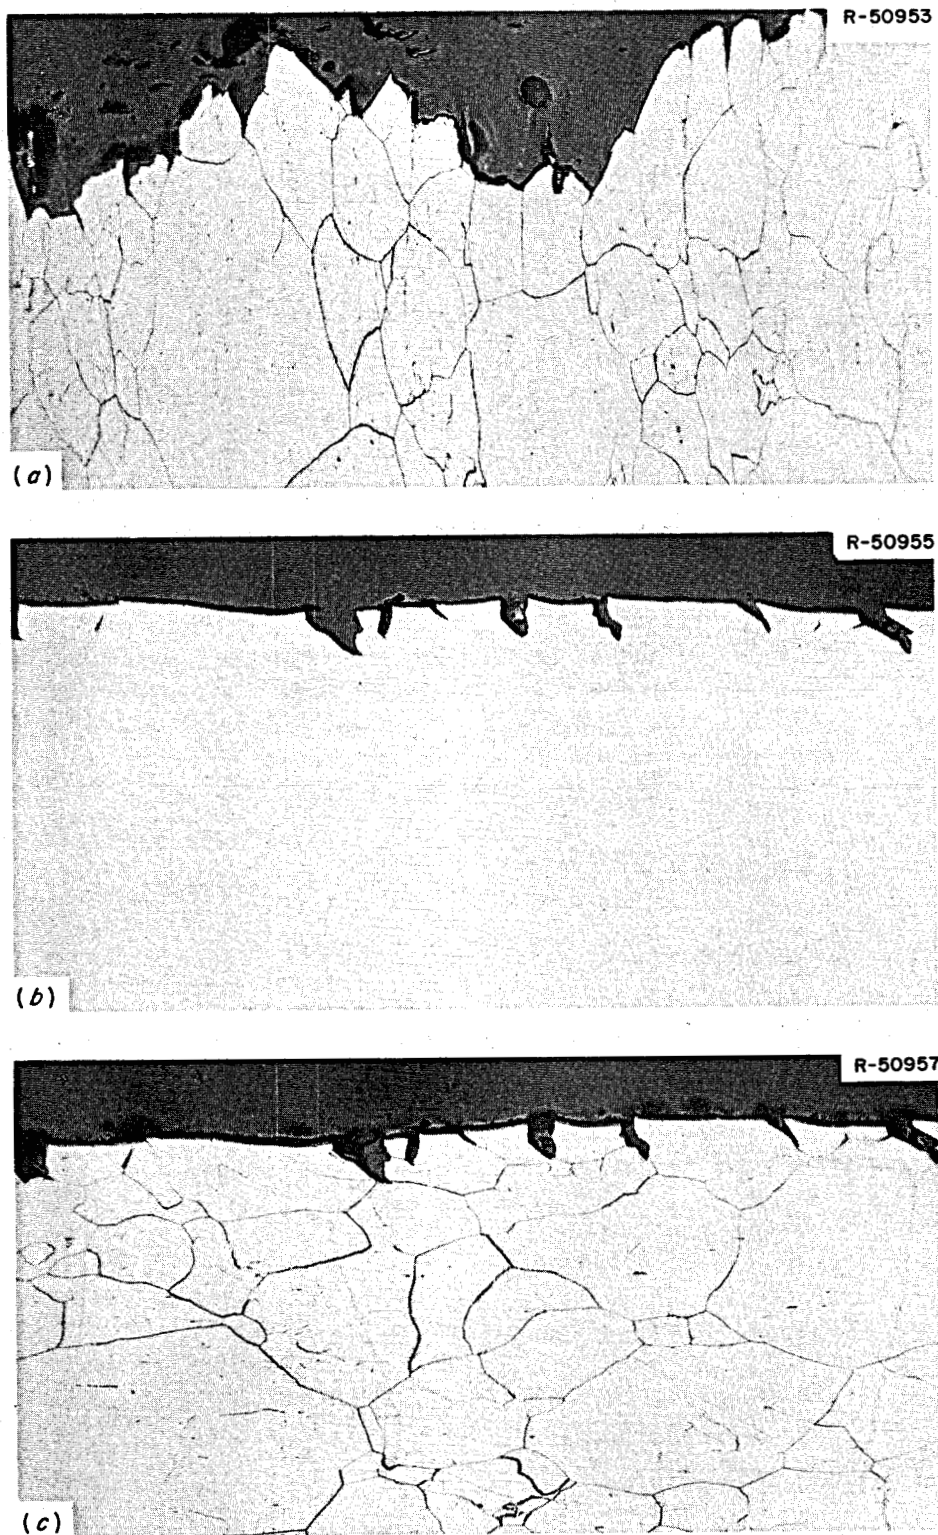
Fig. 53. Photomicrographs of a Modified INOR-8 (Heat 67-551) Sample Tested at 25°C After Being Exposed to the MSRE Core for 7203 hr Above 500°C and Irradiated to a Fluence of 5.1×10^{20} neutrons/cm². (a) Fracture, etched. 100x. (b) Edge, as polished. 100x. (c) Edge, etched. 100x. Etchant: Glyceria regia. Reduced 17%.

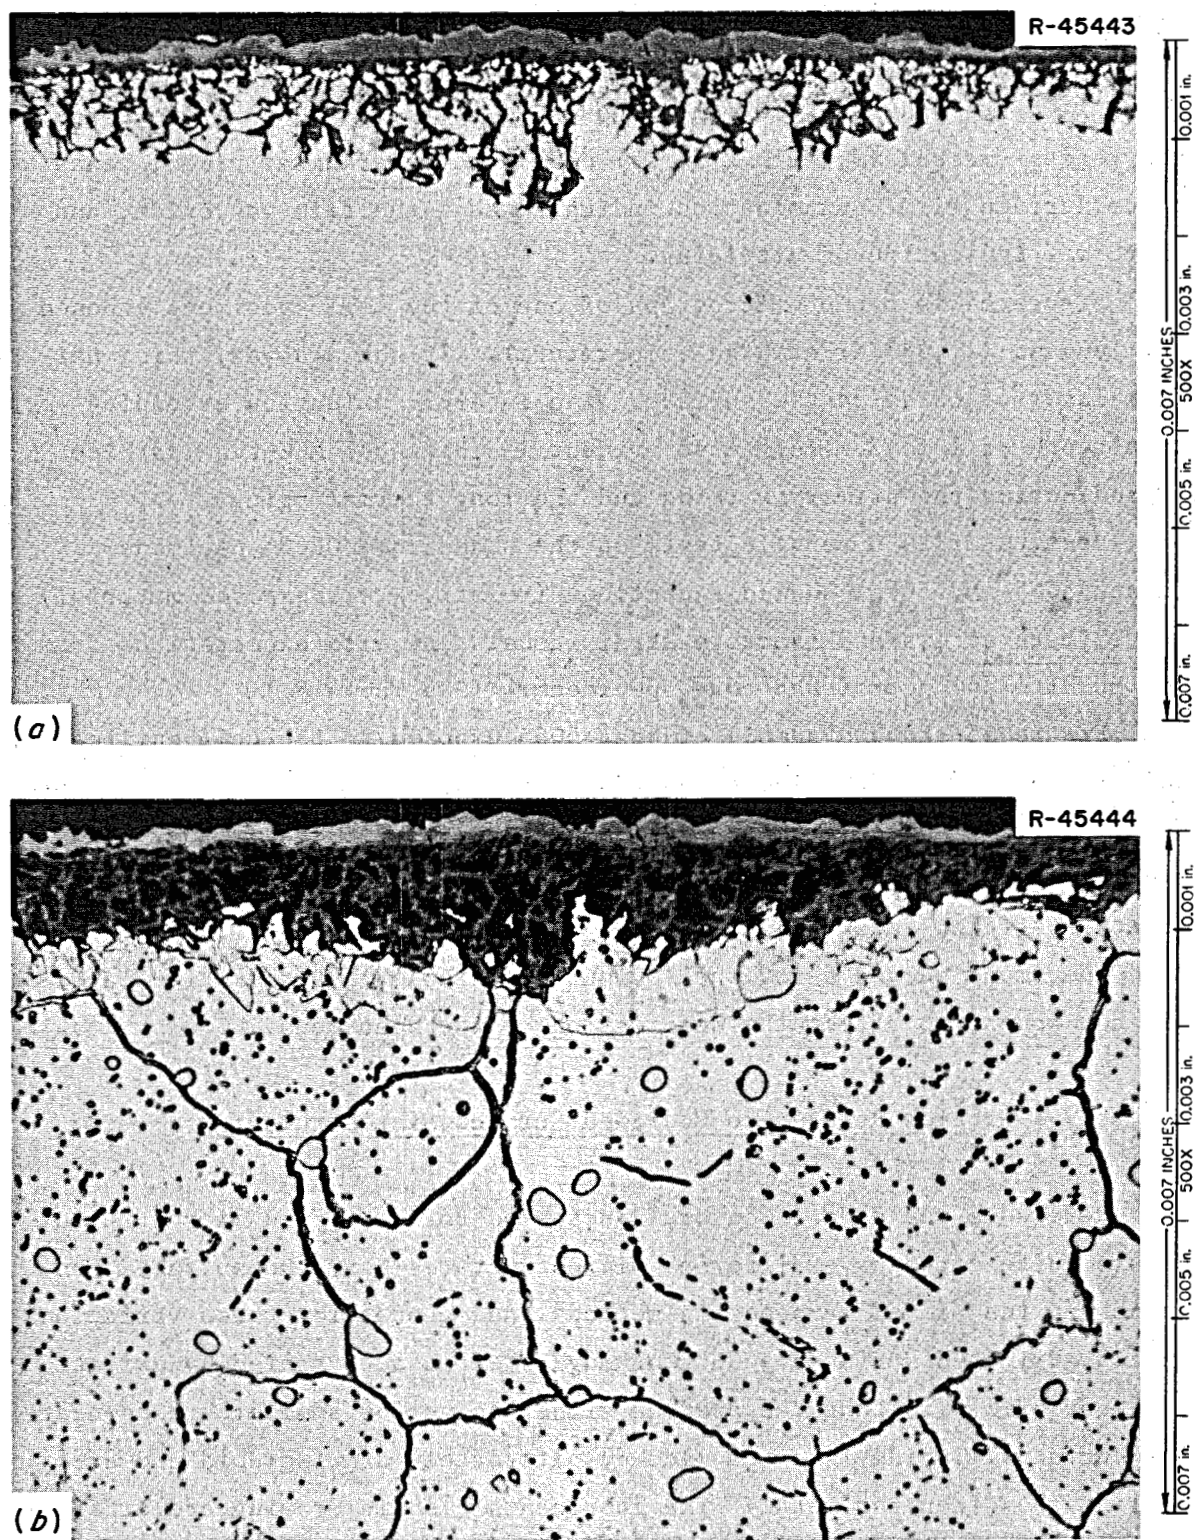
Figure 54 is a photomicrograph of one of the cell specimens exposed the longest (17,483 hr at high temperature). It shows a very thin, uniform layer of oxide on the surface, with internal oxidation extending to a depth of 1 to 2 mils. Also evident is the usual M_6C -type carbide formed during the primary working and the long thermal aging.

Fig. 54. Photomicrographs of Hastelloy N (Heat 5065) Surveillance Specimens Exposed to the Cell Environment of $N_2 + 2$ to 5% O_2 for 20,789 hr at 650°C. 500x. (a) Unetched showing surface oxidation (b) Etched (glyceria regia) showing shallow modification of microstructure due to reaction with cell environment.

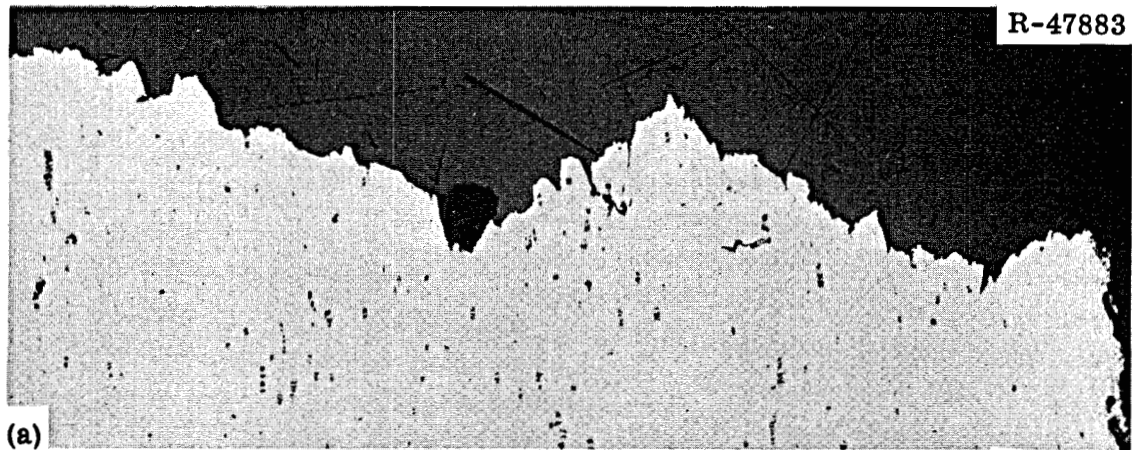
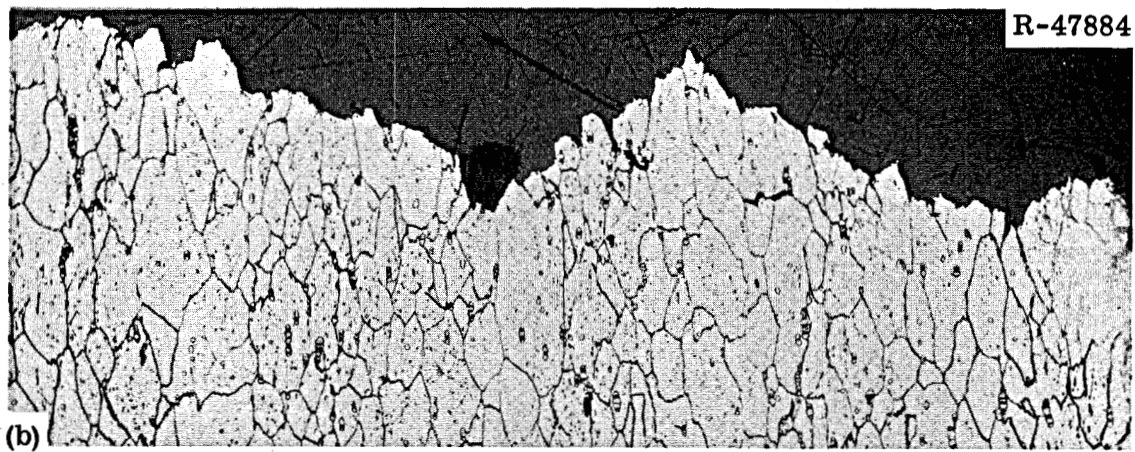
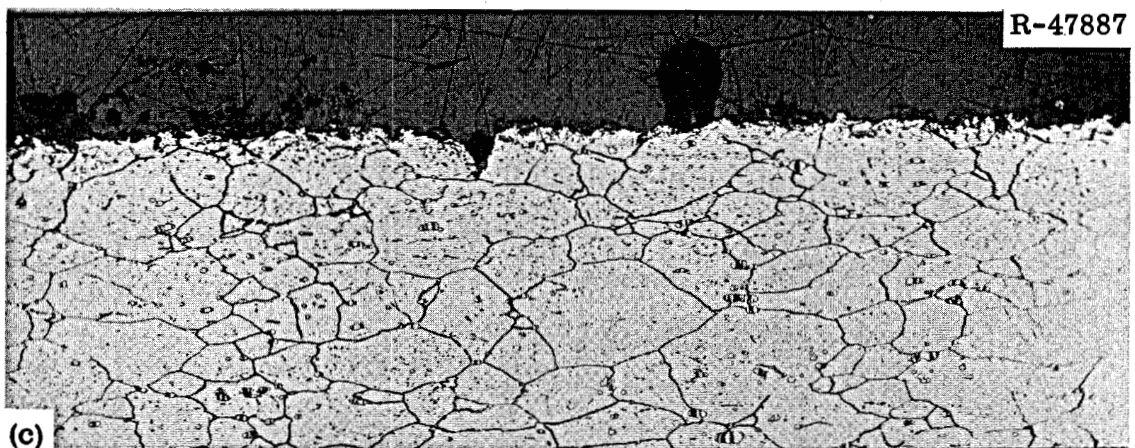
Figure 55 shows a sample of heat 5065 exposed to the cell environment and fractured at 25°C. The elongated grains attest to the large fracture strain (59%), and the fracture is mixed transgranular and intergranular. A heat 5085 specimen exposed the same length of time failed with only 33% fracture strain, in a primarily intergranular mode as shown in Fig. 56. Both specimens showed a few shallow surface cracks, but the oxide layer did not appear to affect the deformation of the specimens.

Fig. 55. Photomicrographs of INOR-8 (Heat 5065) Sample Tested at 25°C at a Strain Rate of 0.05/min. Sample had been irradiated to a thermal fluence of 2.6×10^{19} neutrons/cm² while being exposed to the cell environment above 500°C for 17,483 hr. 100×. (a) Fracture, as polished. (b) Fracture, etched. (c) Edge of stressed portion. Etchant: aqua regia.

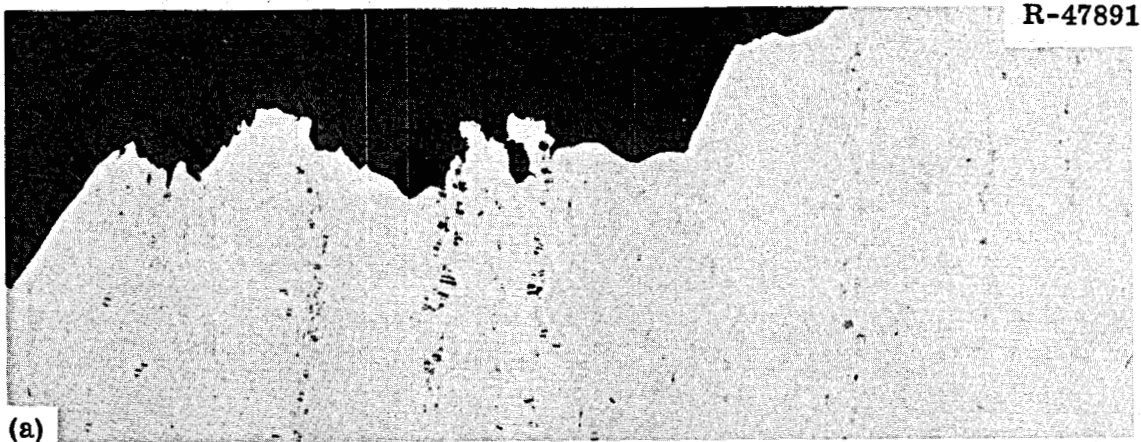
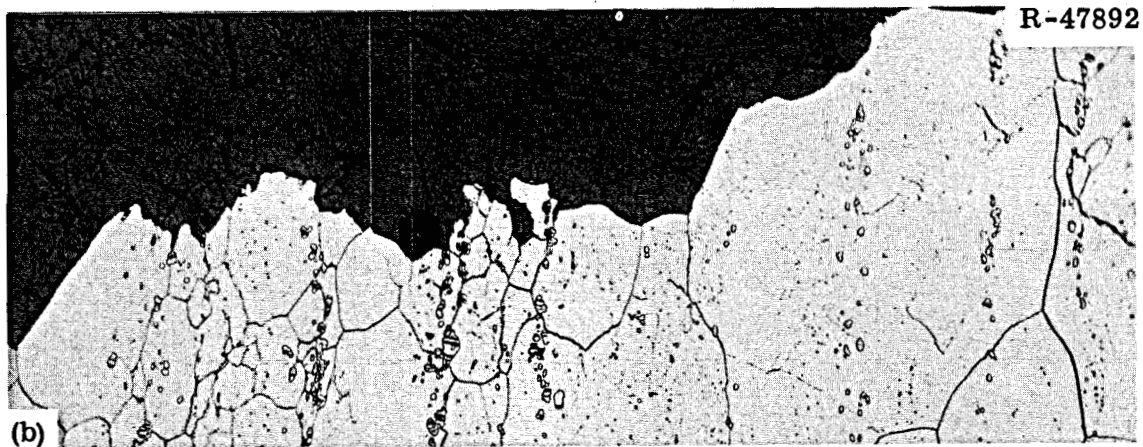
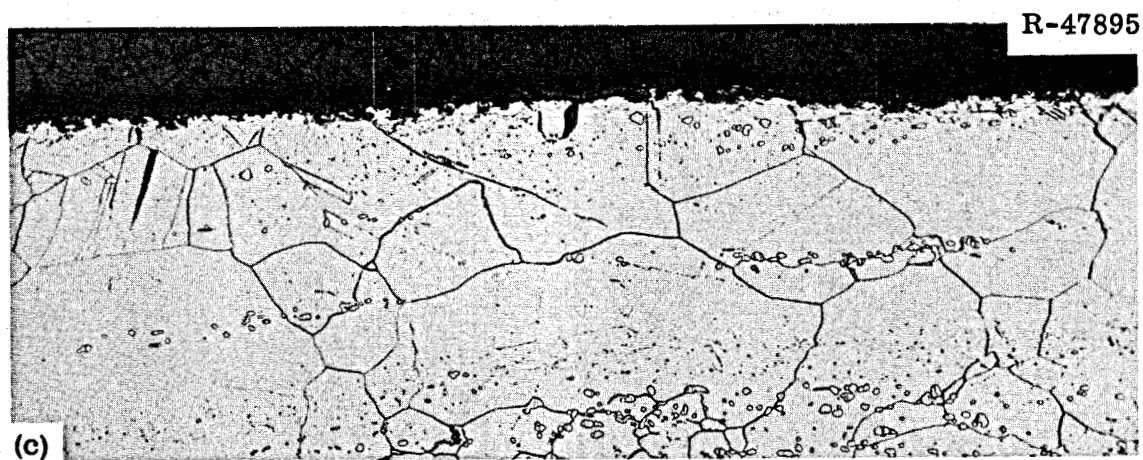
Fig. 56. Photomicrographs of INOR-8 (Heat 5085) Sample Tested at 25°C at Strain Rate of 0.05/min. Sample had been irradiated to a thermal fluence of 2.6×10^{19} neutrons/cm² while being exposed to the cell environment above 500°C for 17,483 hr. 100×. (a) Fracture, as polished. (b) Fracture, etched. (c) Edge of stressed portion. Etchant: aqua regia.

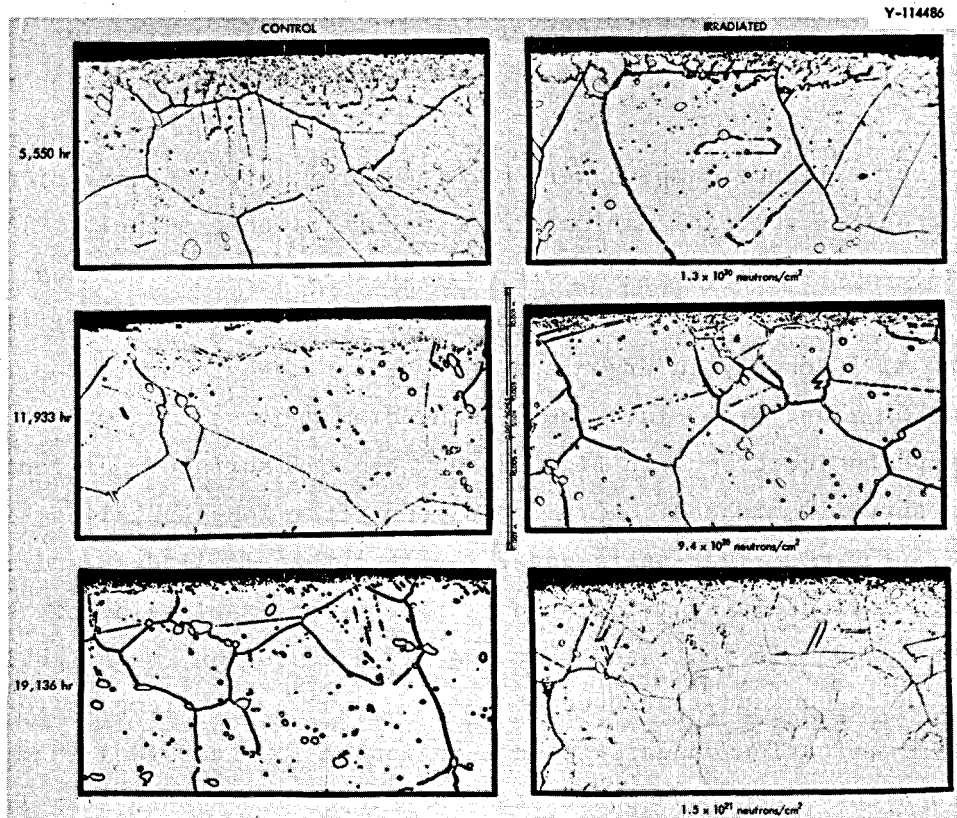
The photomicrographs in Fig. 57 show typical surface modifications noted on surveillance and control specimens after long annealing times at 650°C. The modification is generally less than 1 mil deep and is not detectably influenced by irradiation. Microprobe examination of the first control sample indicated that the modified region was slightly enriched in carbon and that none of the other alloying elements varied. Thus the modification appears to be a region of fine carbides that are dispersed along lines. We postulated that these lines were slip lines that resulted from the surface working during the final stages of fabrication. These slip lines would provide preferred sites for carbide precipitation when the alloy was held at 650°C.

Fig. 57. Photomicrographs of Unstressed INOR-8 (Heat 5085) Control and Irradiated Samples.
