INTERGRANULAR CRACKING OF INOR-8 IN THE MSRE

H. E. McCoy
B. McNabb

ORNL-4829
UC-25 — Metals, Ceramics, and Materials

NOVEMBER 1972

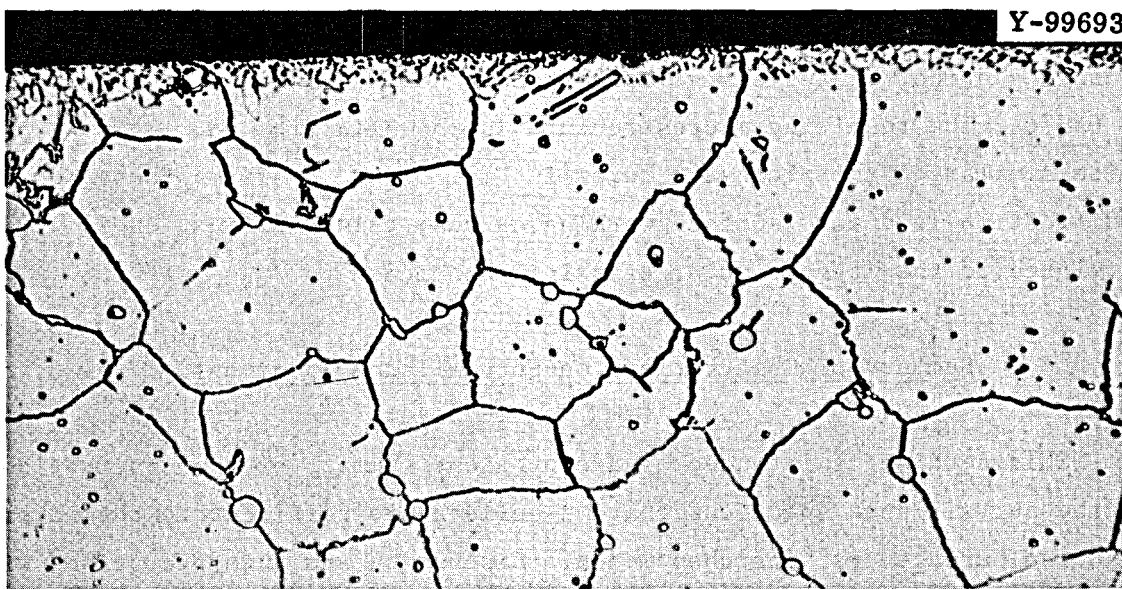
We were able to duplicate the surface modification by solution annealing a rod, centerless grinding, and annealing for a long period at 650°C. The resulting microstructure is shown in Fig. 58. It is quite similar to the microstructures in Fig. 57 and confirms that the modification is due to surface working. Thus, this modification is unrelated to the intergranular cracking phenomenon.

Fig. 58. Photomicrograph of INOR-8 (Heat 5085) Rod that was Annealed 1 hr at 1177°C, Centerless Ground 5.2 mils, and Annealed 4370 hr at 650°C in Argon. 500x. Etchant: glyceria regia.

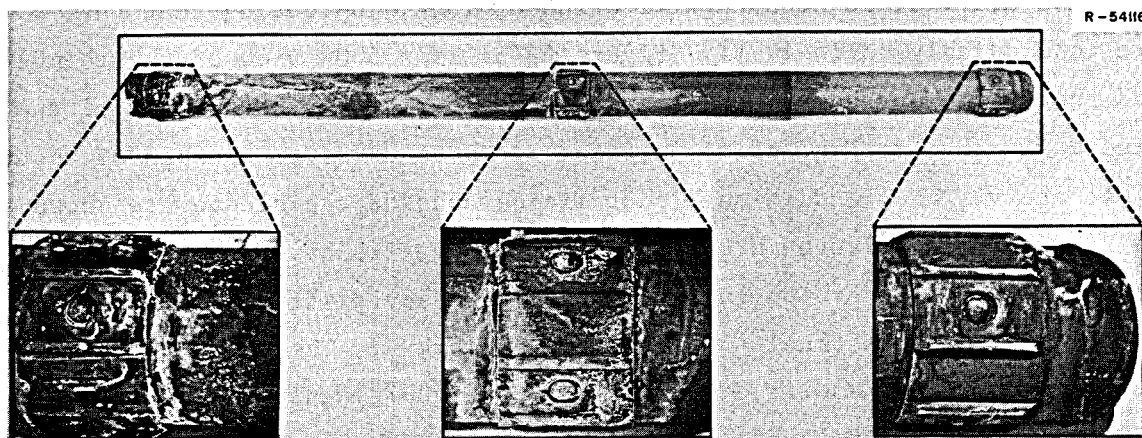
Fig. 60. Portion of Control Rod Thimble that was Examined After Operation of MSRE was Terminated. The thimble is made of 2-in-OD \times 0.065-in.-wall INOR-8 tubing (Heat Y-8487). The electric arc cut on the left was near the center line of the core.

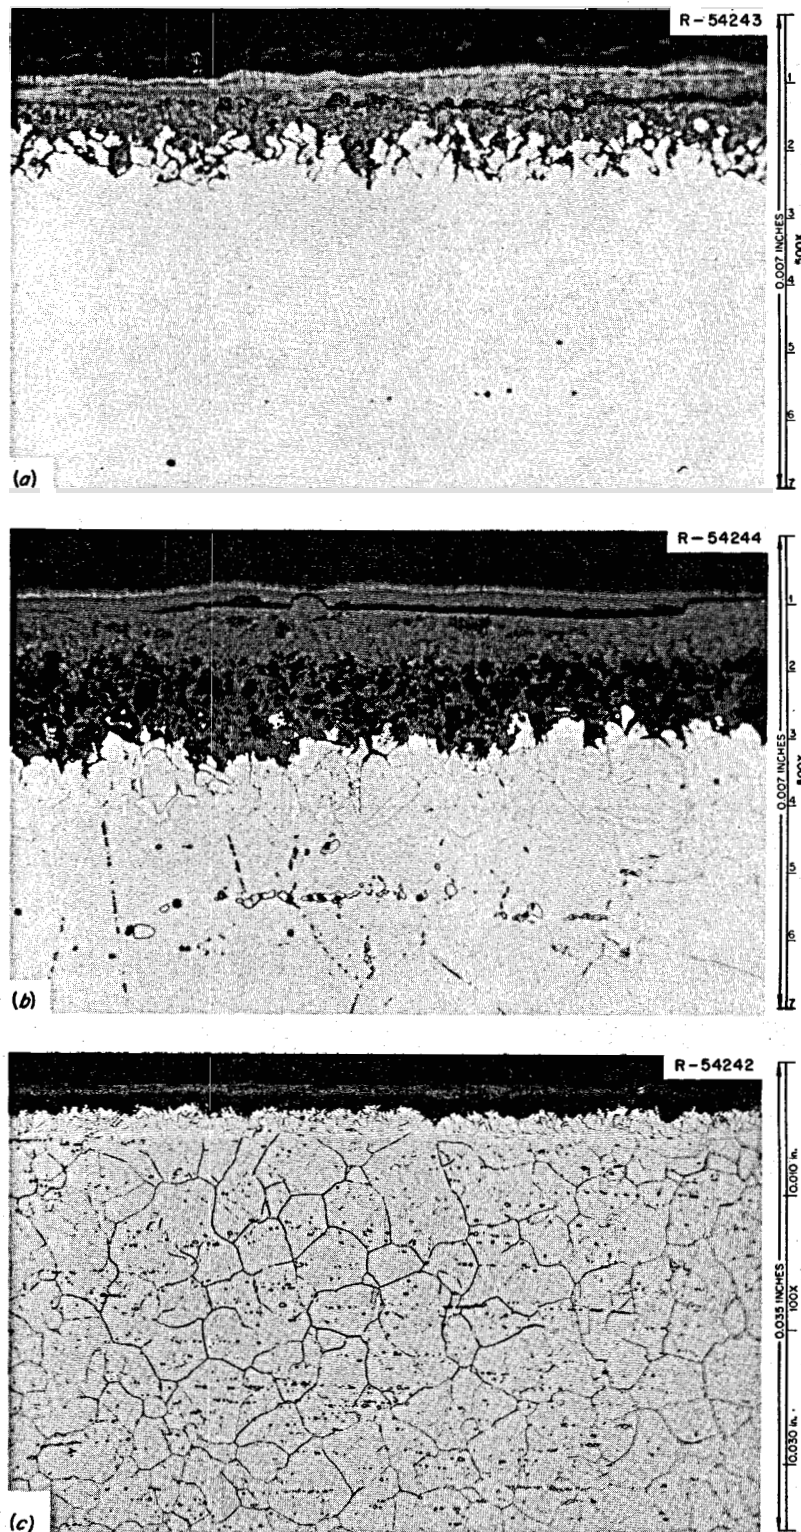
Samples of the control rod thimble and the spacer sleeve were cut and examined to determine their condition at the end of service. Typical photomicrographs of the inside of the thimble tube are shown in Fig. 61. This surface was oxidized to a depth of about 2 mils by the cell environment of nitrogen containing 2 to 5% O_2 . The oxidation process modified the microstructure to a depth of 4 mils, likely due to the selective removal of chromium.

Fig. 61. Photomicrographs of the Inner Surface of the Control Thimble in the As-removed Condition. This surface was exposed to cell environment of N_2 containing 2 to 5% O_2 . (a) As polished. (b) Etched. (c) Etched, typical microstructure. Etchant: Aqua regia. Reduced 30.5%.

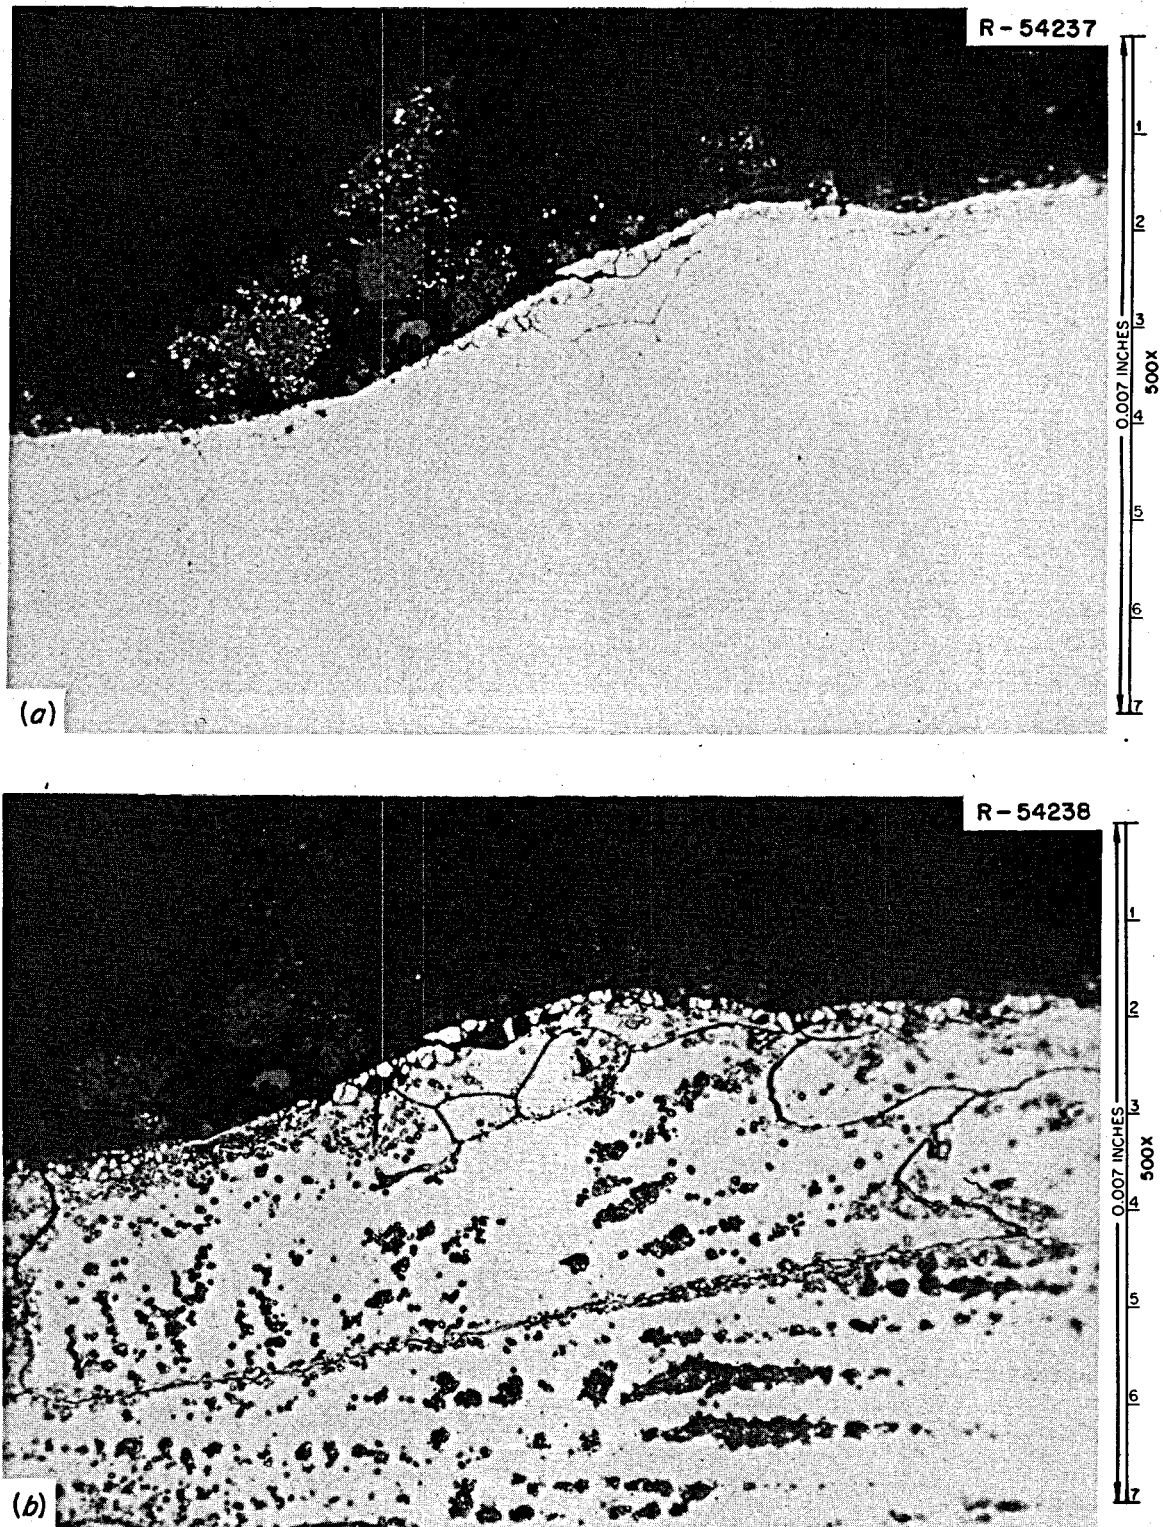
Photomicrographs of one of the weld beads are shown in Fig. 62. All of the surface shown was exposed to flowing fuel salt. Some dislodged grains are near the surface, and grain boundaries are visible in the as-polished condition to a depth of 1 to 1.5 mils.

Fig. 62. Photomicrographs of Outer Surface of Control Rod Thimble Showing the Weld Deposit Made to Hold the Spacer Sleeve. The weld surface was exposed to flowing salt. (a) As polished. (b) Etched: Aqua regia.

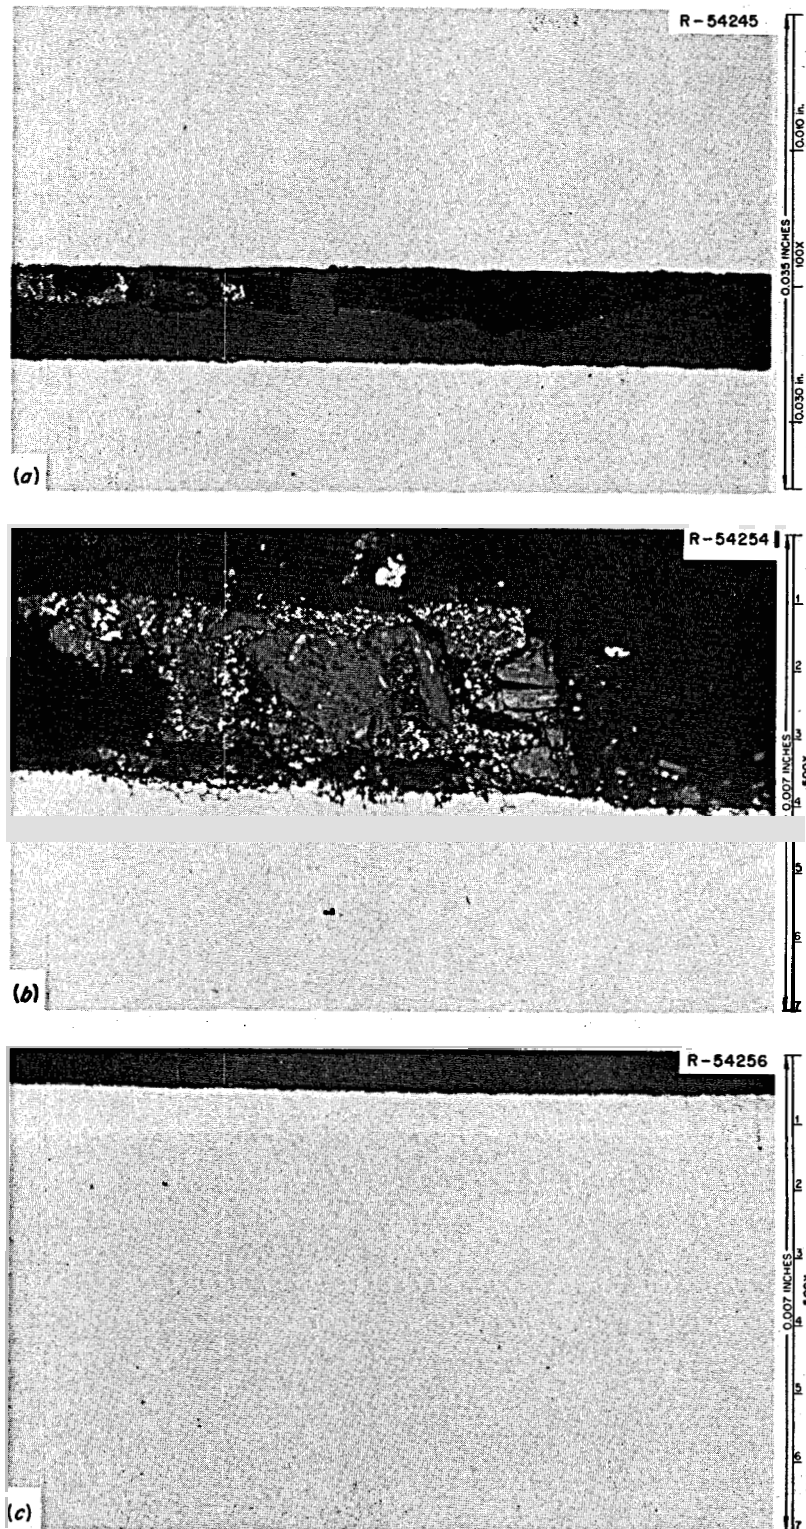
Photomicrographs involving the interface between the thimble and sleeve are shown in Fig. 63. Figure 63(a) shows the annular region with a separation of about 7 mils and some salt present. Few surface irregularities are visible at a magnification of 100x, indicating that they are considerably below 1 mil. Figure 63(b) is a 500x view of the thimble and shows some surface cracks to a depth of 0.3 mil. The outside of the sleeve is shown in Fig. 63(c); a few grain boundaries to a depth of about 1 mil are visible. Additional photomicrographs of the sleeve are shown in Fig. 64. The sleeve material does not appear to have received much working since the carbide is very inhomogeneously distributed. The grain size is larger than usual away from the stringers. The inner and outer surfaces both have modified structures. A higher magnification view of the inner surface [Fig. 64(b)] shows that much of the modification is a high density of primary carbide. The outer surface [Fig. 64(c)] has a shallow layer of small grains, likely due to a working operation.

Fig. 63. Photomicrographs of As-polished Surfaces of Control Rod Thimble and Sleeve. (a) Annulus between thimble and sleeve. Thimble surface is in upper part of picture. (b) Outside surface of control rod thimble, showing presence of some salt and shallow surface cracking. (c) Outside surface of sleeve. Surface exposed to flowing fuel salt.

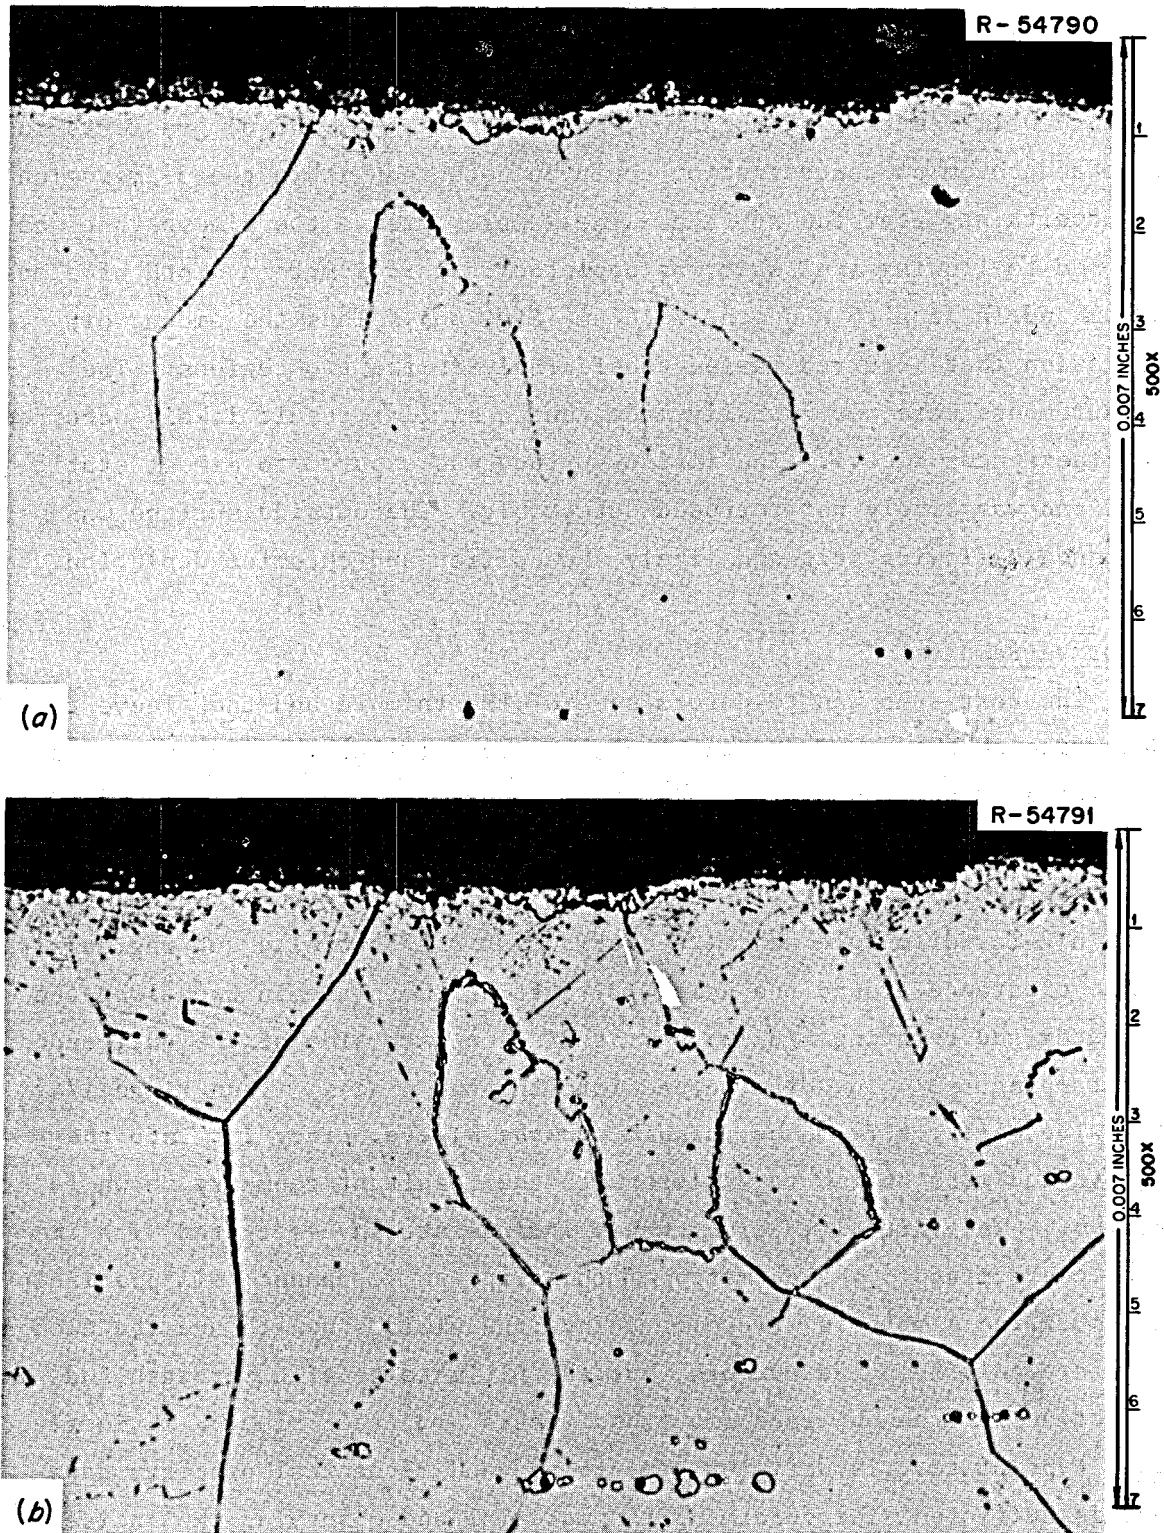
A second cut was made away from the sleeve, and typical photomicrographs are shown in Fig. 65. This part of the thimble was exposed to flowing salt. Some of the grain boundaries are visible in the as-polished condition to a depth of about 4 mils and there is some surface modification [Fig. 65(a)]. Etching [Fig. 65(b)] delineates more of the grain structure and shows the shallow surface modification.

Fig. 65. Photomicrographs of Control Rod Thimble where it was Exposed Directly to Flowing Salt. (a) As polished. (b) Etched: Aqua regia.

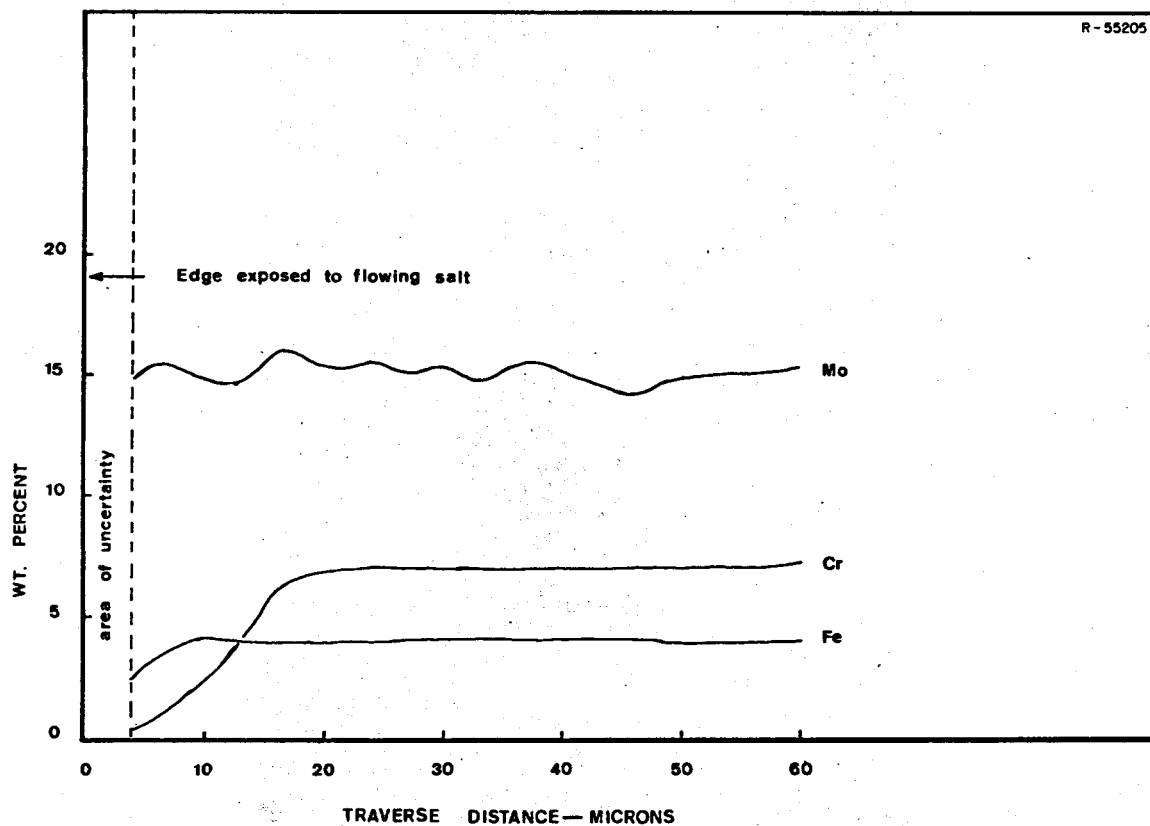
Microprobe scans were run on the thimble samples that were taken from under the sleeve and outside the sleeve. In the first case the thimble wall was exposed to almost static fuel salt, and no gradients in iron and chromium concentration could be detected within the 3- μ m region of uncertainty near the surface. The sample outside the sleeve that was exposed to flowing fuel salt was depleted in chromium to a depth of almost 20 μ m and in iron to a depth of 10 μ m (Fig. 66). Thus the amount of corrosion that occurred varied considerably in the two regions. The measurements were not actually made, but a similar result likely occurred for the spacer sleeve. The inside surface was exposed to almost static salt and was likely not corroded detectably. The outside surface was exposed to flowing salt and likely showed iron and chromium depletion.

Fig. 66. Electron Microprobe Scan of Sample from Control Rod Thimble. The thimble had been exposed to the fuel salt for 21,040 hr and had been above 500°C for 30,807 hr.

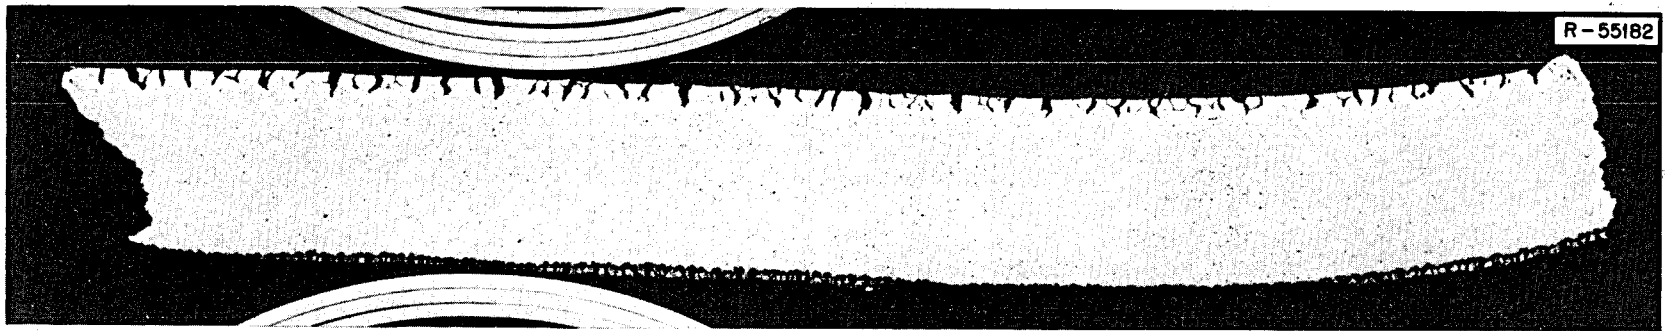
Several of the specimens that had been strained were examined metallographically to determine the extent of cracking during straining. Several photomicrographs of the control rod thimble that was exposed to flowing salt are shown in Fig. 68. The inside surface was oxidized, and the oxide cracked as the specimen was strained. The oxide should be brittle, but it is important that these cracks did not penetrate the metal. The side exposed to the salt exhibited profuse intergranular cracking. Almost every grain boundary cracked, and the cracks generally propagated to a depth of one grain, although there are several instances where the crack depth exceeded a depth of one grain. Several photomicrographs were combined and rephotographed to obtain Fig. 69. This sample had 192 cracks per inch with average and maximum depths of 5.0 and 8.0 mils, respectively. Many of the cracks shown in Fig. 68 and 69 have blunt tips, indicating that they did not propagate into the metal as the specimen was strained.

Fig. 69. Photomicrographs of a Deformed Section of the Control Rod Thimble. The fracture is on the left. The upper surface was in contact with flowing salt and the lower surface was exposed to the cell environment of N_2 plus 2 to 5% O_2 . The sample is about 0.06 in. thick.

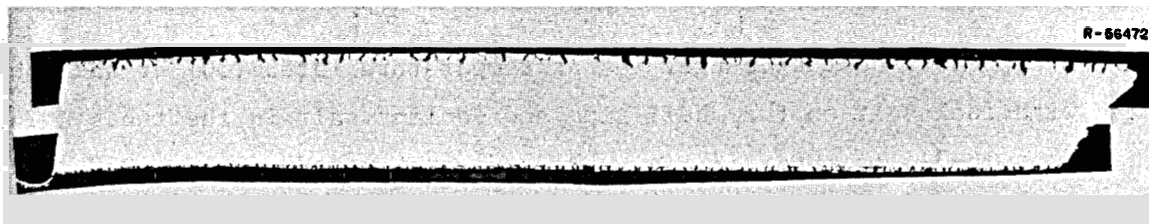
A similar sample was cut from the thimble under the sleeve, where the salt access was restricted. Photomicrographs of a specimen tested at 25°C are shown in Fig. 70. The cracks are quite similar to those in Fig. 68 for a sample that was exposed to flowing salt. The composite photograph in Fig. 71 is quite similar to Fig. 69 of the sample exposed to flowing salt. The sample in Fig. 71 had 257 cracks per inch, with average and maximum depths of 4.0 and 8.0 mils, respectively. The accuracy of our statistics and possible sampling inhomogeneities lead us to conclude that the severity of cracking is equivalent in the samples exposed to flowing and almost static salt. Thus flow rate over the range represented by these two sample locations does not appear to be an important variable.

Fig. 71. Composite Photograph Showing the Density of Cracking Along the Edge of a Portion of the Deformed Control Rod Thimble. 9.5X. The sample is 0.58 in. long. The fracture is on the left, the upper surface was exposed to fuel salt, and the lower surface was exposed to the cell environment of N_2 plus 2 to 5% O_2 .

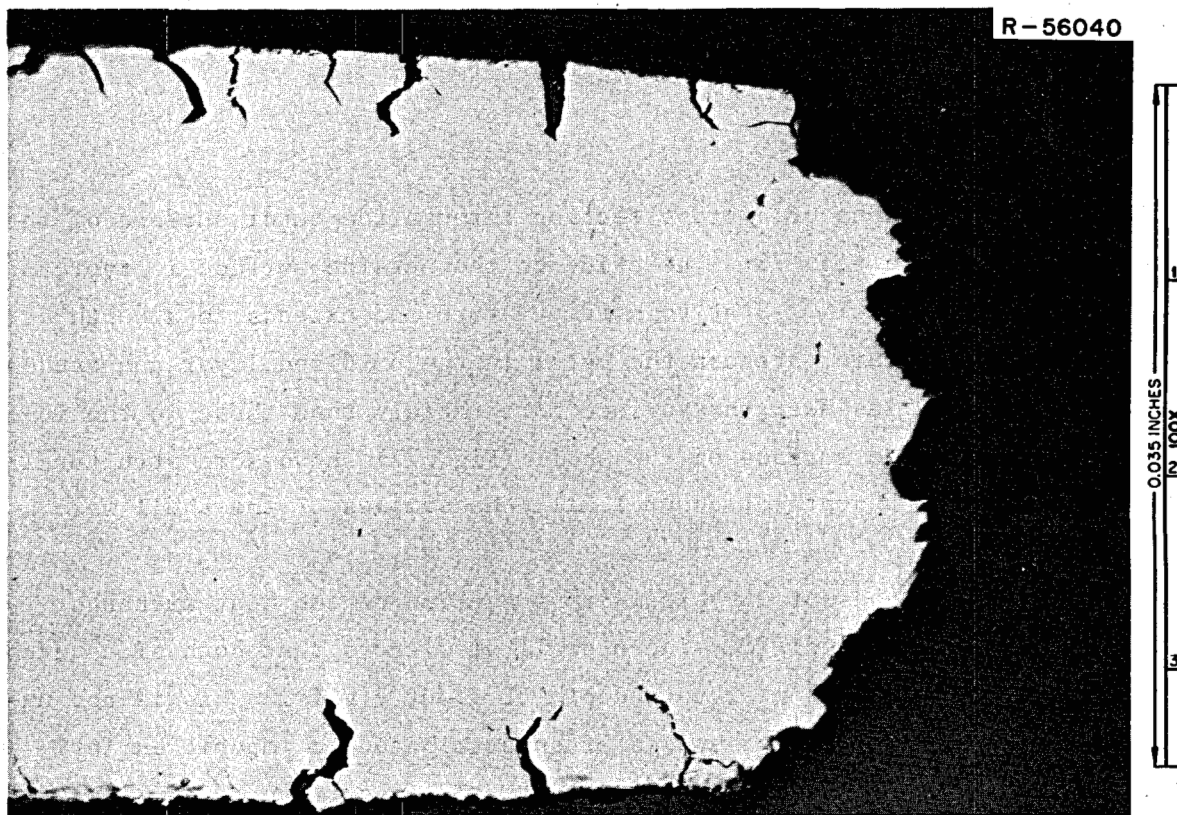
The spacer sleeve gave another opportunity to examine whether a relationship existed between salt velocity and cracking. The photomicrograph in Fig. 72 shows cracks on both sides, with more being present in the field photographed on the side where the salt was rapidly flowing. However, the composite photograph in Fig. 73 shows that the cracking is about equivalent on both sides. Cracking statistics on the side exposed to rapidly flowing salt revealed 178 cracks per inch with a maximum depth of 7.0 mils. The side exposed to restricted salt flow had 202 cracks per inch, with a maximum depth of 5.0 mils. The average depth was 3.0 mils on both sides. These observations again show that salt flow rate is not a significant factor in intergranular cracking.

Fig. 72. Photomicrograph of a Section of Spacer Sleeve Tested at 25°C. As polished. The upper surface was exposed to almost static fuel salt and the lower surface was exposed to rapidly flowing fuel salt.

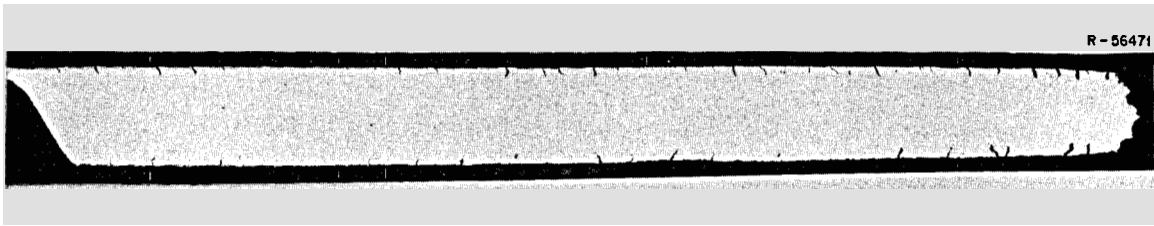
Fig. 73. Composite Photograph Comparing the Density of Cracking of Sides of Spacer Sleeve Exposed to Almost Static Salt (bottom) and to flowing salt (top). 11x. The sample is 0.52 in. long.

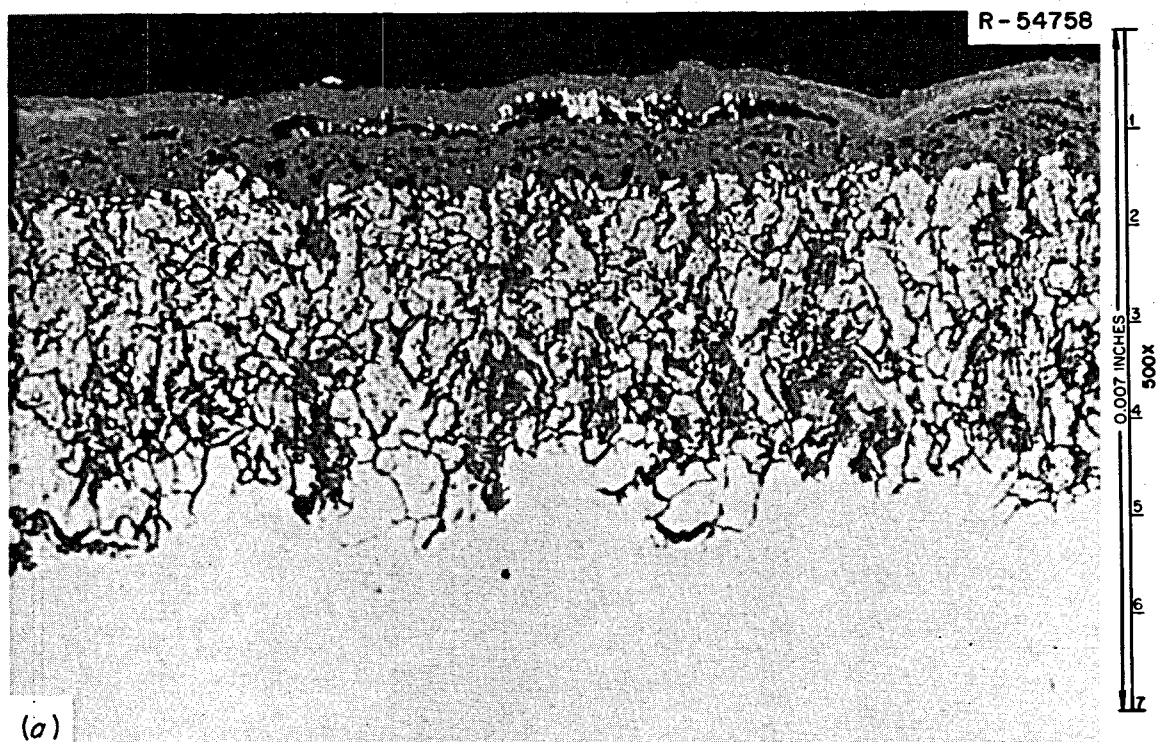
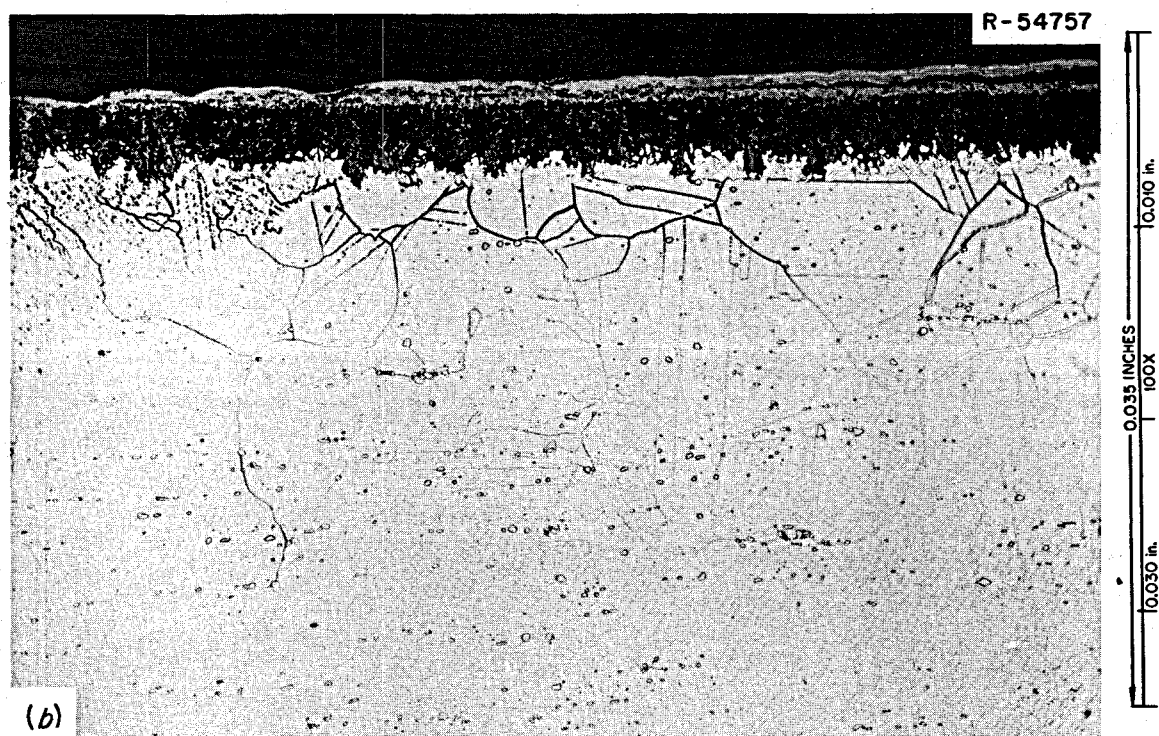
Photomicrographs of a cross section through the outer surface of the shell are shown in Fig. 76. The oxide on the outside surface is typical of that observed on INOR-8 at this temperature and extends to a depth of about 5 mils. Etching attacks the metal in the oxidized layer and etches the grain boundaries near the surface more rapidly than those in the interior. The inside surface of the shell (Fig. 77) shows some structural modifications to a depth of about 1 mil. No samples of the shell were deformed.

Fig. 76. Photomicrographs Showing the Outside Edge of the Primary Heat Exchanger Shell. This surface was exposed to 2 to 5% O_2 in N_2 . (a) As polished, showing the selective oxidation that occurred. (b) Etched view showing that the metal in the oxidized layer was completely removed. Etched with aqua regia.

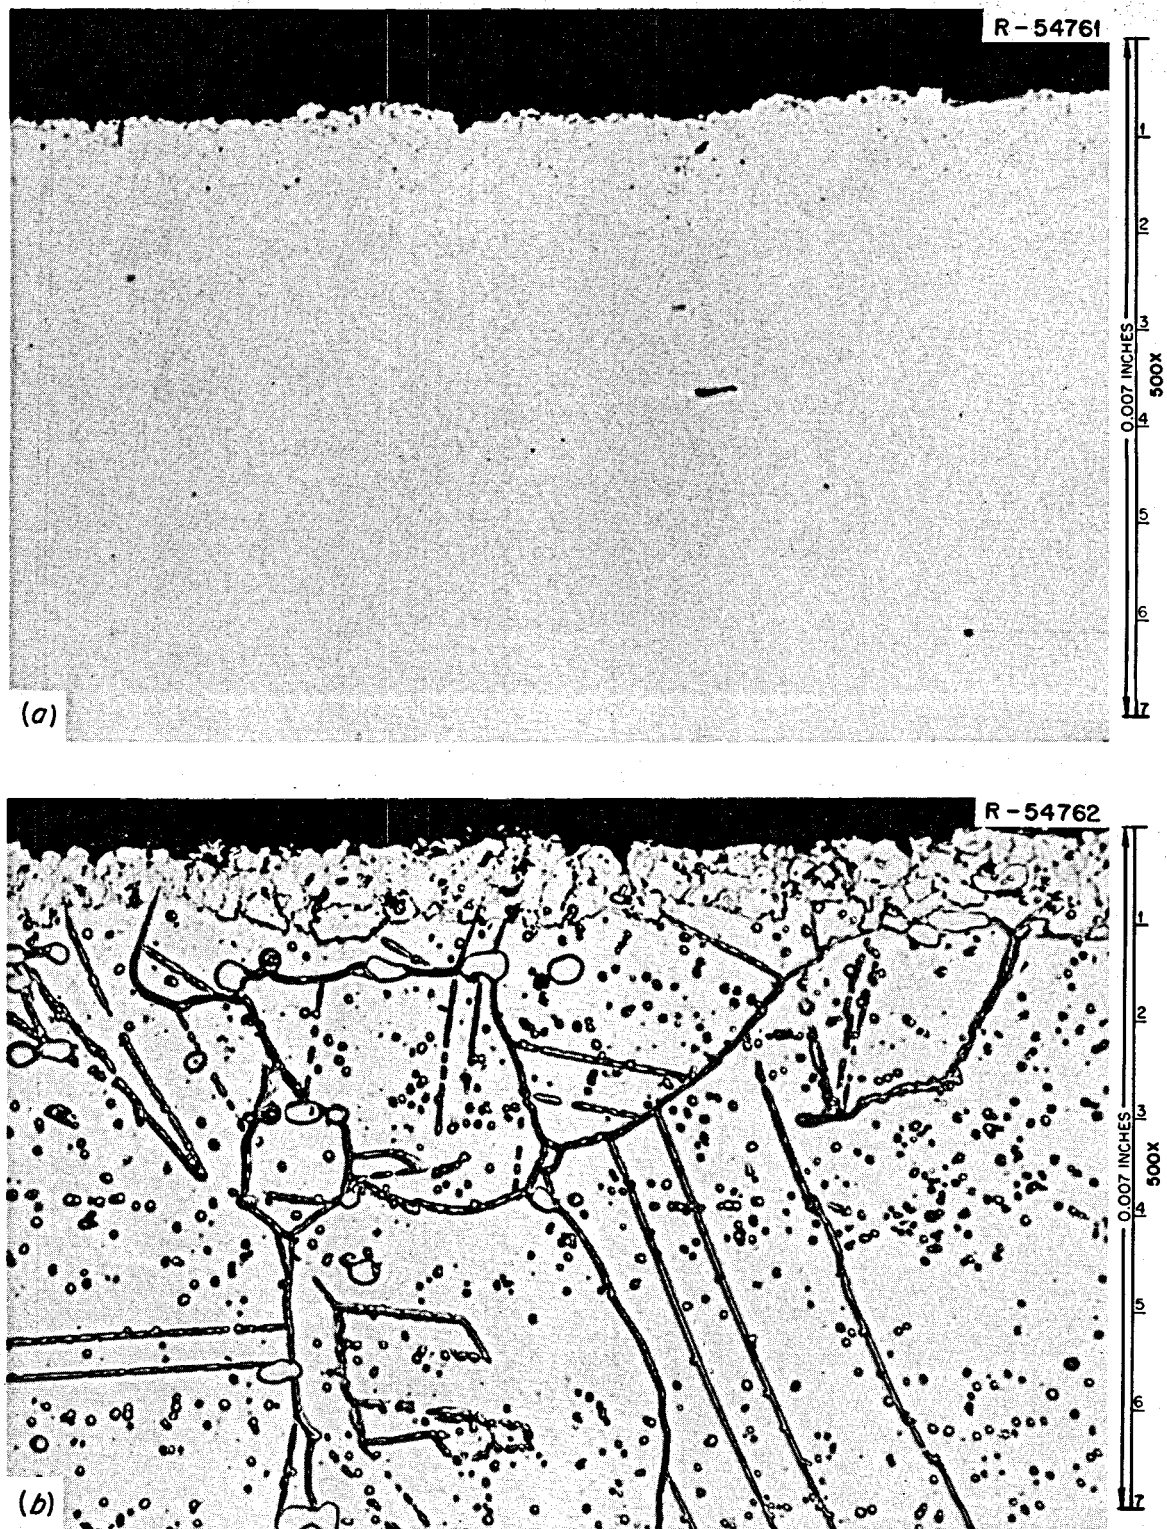
Fig. 77. Photomicrographs of the Inside Surface of the Primary Heat Exchanger Shell. The surface was exposed to fuel salt, and the modified structure to a depth of about 1 mil is apparent. (a) As polished. (b) Etched with aqua regia.

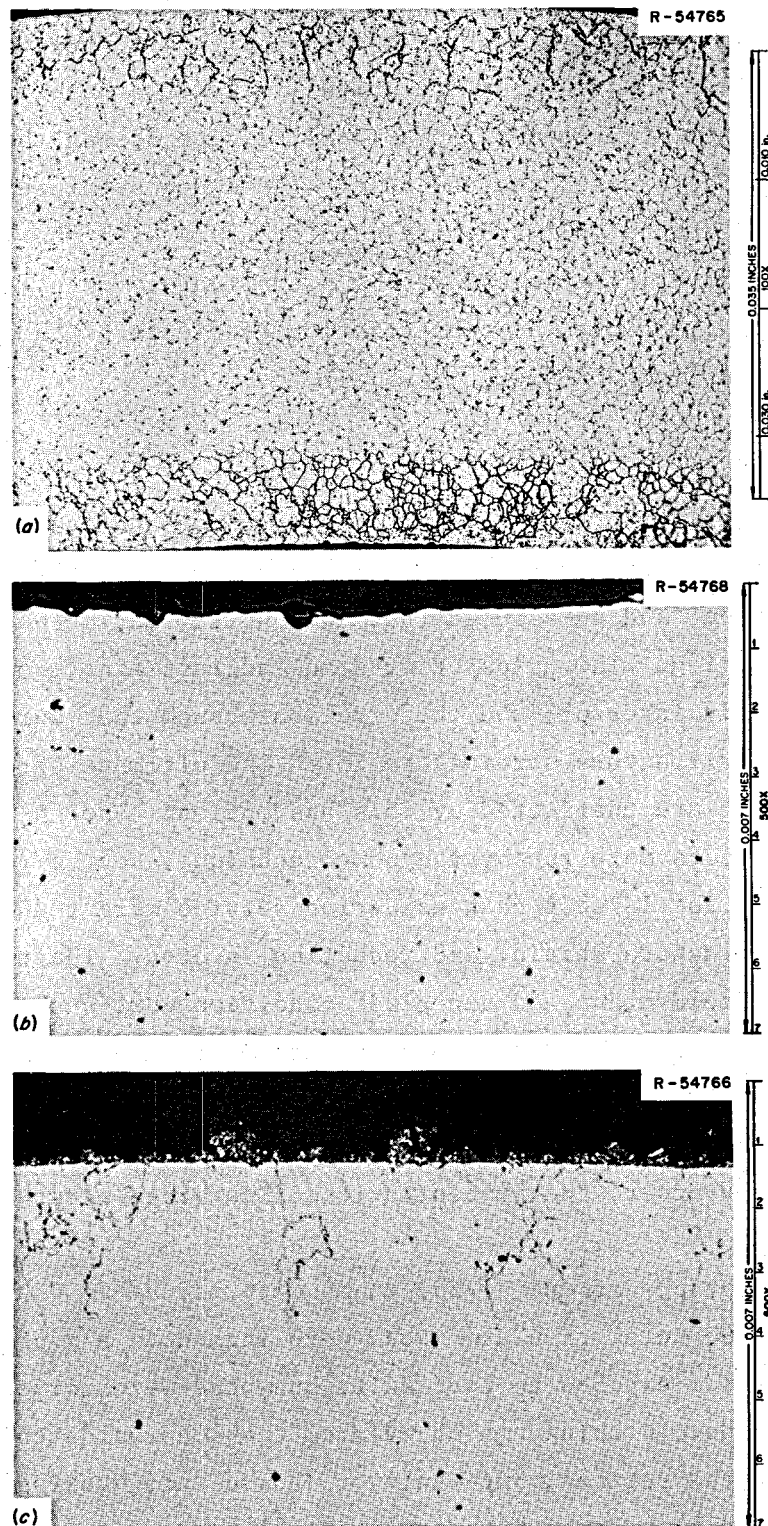
Photomicrographs of a typical cross section of the heat exchanger tubing are shown in Fig. 78. The overall view shows that both sides etch more rapidly than the center to a depth of about 7 mils. This is not unusual for a tubular product and is often attributed to impurities (primarily lubricants) that are worked into the metal surface during repeated steps of deformation and annealing. The higher magnification views in the as-polished condition show that grain boundary attack (or cracking) occurred on the surface exposed to fuel salt (outer) but not on the coolant side (inner). The temperatures under normal operating conditions were such that the fuel salt side (OD) would have been in compression.

Fig. 78. Photomicrographs of a Cross Section of an INOR-8 Heat Exchanger Tube. (a) Etched with glyceria regia. (b) Inside surface in the as-polished condition after exposure to coolant salt. (c) Outside surface in the as-polished condition after exposure to fuel salt. Reduced 34%.

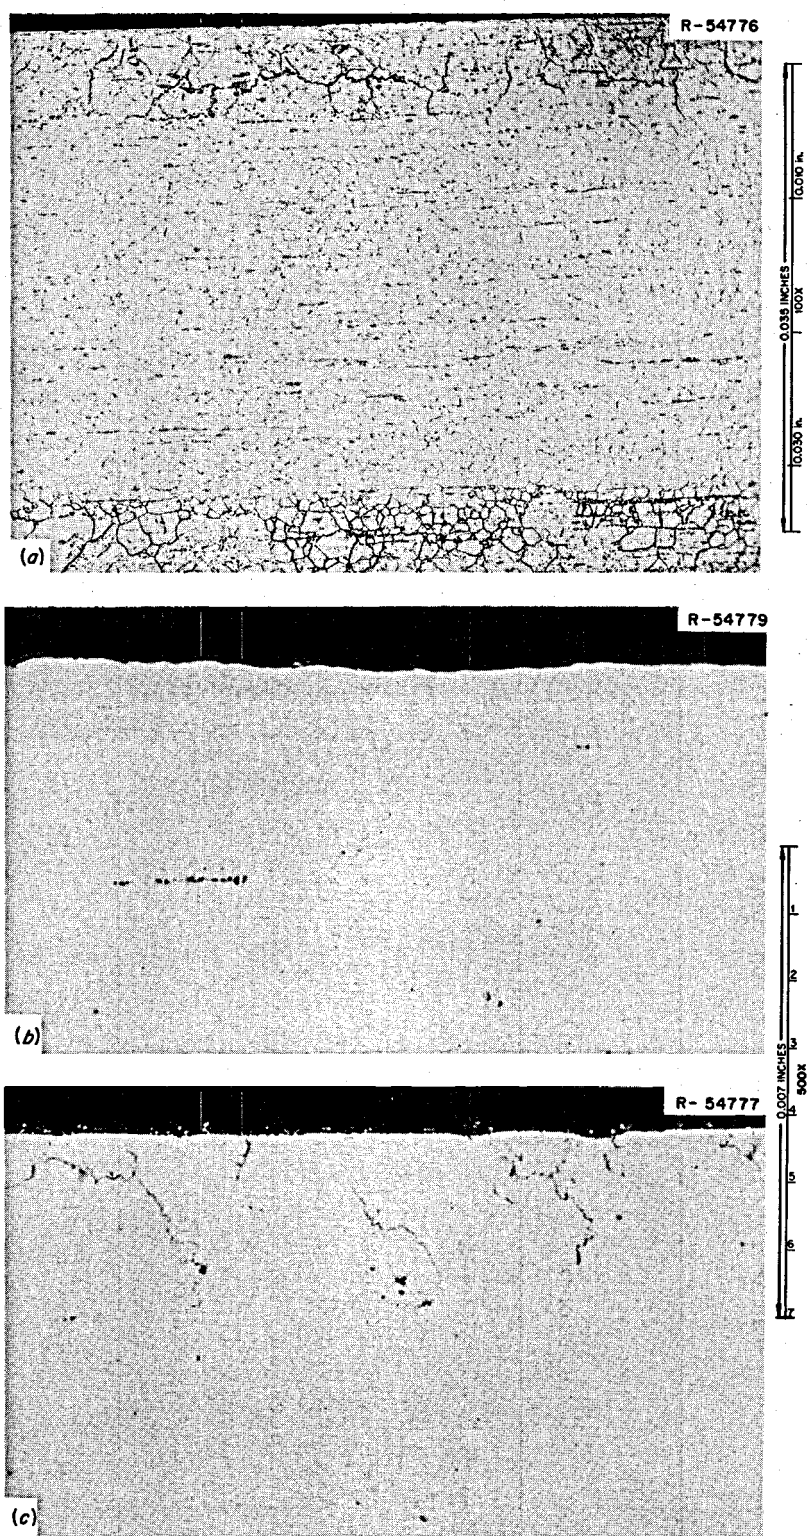
Similar photomicrographs of a longitudinal section of tubing are shown in Fig. 79. The features are quite similar to those discussed for Fig. 78. Both figures show some metallic deposits on the outside surface, which was exposed to fuel salt. These deposits are extremely small and could not be analyzed with much accuracy with the in-cell microprobe. However, they seemed to be predominately iron. Scanning across the tubing detected no concentration gradients of the major alloying elements in INOR-8.

Fig. 79. Photomicrographs of a Longitudinal Section of an INOR-8 Heat Exchanger Tube. (a) Etched with glyceria regia. (b) Inside surface in the as-polished condition after exposure to coolant salt. (c) Outside surface in the as-polished condition after exposure to fuel salt. Reduced 31%.

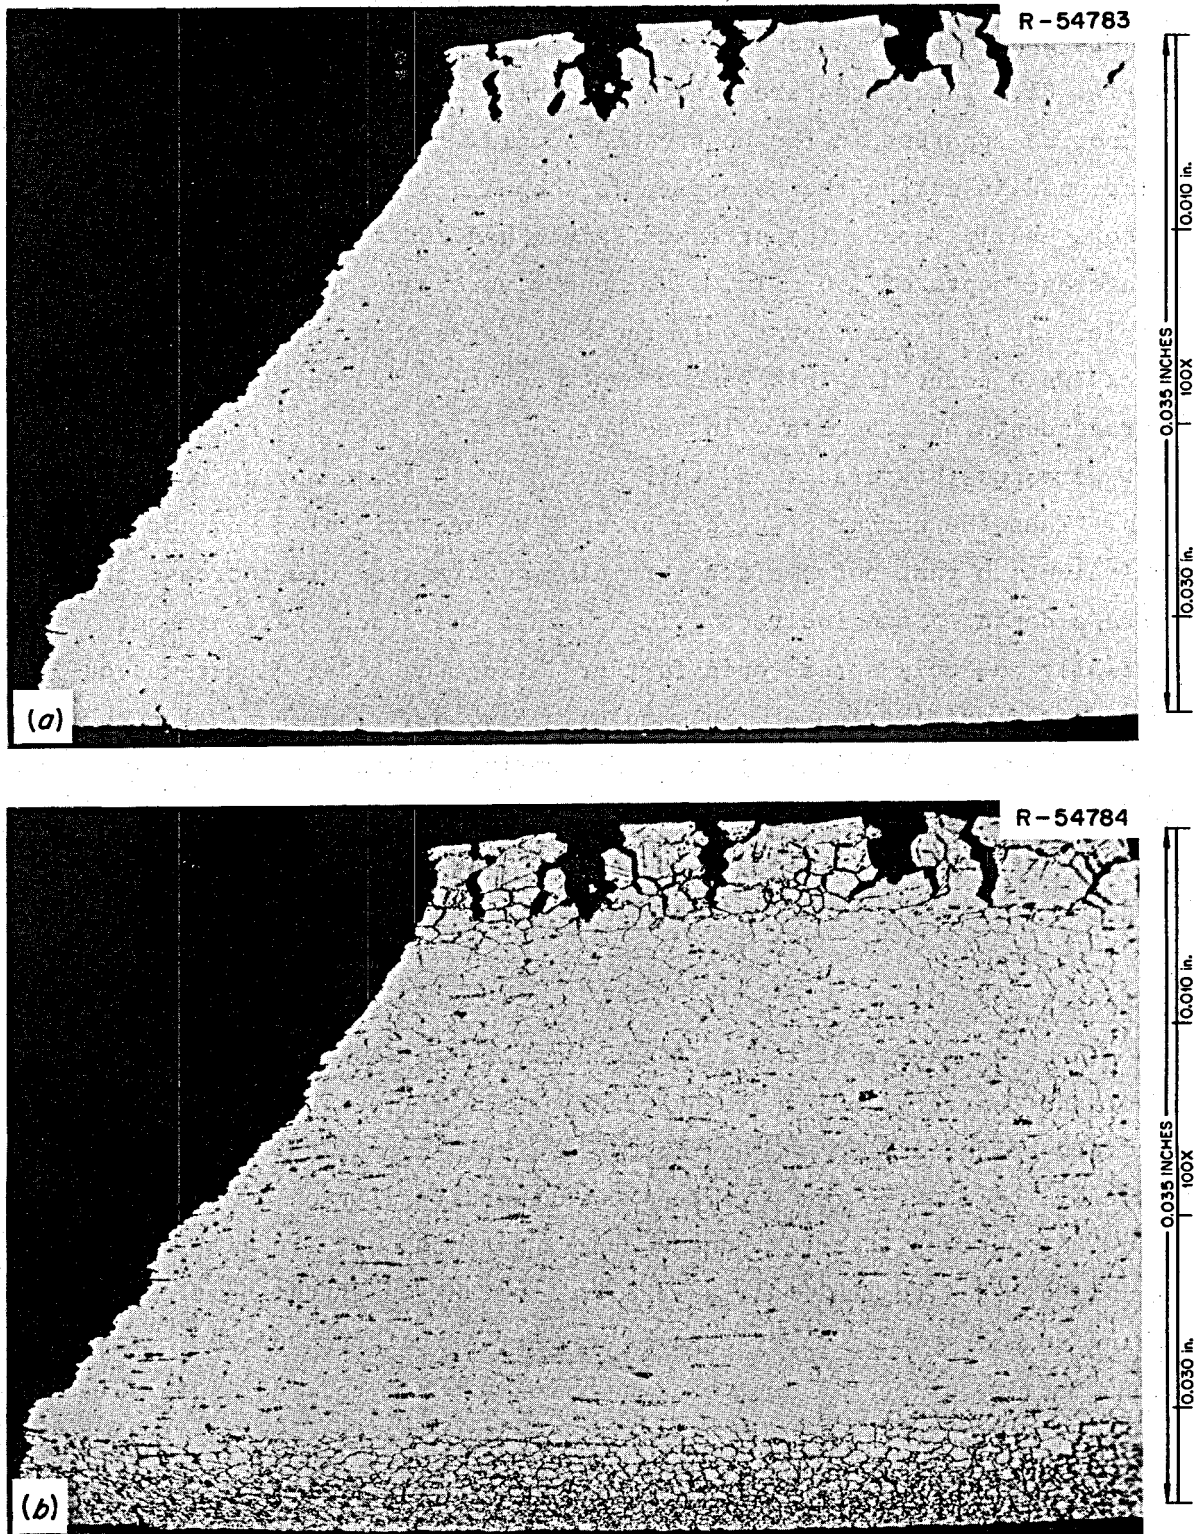
Fig. 80. Photomicrographs of a Heat Exchanger Tube Deformed to Fracture at 25°C. (a) As polished. (b) Etched with aqua regia.

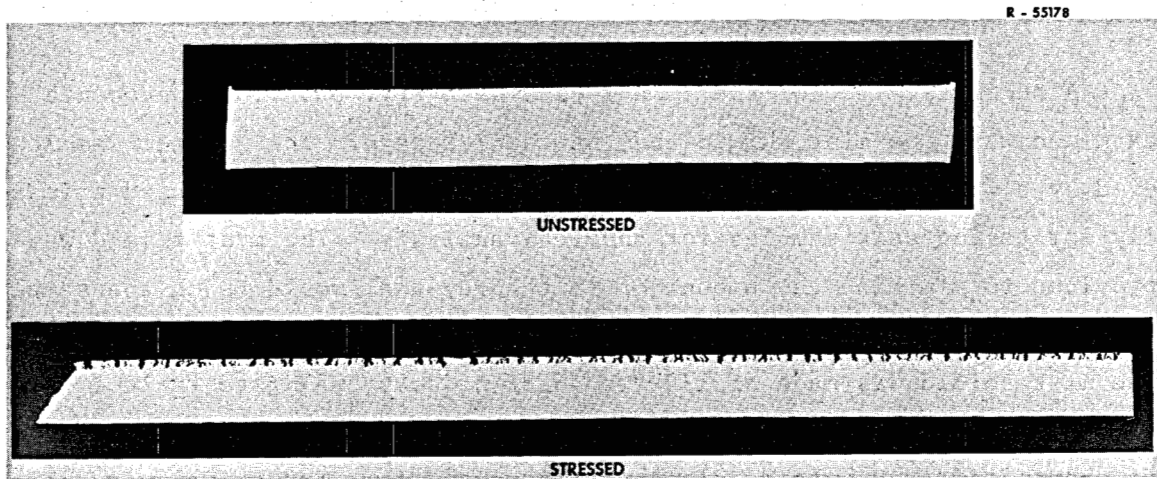
numbers and depths. A composite photograph of the two samples is shown in Fig. 81. The cracks are readily visible in the stressed sample but may not be apparent in the unstressed sample. A higher magnification print used in making the composite is shown in Fig. 82; the cracks can be more easily seen. The stressed sample had 262 cracks per inch with an average depth of 5.0 mils. Two counts were made on the unstressed sample. In the first count only those features that unequivocally were cracks were counted. This gave a crack count of 228 per inch with an average depth of 2.5 mils. In another count, we included some features that were possibly cracks and this gave a crack frequency of 308 per inch. Thus the number of cracks present before straining was about equivalent to that noted after straining. Straining did increase the *visible* depth. Some indirect evidence that the cracks were present initially and only spread open further during the tensile test was obtained from examination of the sample in Fig. 81. The sample length shown deformed 39% (Table 9), and the combined widths of the cracks account for 35% strain. Thus, the cracks widths very closely account for the total strain and indicate that the cracks formed with little or no deformation and spread open as the sample was deformed.

Fig. 81. Composite Photographs of Heat Exchanger Tubing Before and After Stressing. The width of the unstressed sample is 0.042 in.
