INTERGRANULAR CRACKING OF INOR-8 IN THE MSRE

H. E. McCoy
B. McNabb

ORNL-4829
UC-25 — Metals, Ceramics, and Materials

NOVEMBER 1972

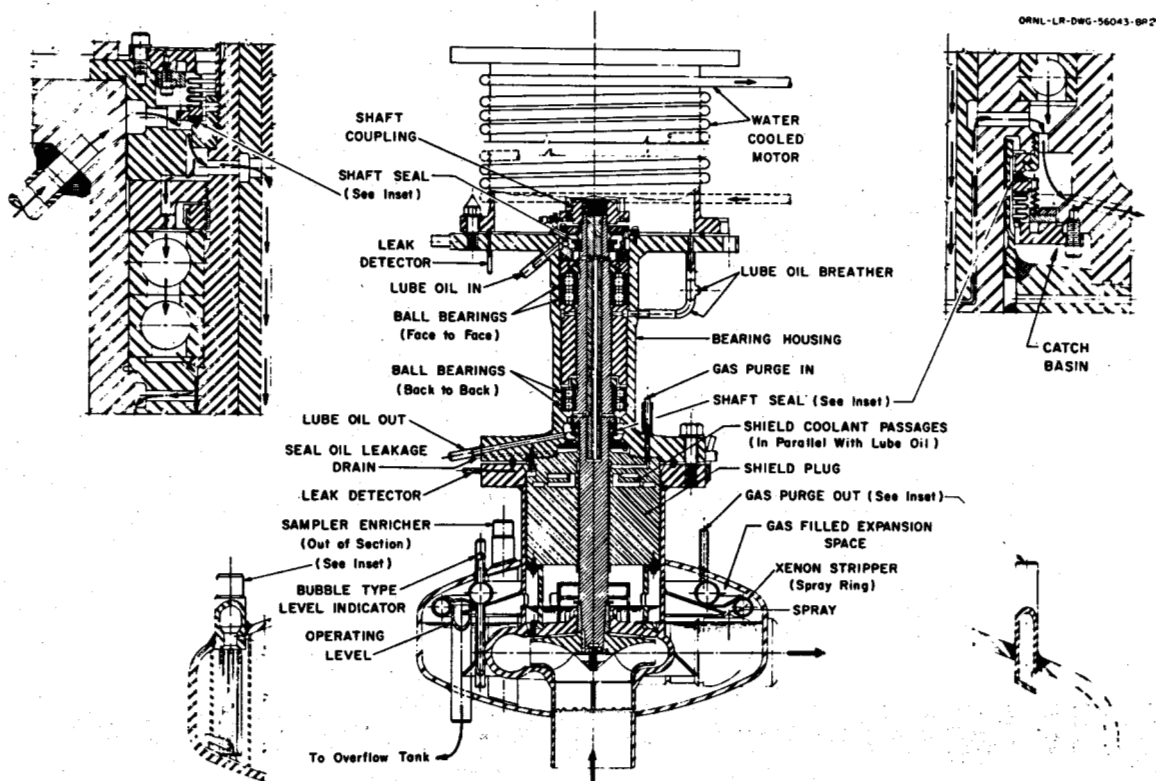
A schematic view of the pump is shown in Fig. 83. The components examined were the mist shield and the sampler cage. The sampler was lowered by a windlass arrangement into the sampler cage and was used primarily for taking salt samples for chemical analysis. The mist shield was provided to minimize the amount of salt spray that would reach the sampler. The vertical sampler cage rods were 1/4 in. diam and made of heat 5059. The mist shield was made of 1/8-in. sheet of heat 5057 (see Table 1 for chemical analysis). The mist shield was a spiral with an inside diameter of about 2 in. and outside diameter of about 3 in. The spiral was about 1 1/4 turns, and the outside was exposed to agitated salt and the inside to salt flowing much slower. The outside was exposed to salt up to the normal liquid level and to salt spray above this level. The inside was exposed to salt up to the normal salt level and primarily to gas above this level.

Fig. 83. Section of MSRE Fuel Pump with Details of Several Areas. The mist shield and the sampler cage that were examined are shown in the lower left insert.

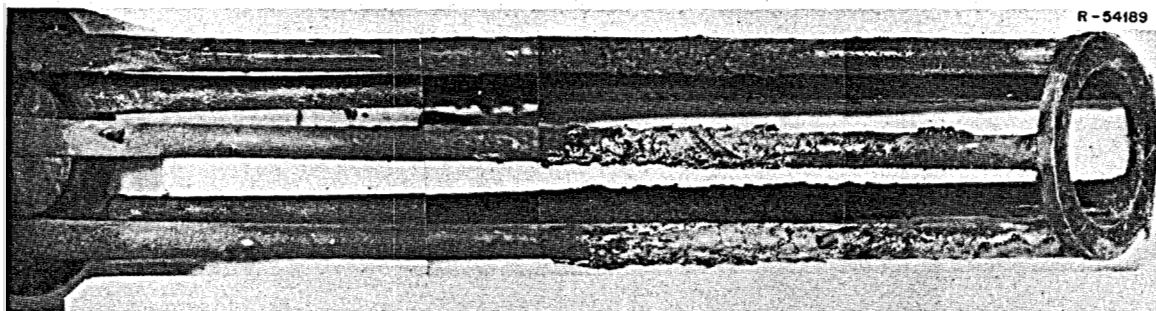
The general appearance of the sampler cage is shown in Fig. 84. The salt normally stayed at a level near the center of the cage, but the level fluctuated slightly. The amount of material deposited on the surface is much higher below the liquid interface than above. A gross gamma scan had a similar profile with a maximum near the liquid interface. A carbonaceous deposit was present at the top of the sampler. The mist shield had some deposits, and these were heavier below the liquid level and on the outer surface of the shield.

Fig. 84. Sampler Cage. The assembly is 8.5 in. high. The salt-vapor interface corresponds with the region of highest material deposition.

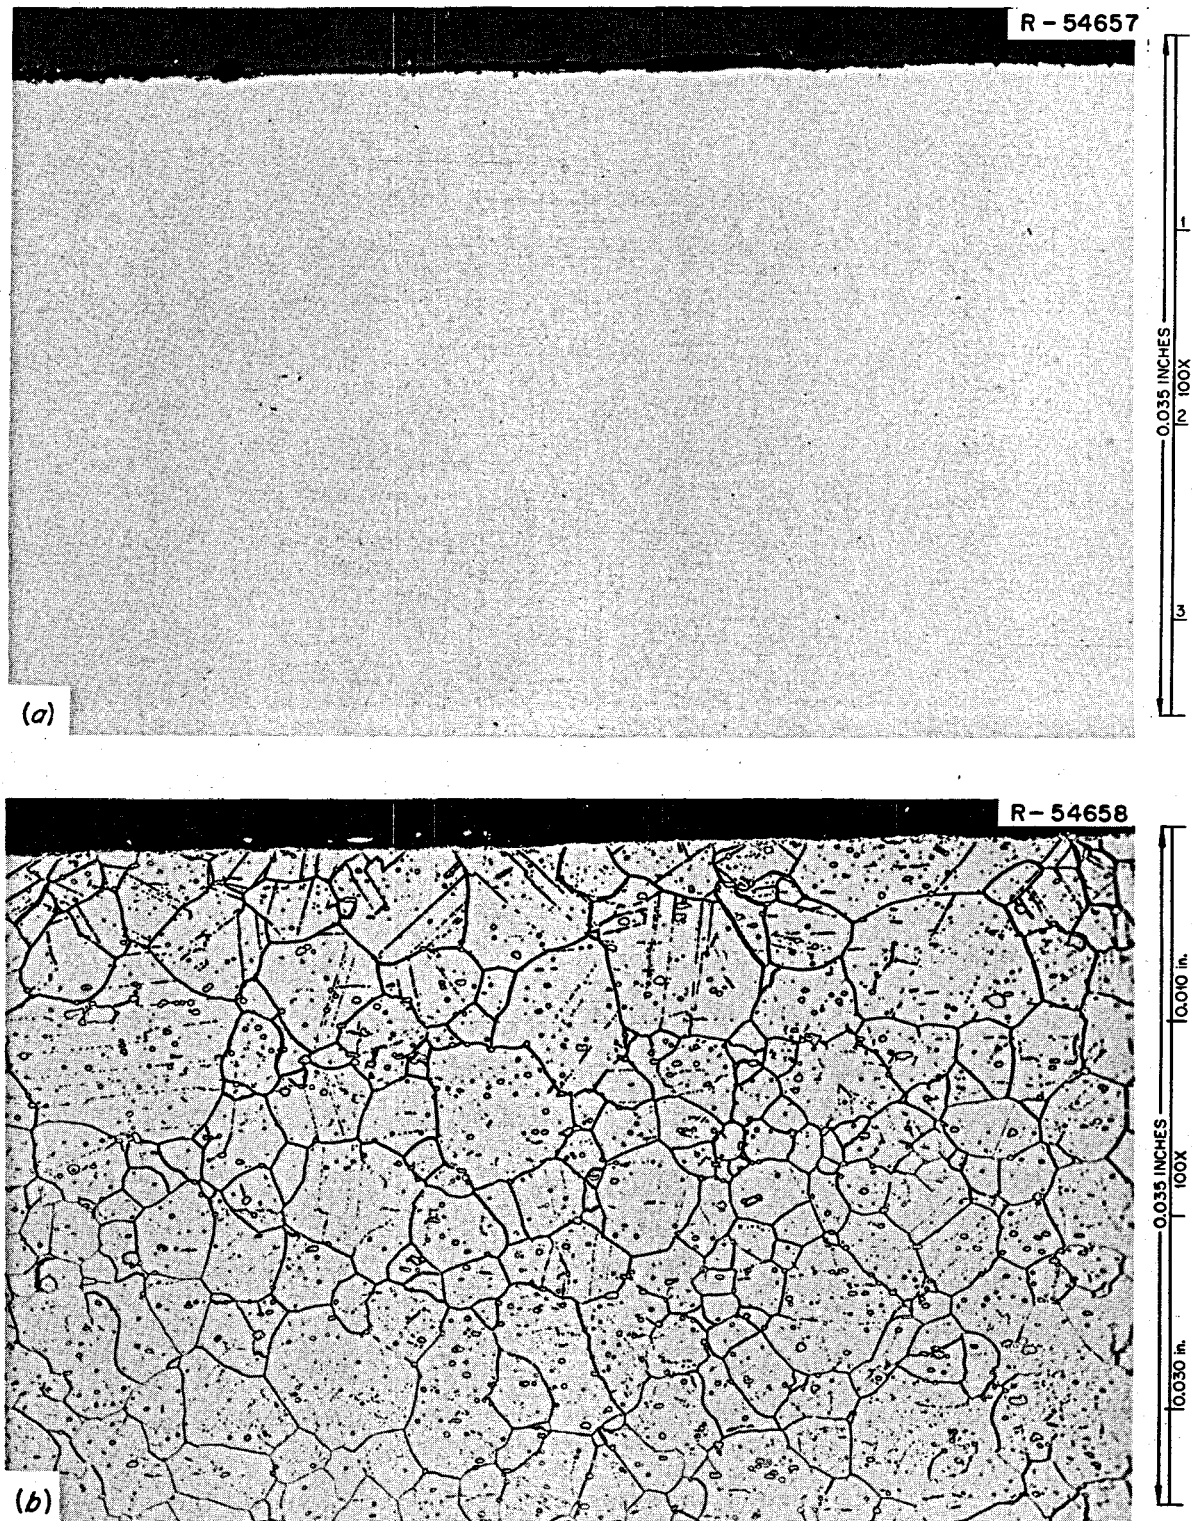
One of the sampler cage rods was examined metallographically. Photomicrographs of samples from the vapor and liquid regions are shown in Fig. 85 and 86, respectively. There is no intergranular penetration visible at this magnification. A heavy surface deposit is on the sample from the liquid region. This deposit was not examined by the electron microprobe analyzer, but a similar deposit on a copper capsule taken from

Fig. 85. Photomicrographs of an INOR-8 Rod from the Sampler Assembly Located Above the Normal Salt Level. (a) As-polished. (b) Etched with aqua regia.

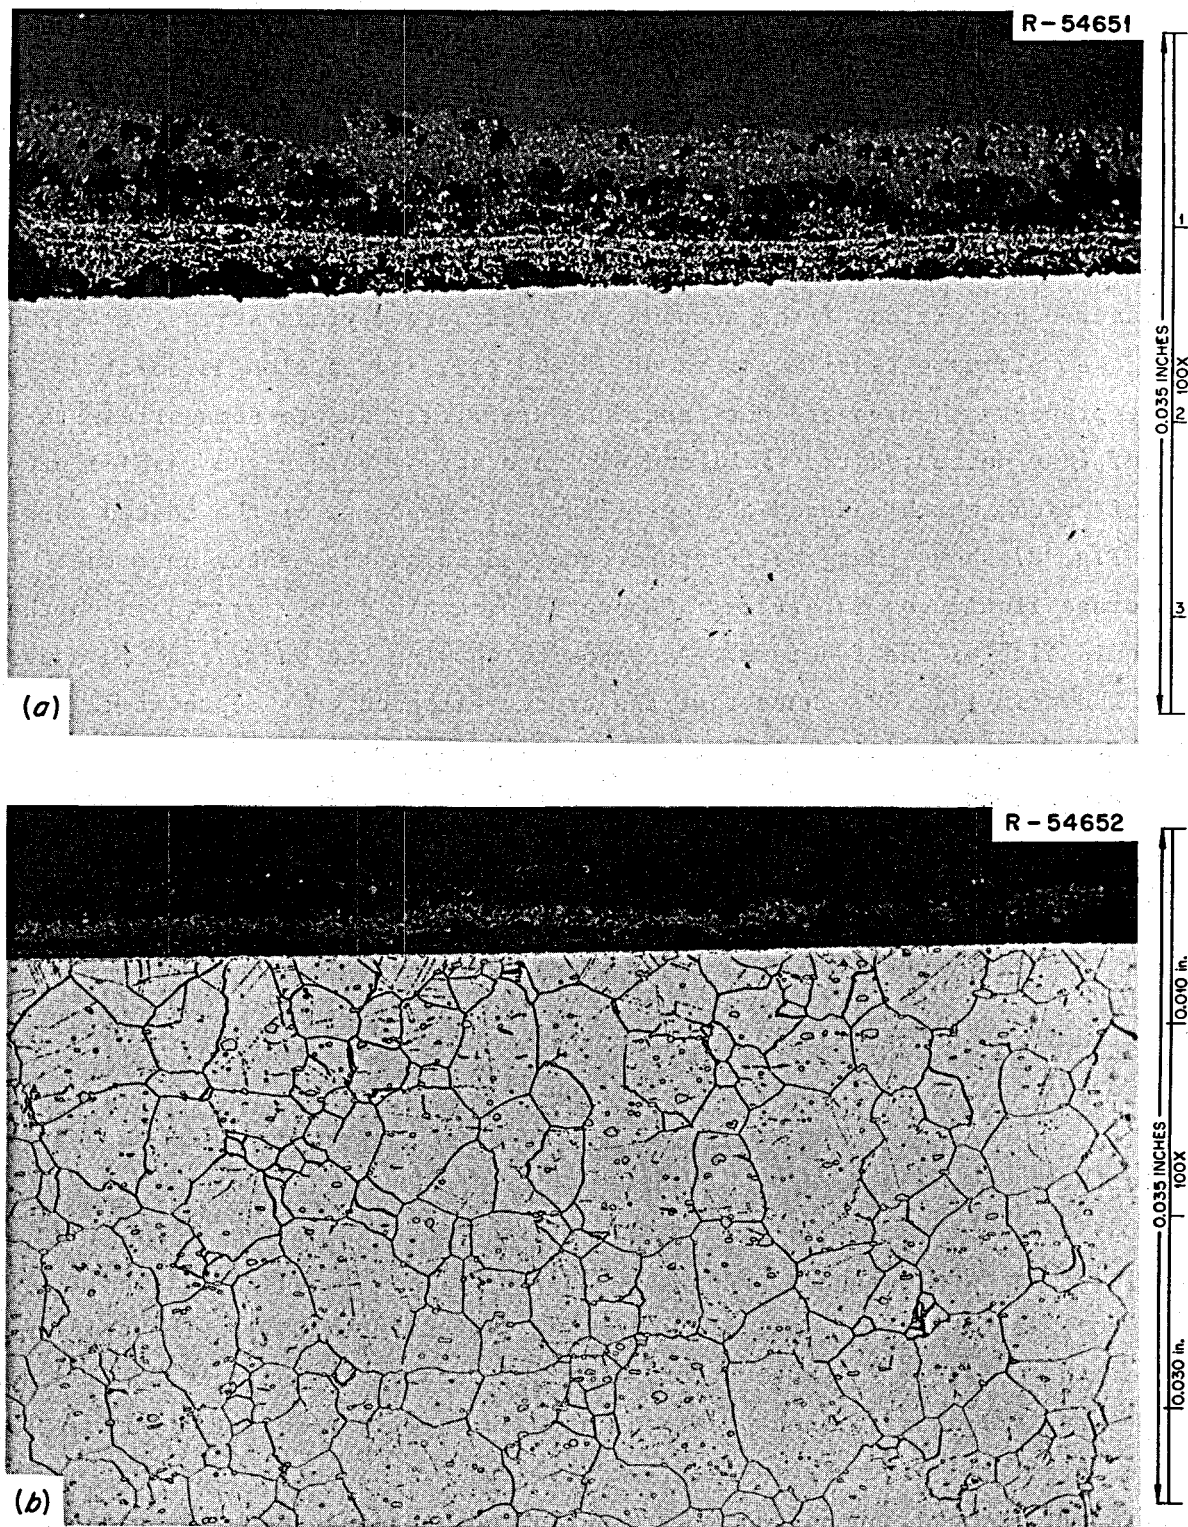
Fig. 86. Photomicrographs of an INOR-8 Rod from the Sampler Assembly. Normally located below the salt level. (a) As polished. (b) Etched with aqua regia.

the sampler region was examined. The deposit contained some salt, but had regions that were high in the alloying elements in INOR-8: Ni, Cr, Fe, and Mo.

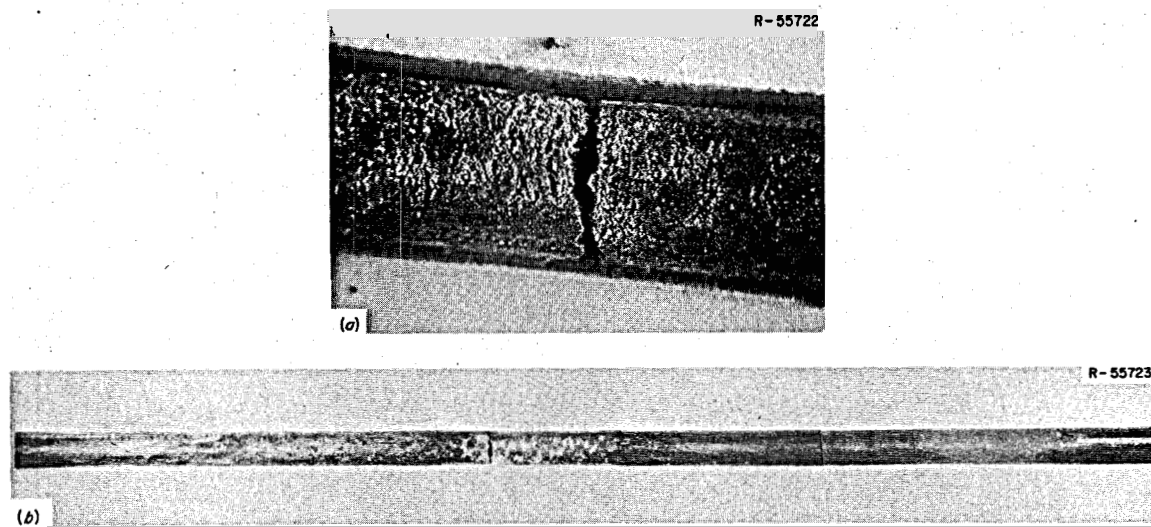
One of the sampler cage rods was pulled in tension at 25°C. The certified properties of this material were a yield stress of 51,200 psi, an ultimate tensile stress of 115,300, and an elongation of 51%. The measured properties of the sampler cage rod were a yield stress of 42,500 psi, an ultimate tensile stress of 93,400 psi, and an elongation of 35.7%. The property changes are not large and are likely due to some stress relief that decreased the yield and ultimate stress values and carbide precipitation, which reduced the ductility. A composite of the tested sample in Fig. 87 shows that the fracture occurred below the center near the average liquid-gas interface. One metallographic sample was taken on the liquid side of the fracture. A composite showing the badly cracked edges is shown in Fig. 88. Note that the cracks extended to a depth of 12 mils. A higher magnification view of an area near the fracture shows that the cracks extend in excess of 3 grains deep and that several grains have fallen out (Fig. 89). Another metallographic sample was taken 3/4 in. above the fracture. A composite of photographs along the edge shows that the depth of cracking decreases with increasing distance into the vapor region (Fig. 90). The severity of cracking is different on the two edges of the rod. Unfortunately, we do not know the orientation of the rod relative to the sampler and the mist shield.

Fig. 87. (a) Tensile-tested Sampler Cage Rod from Pump Bowl. Rupture occurred near the average liquid-vapor interface. (b) Photograph of rupture area showing extensive surface cracking. Rod diameter is $1/4$ in.

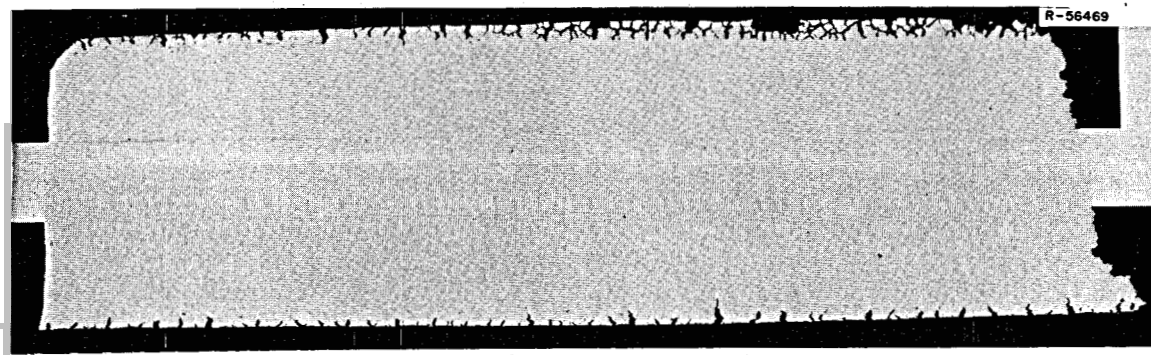
Fig. 88. Section of Sample Cage Rod that was Deformed at 25°C . $9.2\times$. The fracture (left) occurred at the salt-vapor interface. The rod is immersed further in the liquid from left to right. The length of the sample is 0.63 in.

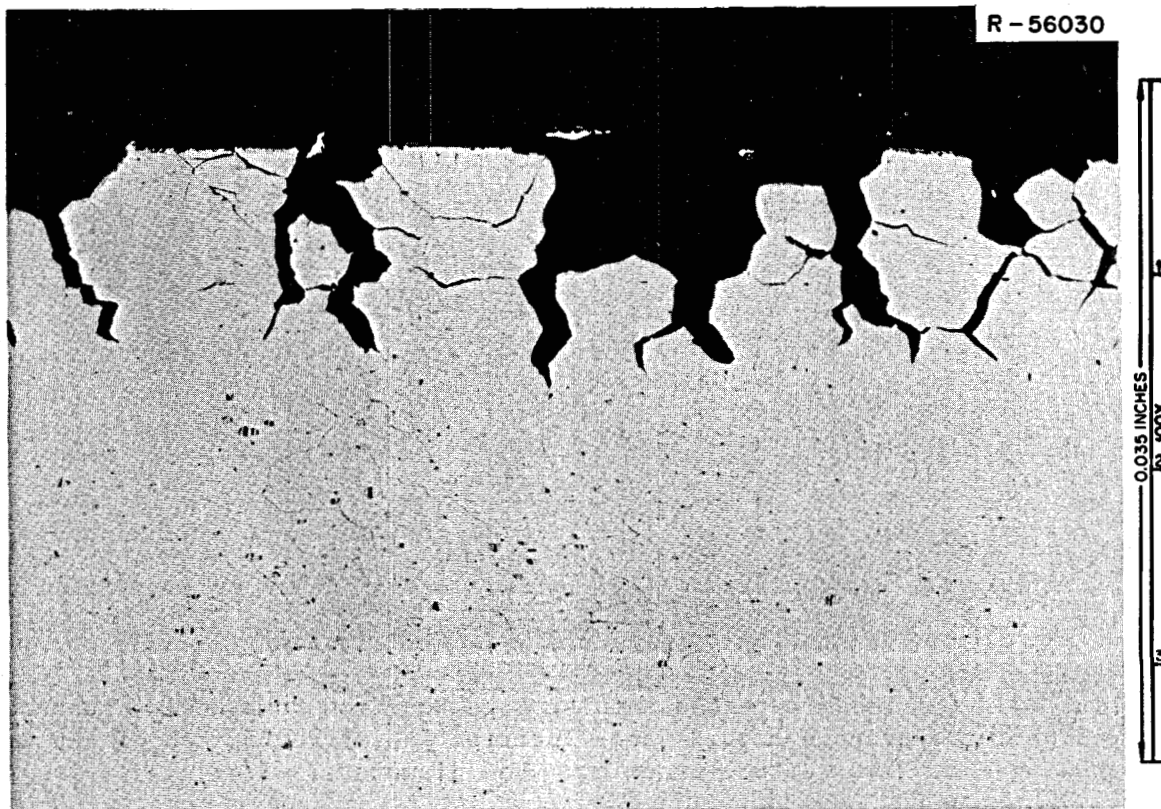
Fig. 89. Photomicrograph of Deformed Sampler Cage Rod Near the Fracture. As-polished.

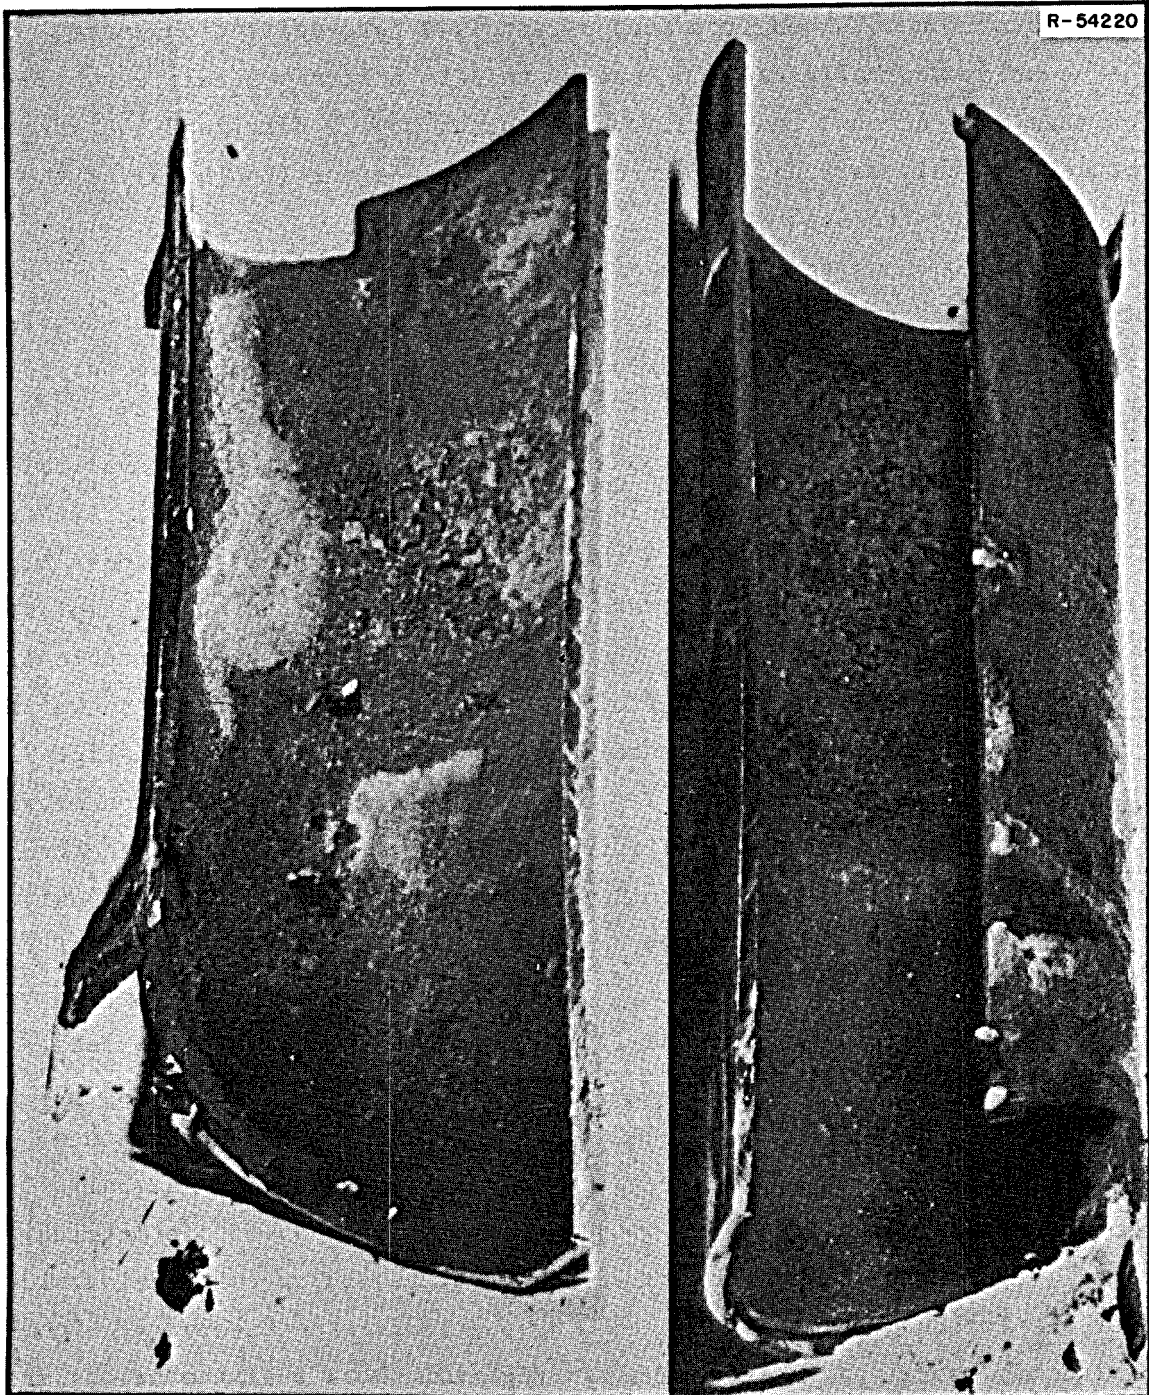
Figure 91 shows the mist shield after removal from the MSRE. The shield has been split to reveal the inside surface. Four specimens approximately 1 in. (vertical) \times 1/2 in. (circumferential) were cut from the mist shield. Their locations were (1) outside the spiral and immersed in salt, (2) outside the spiral and exposed to salt spray, (3) inside the spiral and immersed in salt, and (4) inside the spiral and exposed primarily to gas. Bend tests were performed on these specimens at 25°C using a three point bend fixture.²² They were bent about a line parallel

Fig. 91. Interior of Mist Shield. Right part of right segment overlapped left part of segment on left.

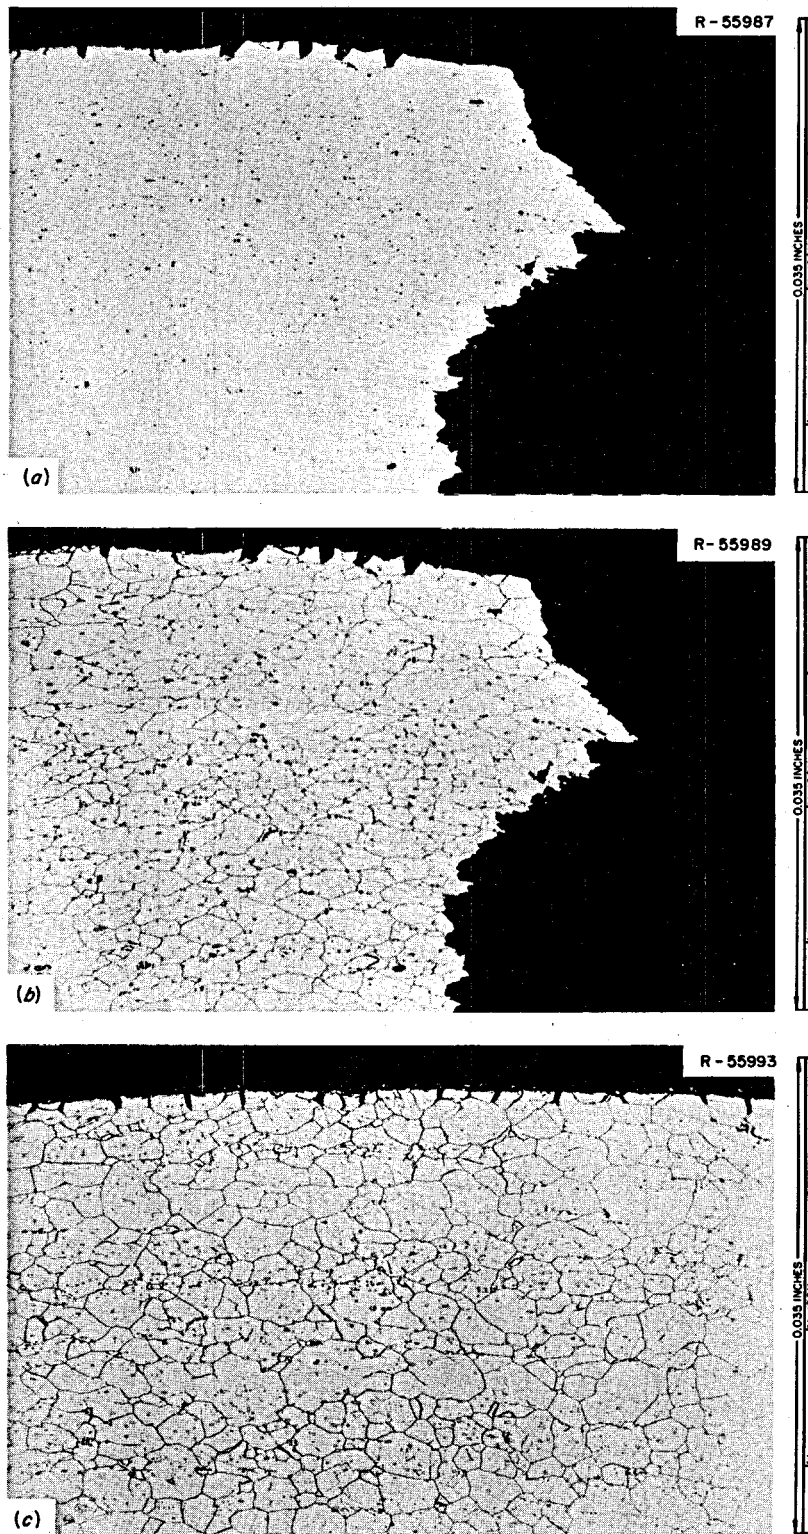
The bend samples of the mist shield were examined metallographically. Photomicrographs of the sample from the inside vapor region are shown in Fig. 92, and a composite of several photomicrographs is shown in Fig. 93. The edge cracks were intergranular and about 1 mil deep. The photomicrographs of the sample from the liquid region (Fig. 94) show that the cracks extended to a depth of about 8 mils in the liquid region. The composite photograph in Fig. 95 also shows the increased frequency and depth of cracking in the liquid region.

Fig. 92. Photomicrographs of Bend Specimen of Mist Shield from Inside Vapor Region. (a) Fracture and tension side, as polished. (b) Fracture and tension side, etched. (c) Tension side, etched. Etchant: Aqua regia. Reduced 31%.

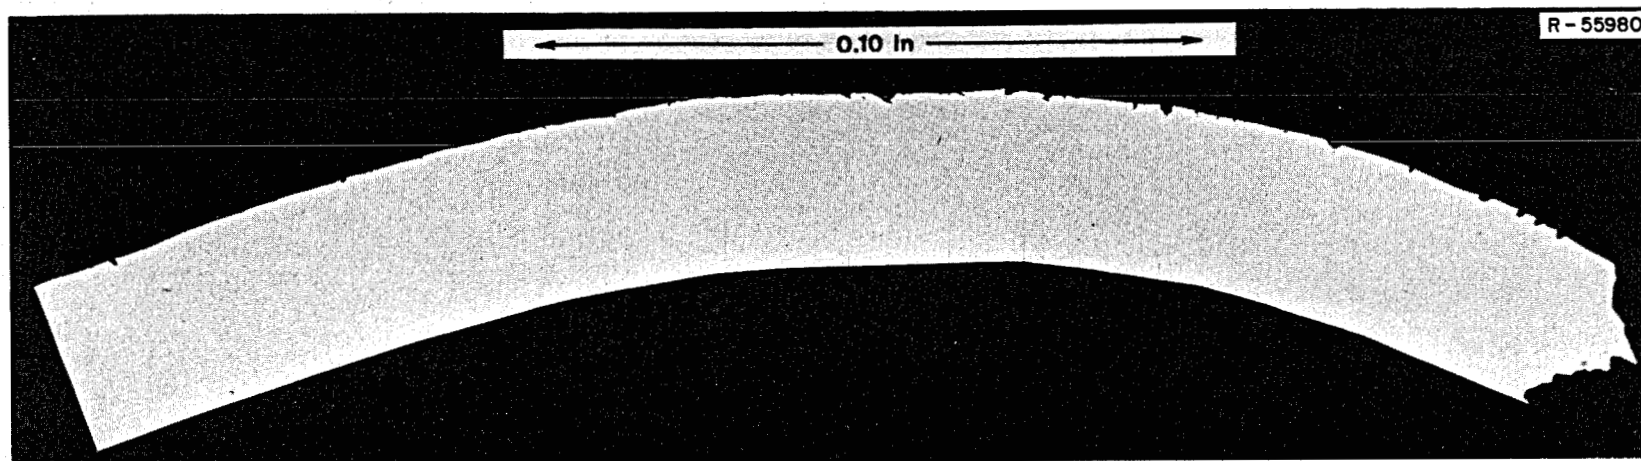
Fig. 93. Composite Photograph of the Tension Side of a Bend Sample from Inside Vapor Region of Mist Shield. Lower edge is not the compression side of the sample.

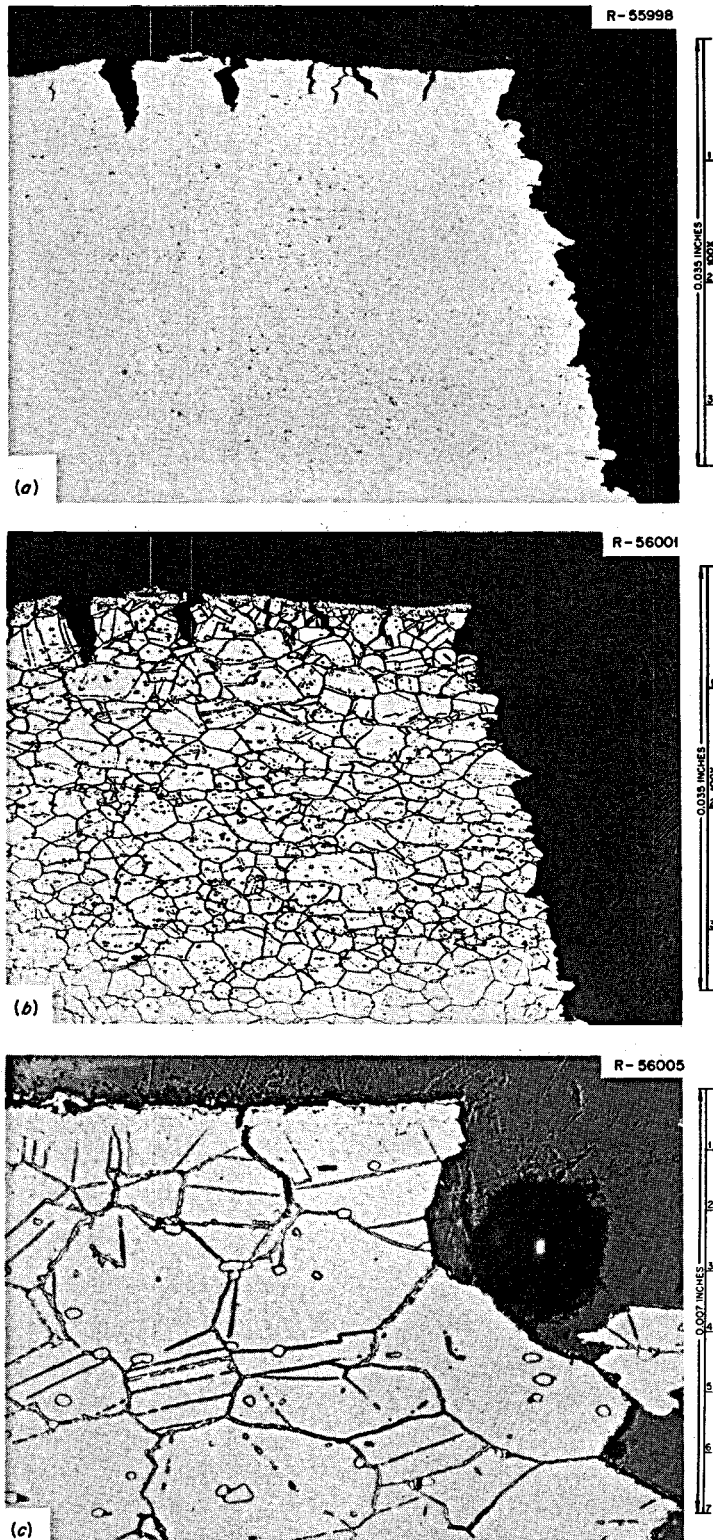
Fig. 94. Photomicrographs of Bend Specimen of Mist Shield from Inside Liquid Region. (a) Fracture and tension side, as polished. (b) Fracture and tension side, etched. (c) Fracture and tension side, etched. Etchant: Aqua Regia.

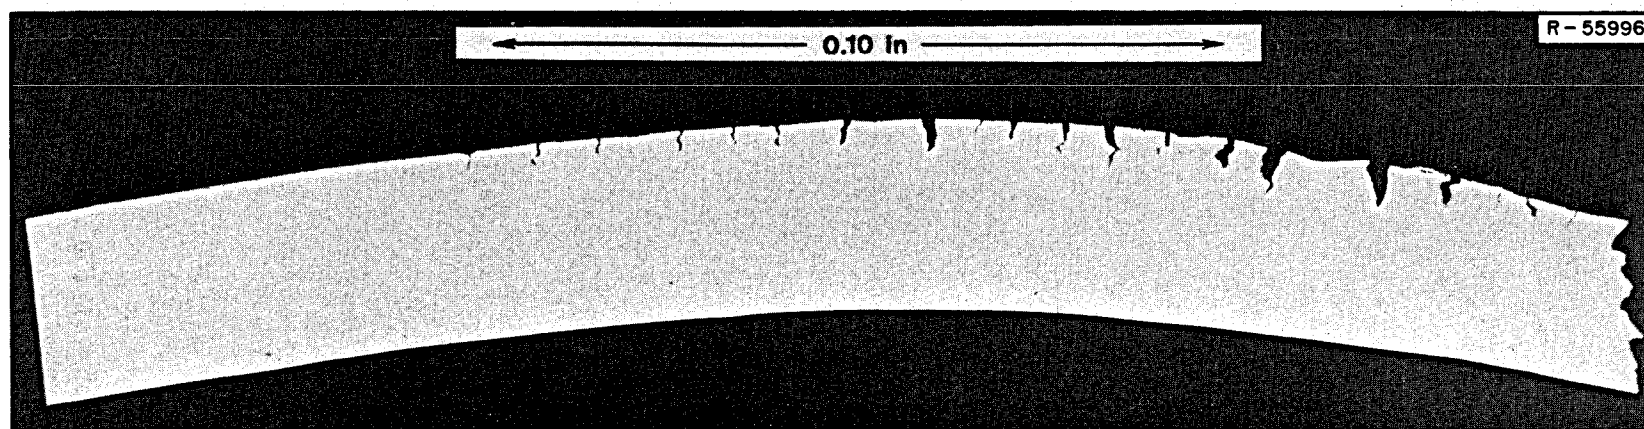
Fig. 95. Composite Photograph of the Tension Side of a Bend Sample from Inside Liquid Region of Mist Shield. Lower Edge is not the compression side of the sample.

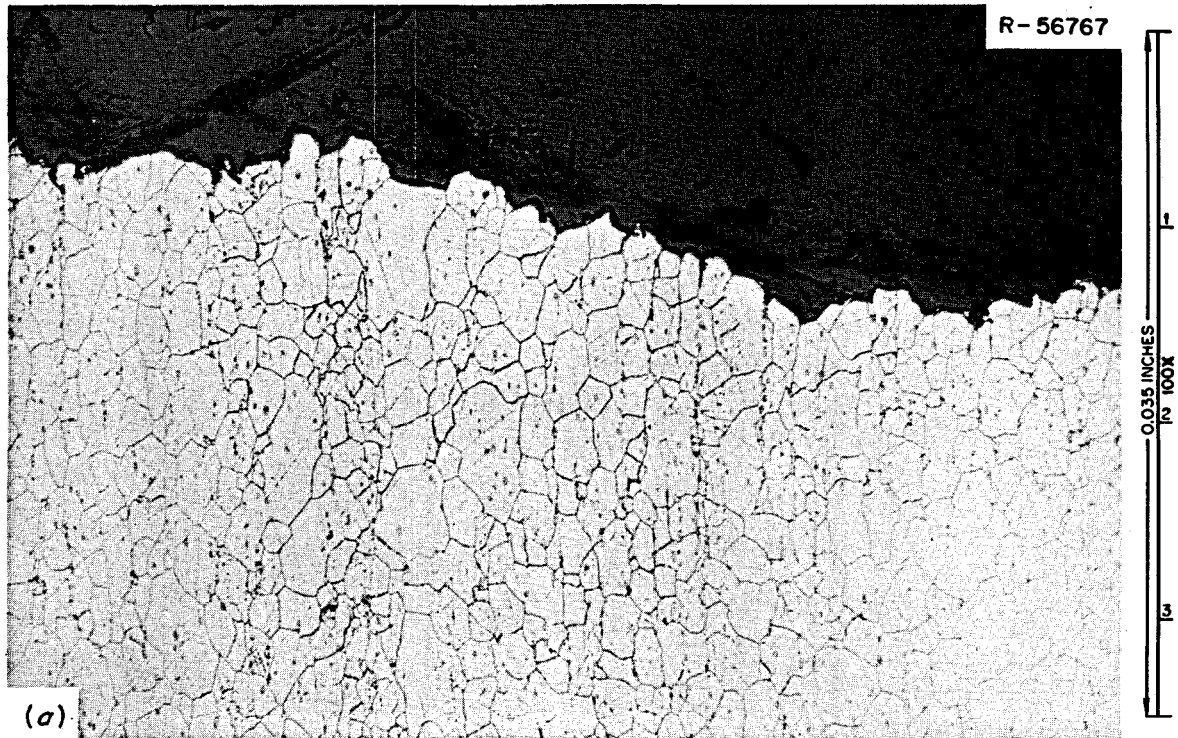
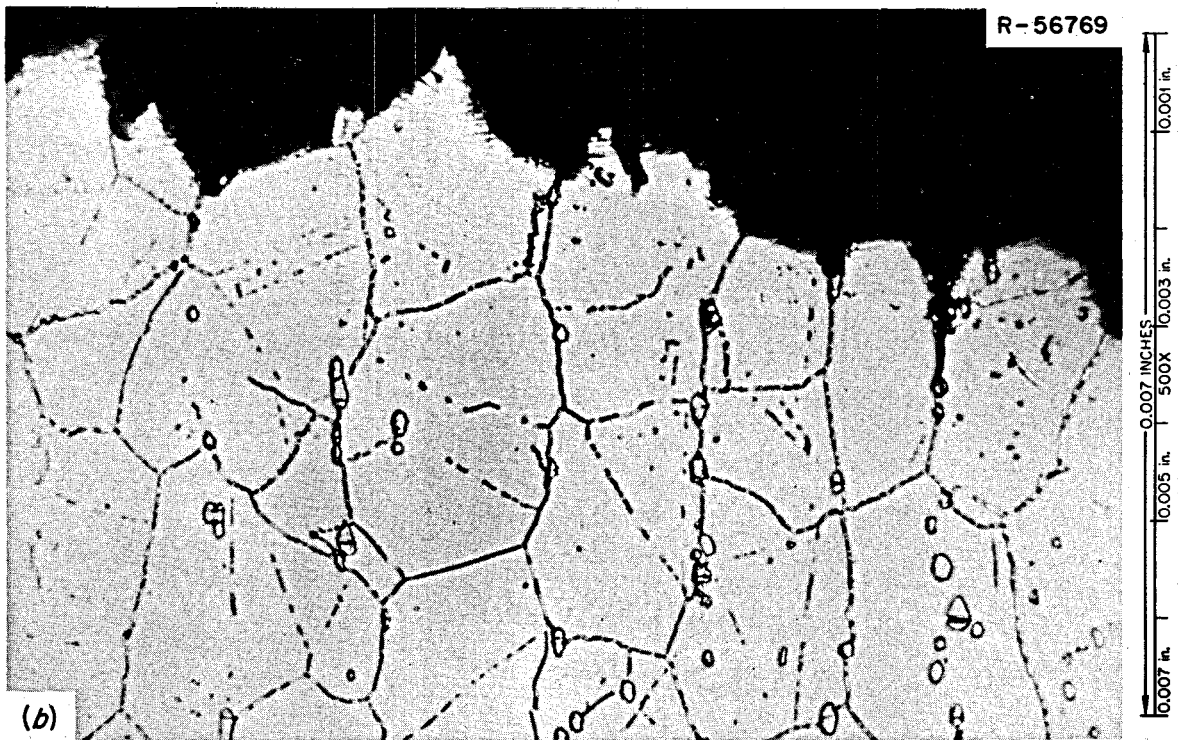
The sample from the outside liquid region was quite similar metallographically to that from the inside liquid region. Photomicrographs of the fracture and a typical region of the tension near the fracture are shown in Figs. 96 and 97, respectively. A composite of several photomicrographs is shown in Fig. 98. Photomicrographs of the outside vapor (salt spray) bend specimen at the fracture and on the tension side near the fracture are shown in Figs. 99 and 100, respectively. The composite of several photomicrographs in Fig. 101 shows that the cracks are not much deeper nor more frequent than in the liquid regions (compare Figs. 95, 98, and 101), but the tendency for grains to fall out is much greater. This is even more significant when one notes that the strain was the least in the sample from the outside vapor region (Table 10).

Fig. 96. Photomicrographs of the Fracture of a Bend Specimen from the Outside Liquid Region of the Mist Shield. (a) 100x. (b) 500x. Etchant: Lactic acid, HNO_3 , HCl .

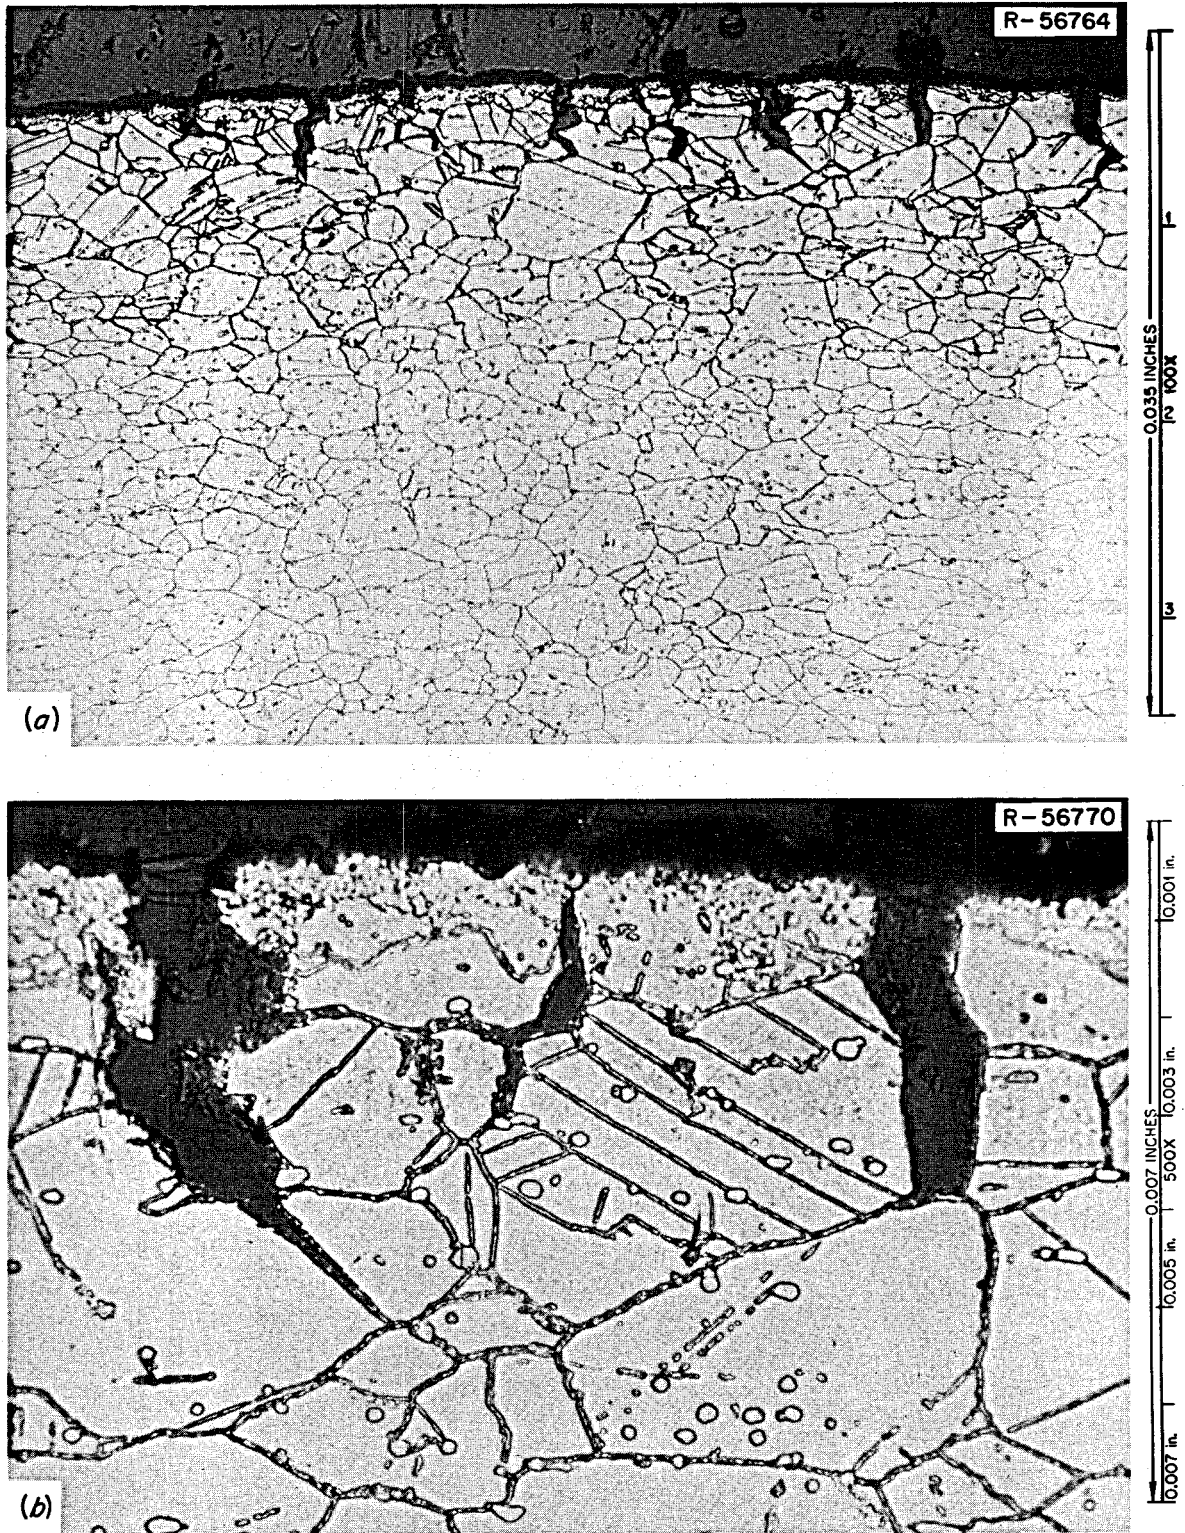
Fig. 97. Photomicrographs of the Tension Side Near the Fracture of a Bend Specimen from the Outside Liquid Region of the Mist Shield. (a) 100 \times . (b) 500 \times . Etchant: lactic acid, HNO_3 , HCl .

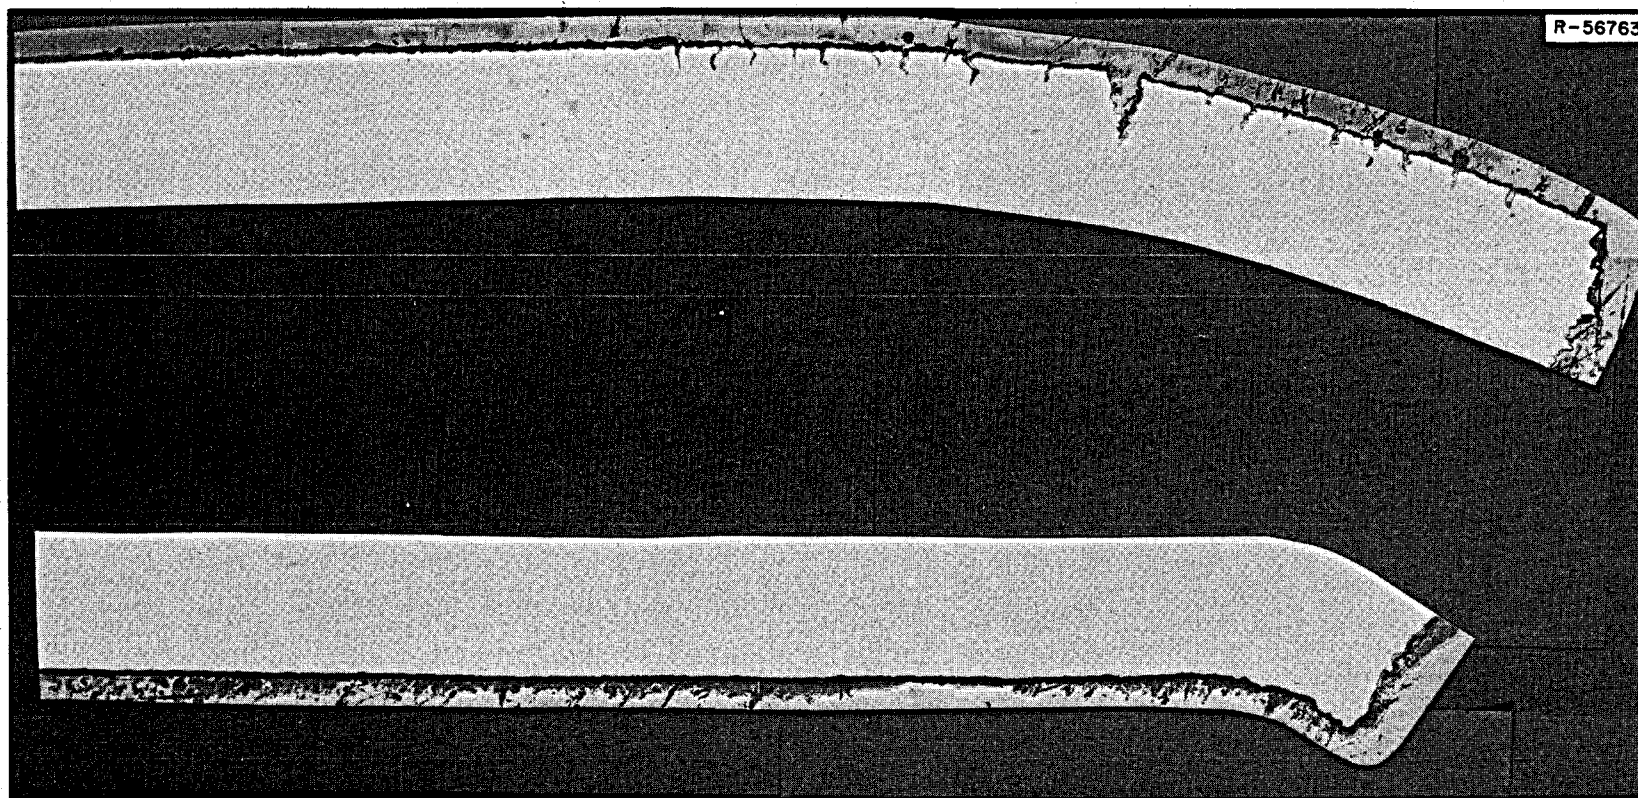
Fig. 98. Composite of Several Photomicrographs of a Bend Specimen from the Outside Liquid Region of the Mist Shield. Top portion shows the tension side and the lower portion shows the compression side. 24x.

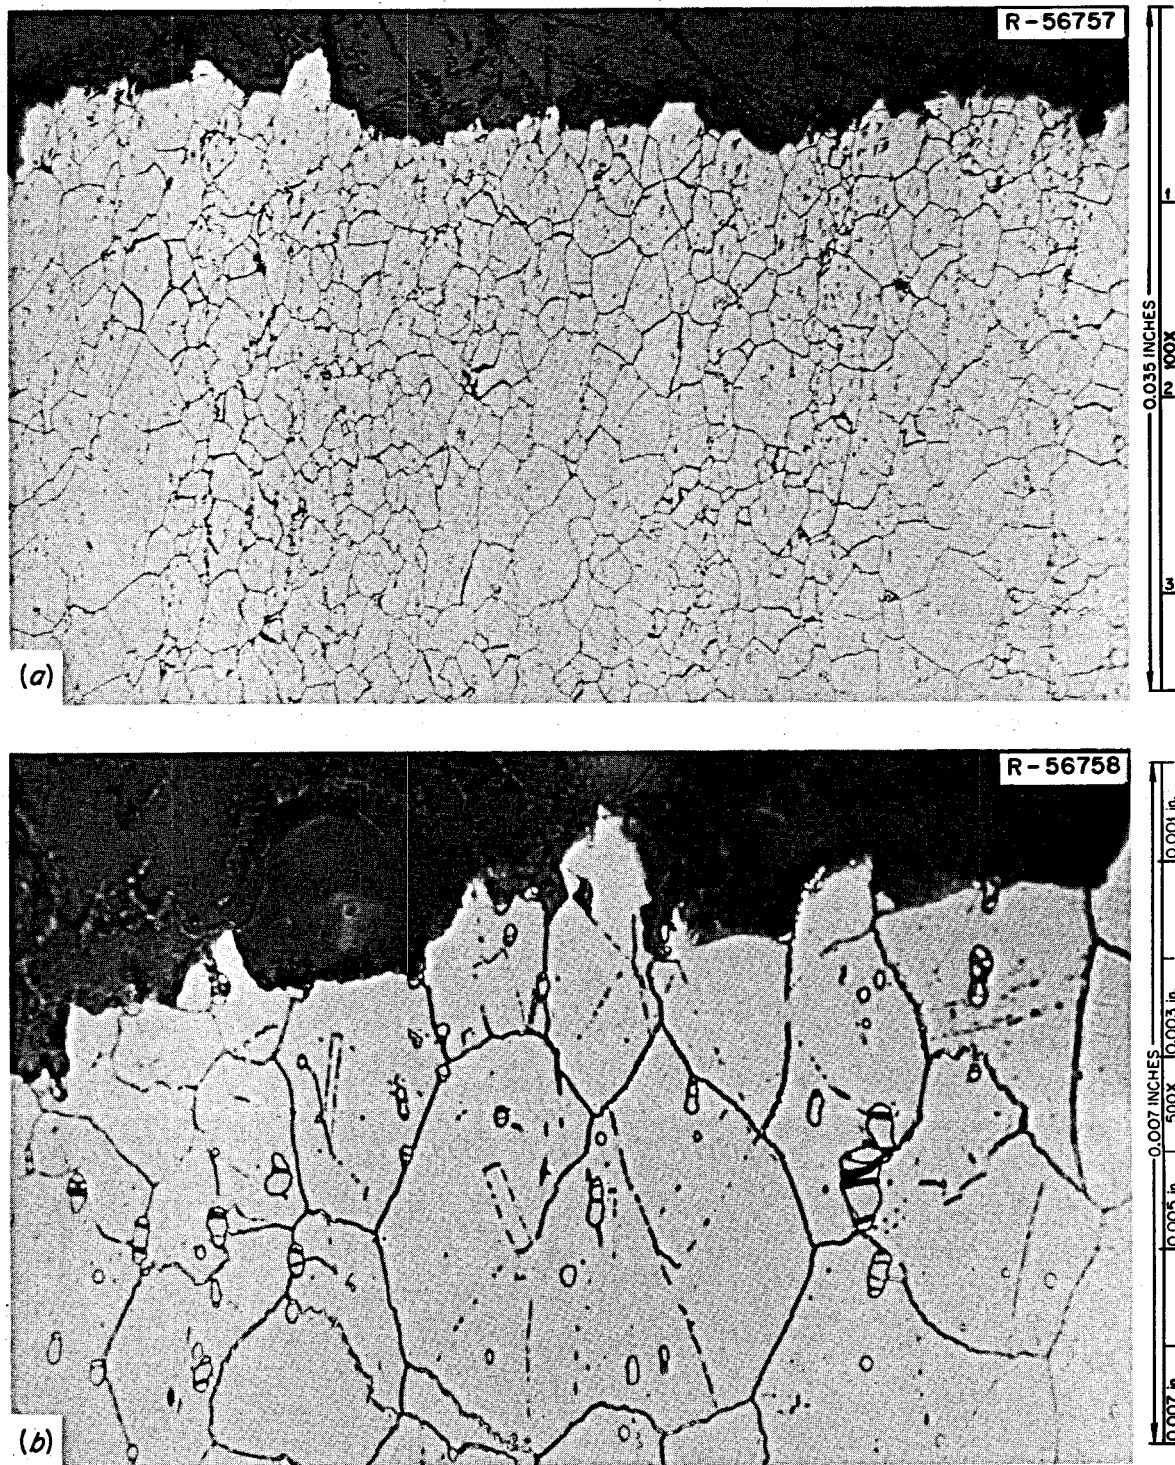
Fig. 99. Photomicrographs of the Fracture of a Bend Specimen from the Outside Vapor Portion of the Mist Shield. (a) 100x. (b) 500x. Etchant: Lactic acid, HNO_3 , HCl .

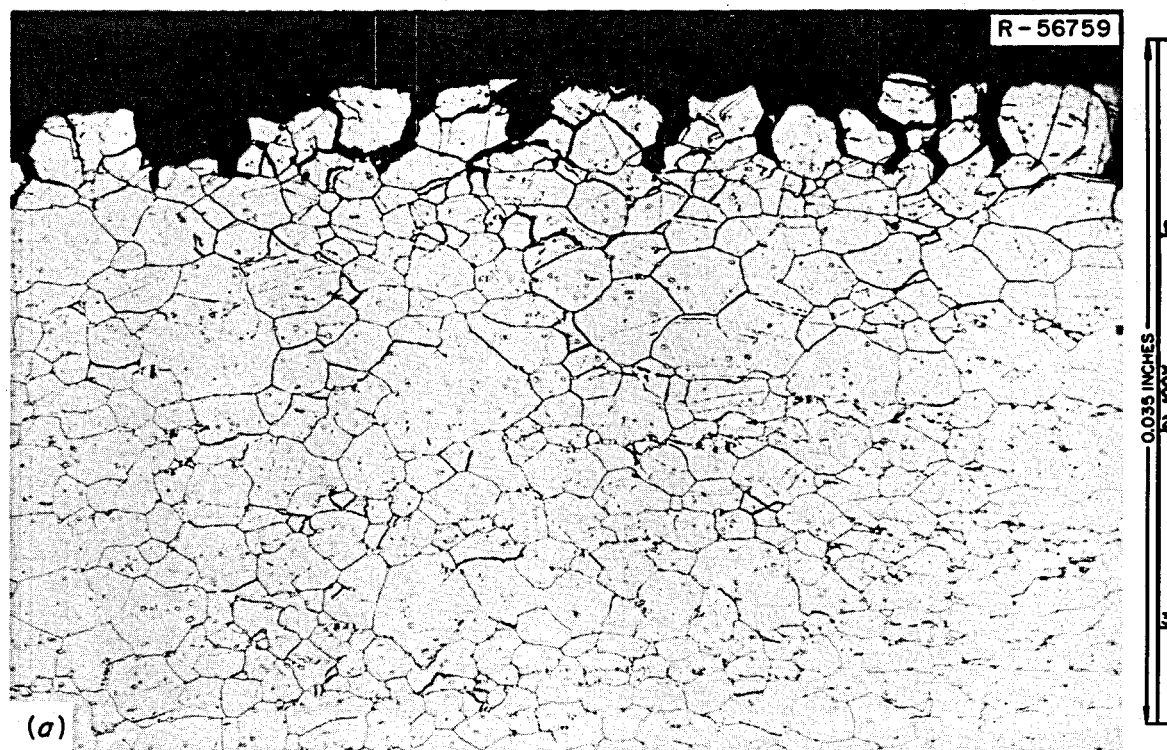
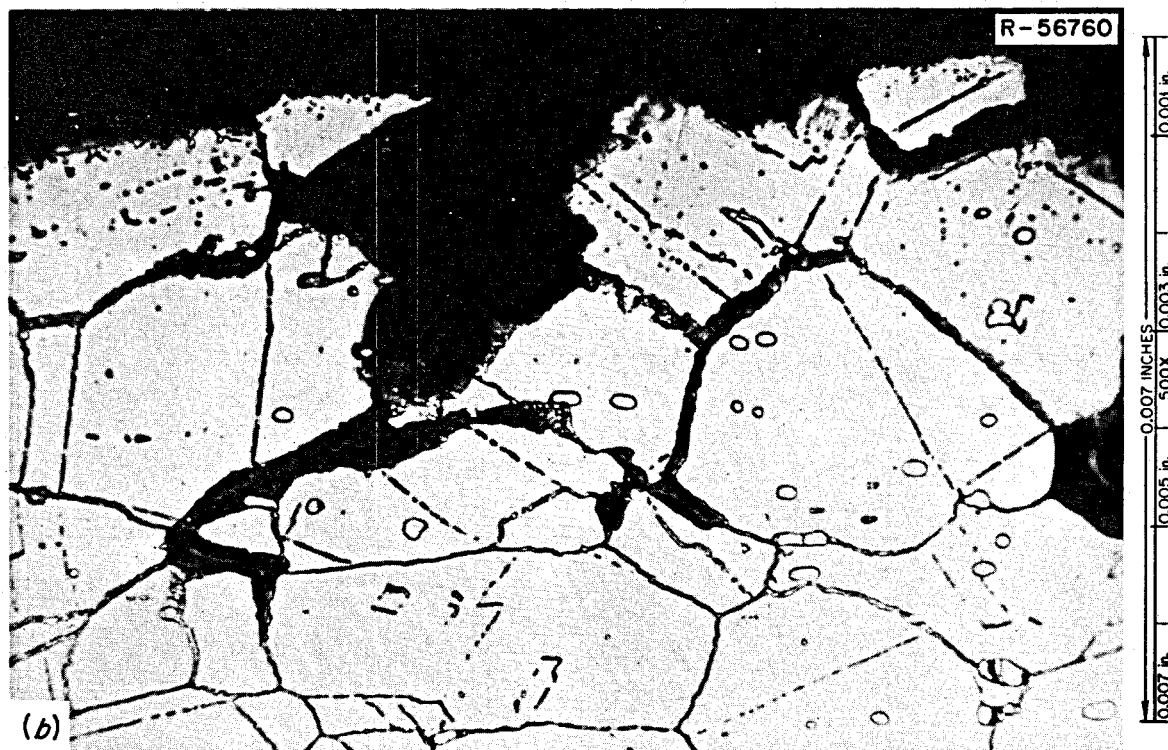
Fig. 100. Photomicrographs of the Edge Near the Fracture of a Bend Specimen from the Outside Vapor Portion of the Mist Shield. (a) 100x. (b) 500x. Etchant: Lactic acid, HNO_3 , HCl .
