INTERGRANULAR CRACKING OF INOR-8 IN THE MSRE

H. E. McCoy
B. McNabb

ORNL-4829
UC-25 — Metals, Ceramics, and Materials

NOVEMBER 1972

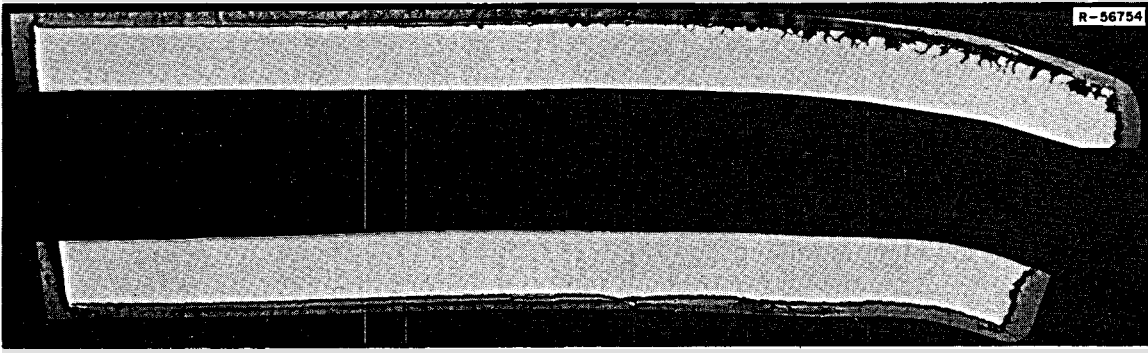
Fig. 101. Composite of Several Photomicrographs of a Bend Specimen From the Outside Vapor Region of the Mist Shield. Top portion is the tension side and the lower part is the compression side. 15x.

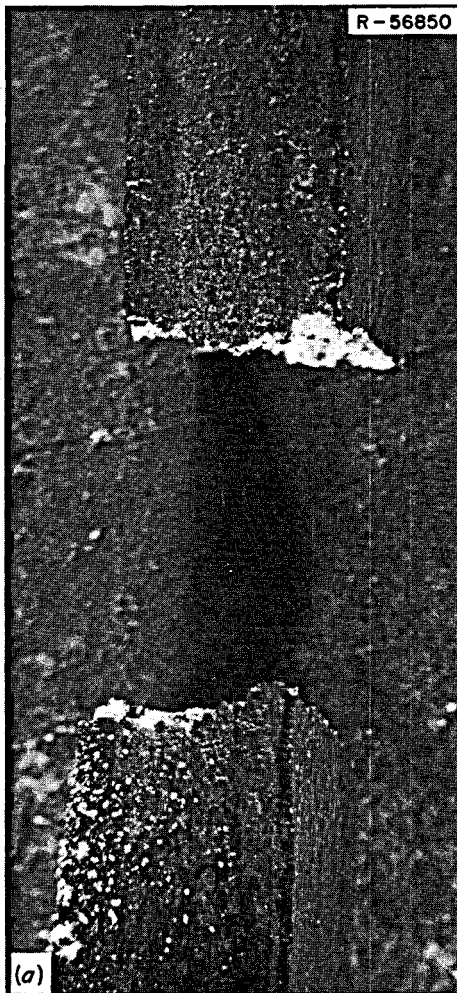
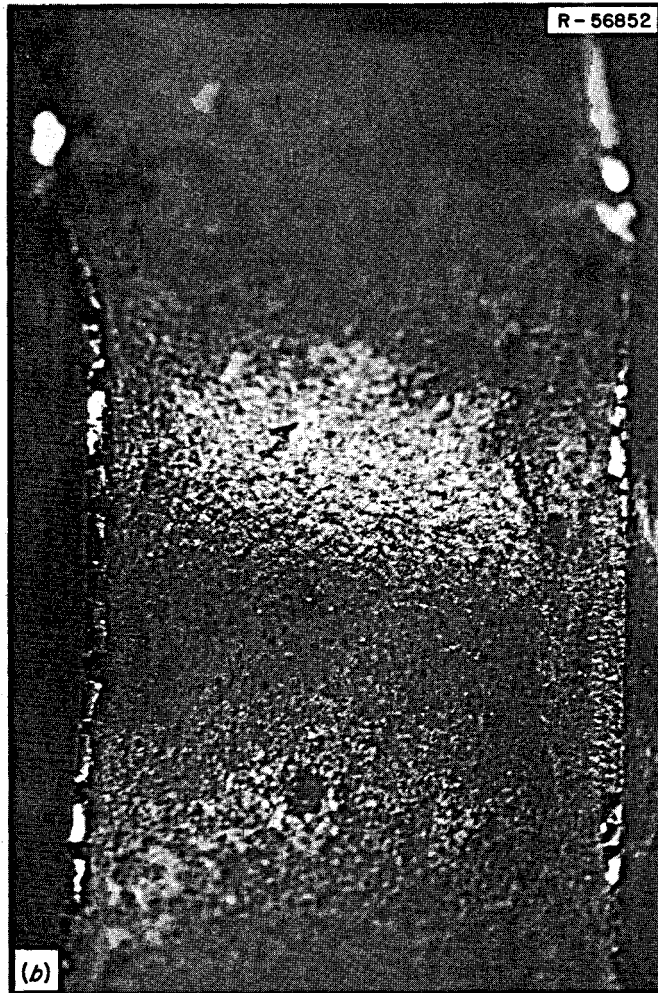
Rings 3/16 in. wide were cut, away from the flattened portion of the pipe. They were subjected to the ring test described previously. A bend specimen and a specimen for chemical analysis were cut from adjacent regions. The results of the mechanical property tests are given in Table 11. As shown in Fig. 102 both the bend specimen and the ring specimens showed some surface cracking when viewed at low magnification.

Fig. 102. The Surfaces Exposed to Salt in Freeze Valve 105 After Deformation at 25°C. (a) Fracture of ring specimen pulled in tension. Note surface cracks near the fracture. 4x (b) Surface of bend specimen. Note some cracks on surface and edge cracks. 7x. Reduced 18.5%.

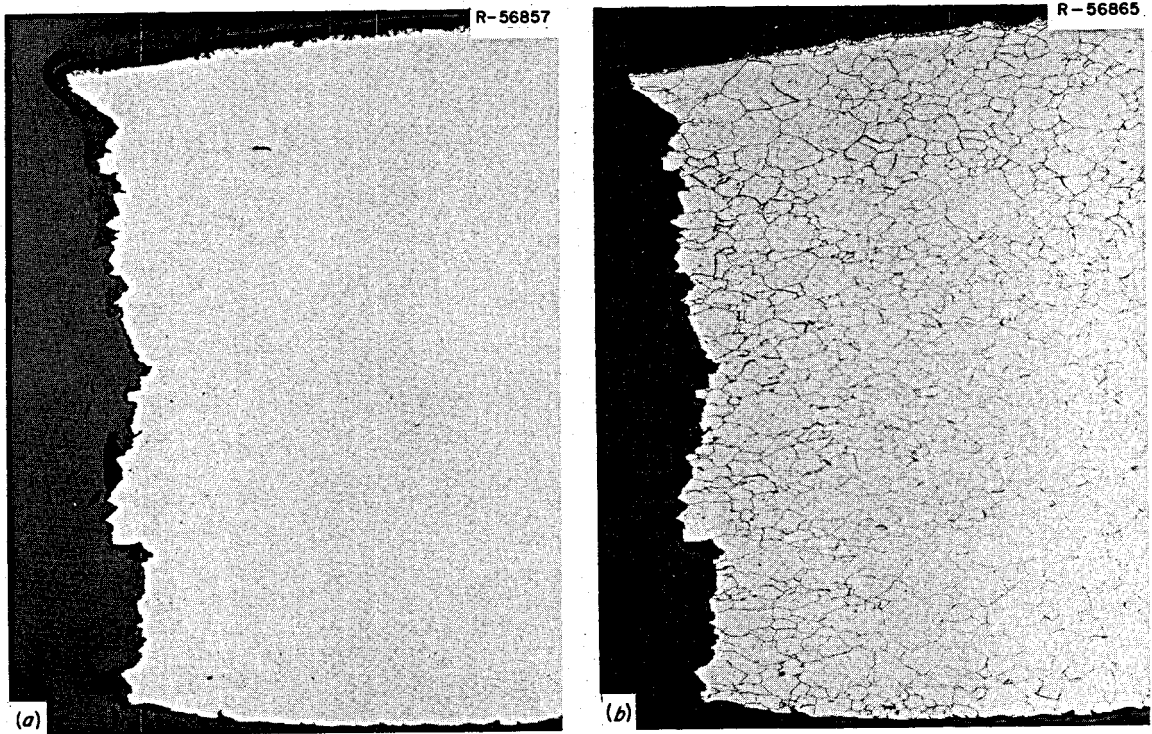
A metallographic section of one of the ring specimens is shown in Figs. 103 and 104. The fracture and both edges are visible in Fig. 103. The oxide is on the outside surface that was exposed to air (top) and shallow cracks formed on the salt side. Typical edges near the fracture are shown in Fig. 104. The cracks on the air side followed the oxide and did not penetrate further. The cracks on the salt side were intergranular and penetrated about 1 mil.

Fig. 103. Photomicrographs of the Fracture of a Ring Specimen from Freeze Valve 105 that was Deformed at 25°C. (a) As polished. (b) Etchant: Lactic acid, HNO_3 , HCl . 40 \times . Reduced 29.5%.

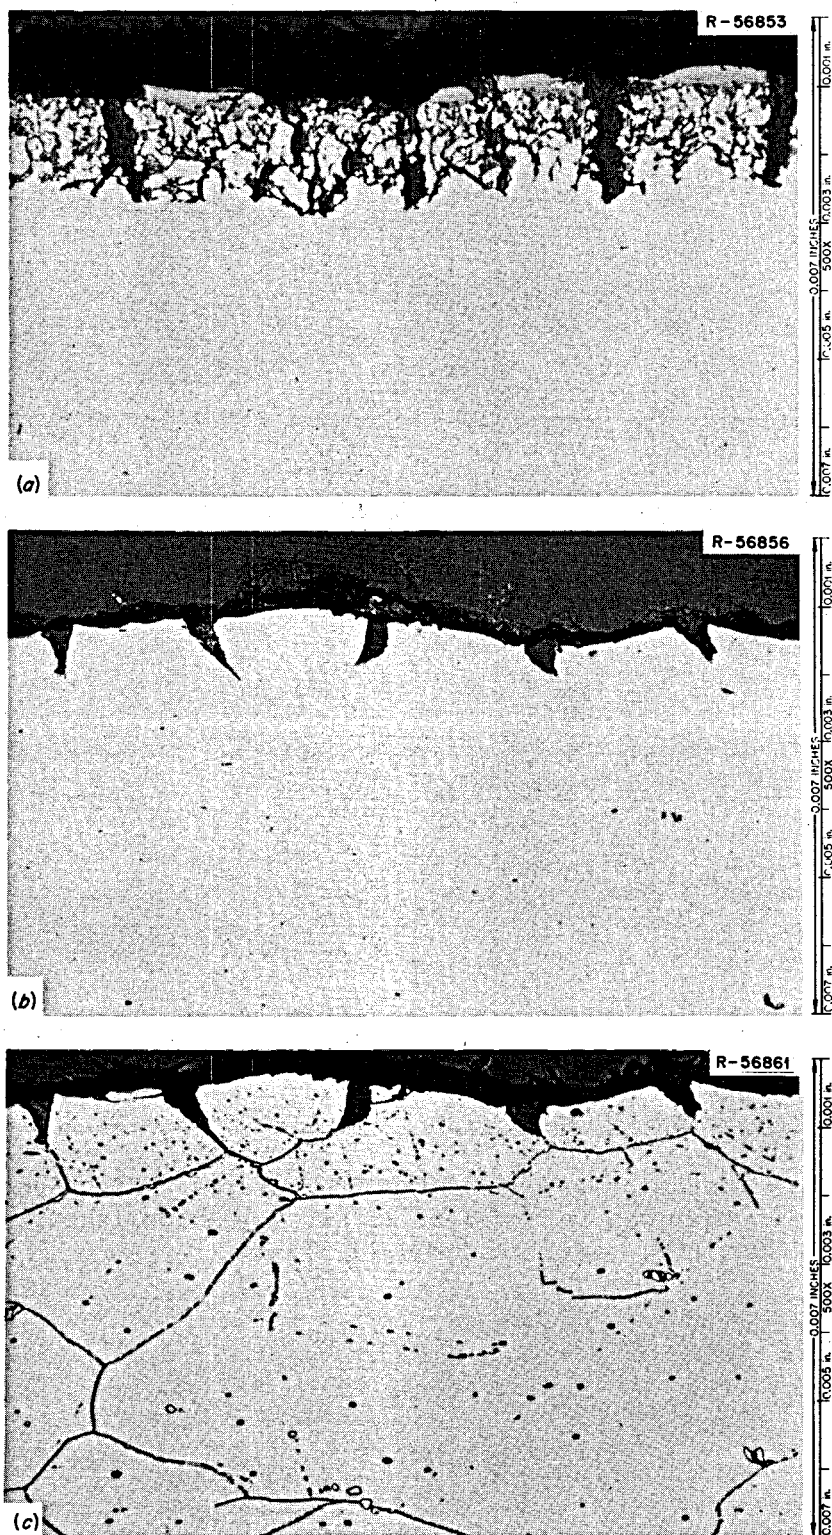
Fig. 104. Photomicrographs Near the Fracture of a Ring Sample from Freeze Valve 105 Deformed at 25°C. (a) Edge exposed to air, as polished. (b) Edge exposed to salt, as polished. (c) Edge exposed to salt, etched with lactic acid, HNO_3 , HCl . Reduced 30%.

product concentration was the one from FV 105. The fission product concentrations were generally less than on the other samples by an order of magnitude (Table 14) and the cracks were very shallow (Fig. 104).

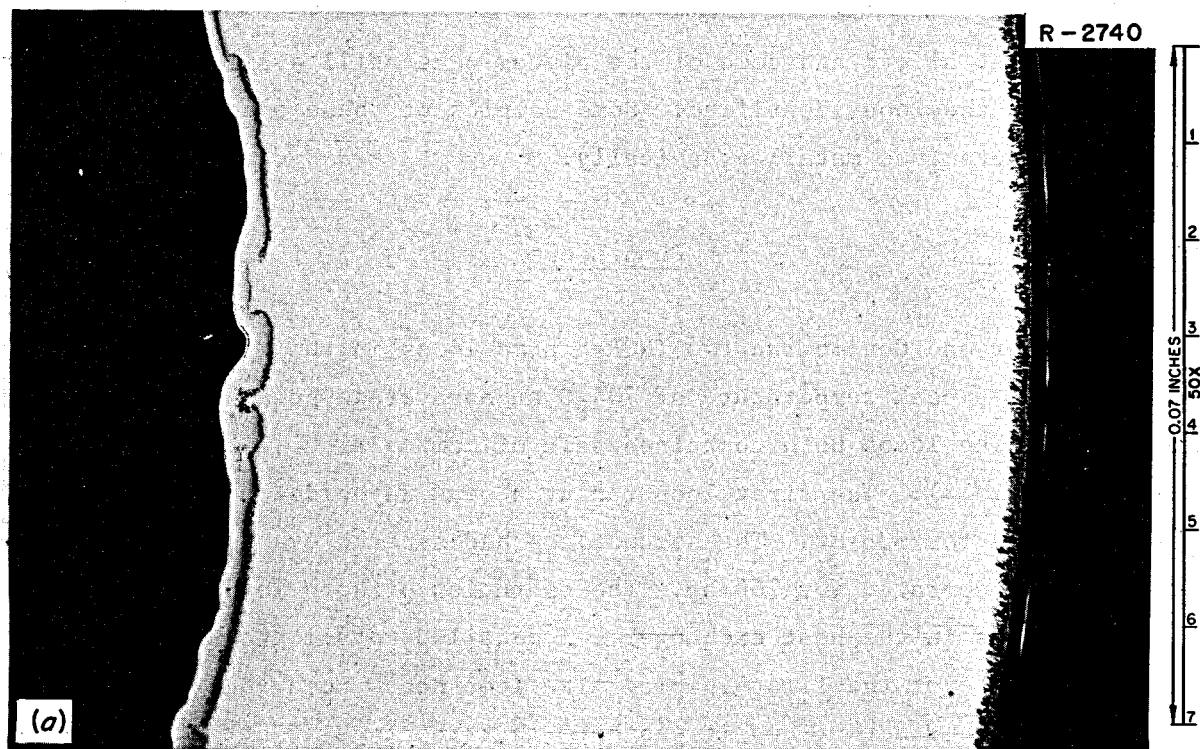
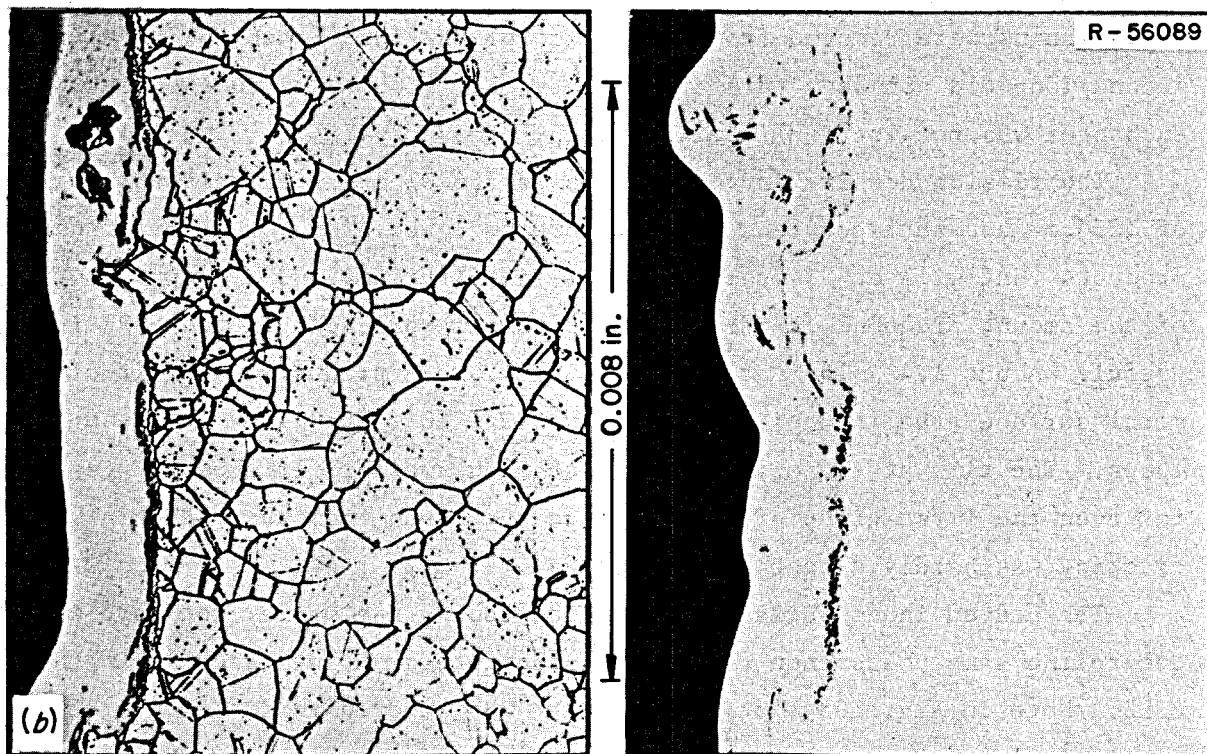
The uneven inner surface of the loop tubing may or may not have been due to the same phenomenon that caused the intergranular cracking in the MSRE. Note in Fig. 105 that the material was removed in increments of single grains. However, there is no evidence of partially cracked grains that had not been completely removed. The explanation of cavitation is also not very acceptable since the peak velocity was only about 1 ft/sec.

Fig. 105. Inside Tube Wall of INOR-8 from In-pile Loop MTR 44-1. The coating is nickel plating used for edge preservation.

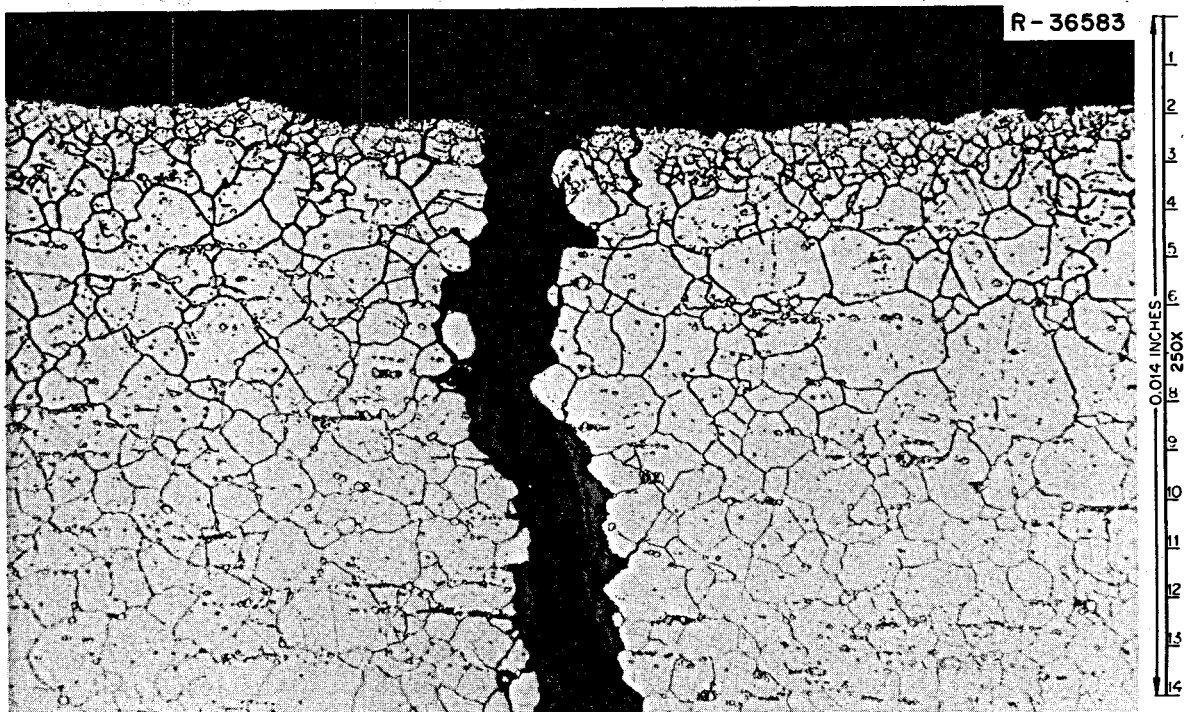
A more recent in-reactor thermal convection loop was run by Compere et al.²⁶ A schematic of the loop is shown in Fig. 106, and the pertinent operating statistics are given in Table 12. The loop was constructed of INOR-8, contained salt of composition ${}^7\text{LiF}-\text{BeF}_2-\text{ZrF}_4-\text{UF}_4$ (65.3-28.2-4.8-1.7 mole %), and had a graphite region where power densities of 150 W/cm^3 of salt were attained. The loop had maximum and minimum operating temperatures of 720 and 545°C , respectively. The loop failed at the hottest portion after 1366 hr of nuclear operation. The failure (Fig. 107) is quite typical of high-temperature failures noted previously in this material after irradiation.⁴⁻⁷ Note that the inside surface is free of cracks except very near the point of failure.

Fig. 107. Photomicrograph of a Cross Section Showing the Inner Surface and Crack in Core Outlet Pipe of In-Reactor Loop 2. Located on top side of tubing. Etchant: Aqua regia.

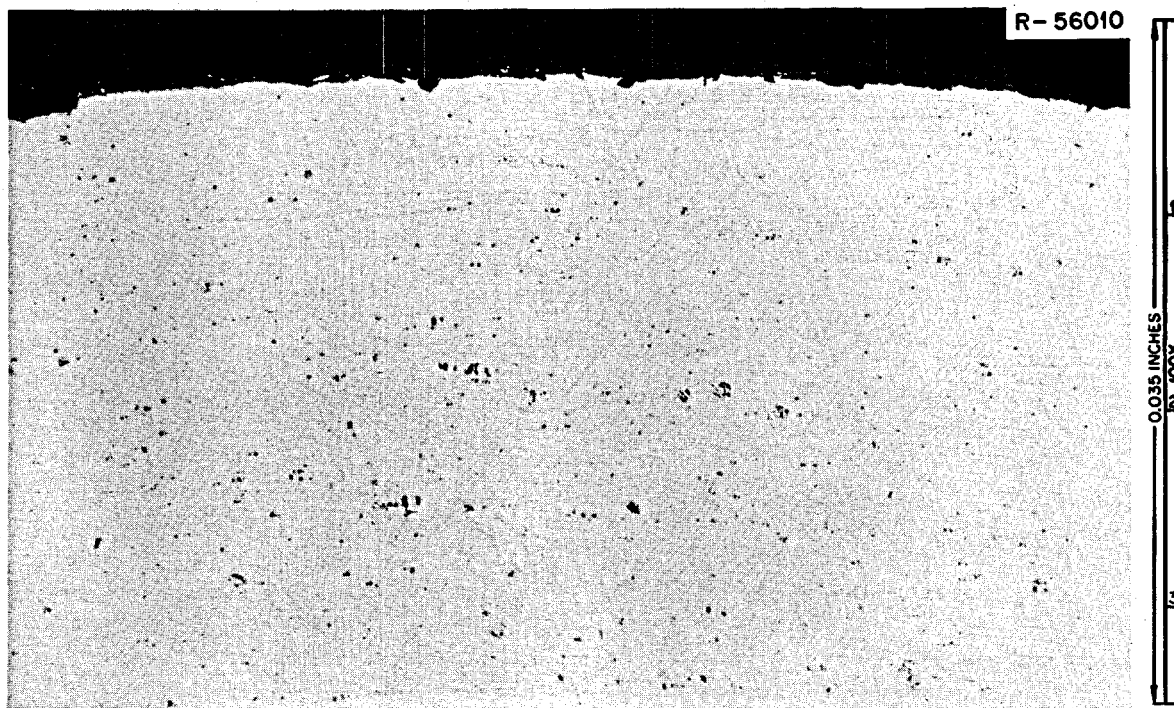
Two pieces of the loop were retrieved and tested. One sample was from the flat sheet used to fabricate the top of the "core section" where the graphite was located. A small sheet was cut, bent so that the surface exposed to the fuel salt was in tension, and examined metallographically. A typical photomicrograph is shown in Fig. 108. Surface cracks were very infrequent and extended to a maximum depth of 0.5 mil.

Fig. 108. Bend Specimen from Section of In-Reactor Loop Which Operated at 720°C. The tension side was exposed to the fuel salt.

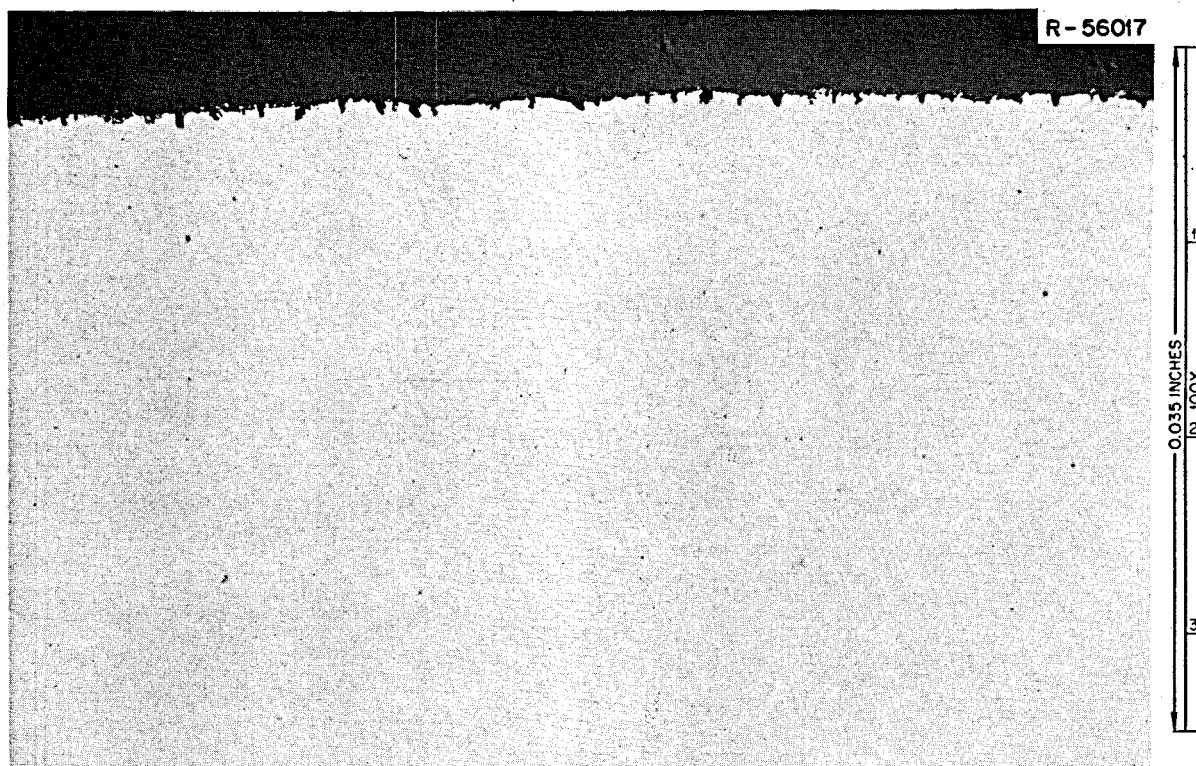
A piece of tubing was available from the coldest section, and it was deformed by crushing in a tensile machine. A typical view of the inside surface is shown in Fig. 109. Cracks occurred along almost every grain boundary, but they only extended to a maximum depth of 1 mil.

Fig. 109. Tension Side of Crushed Tubing from Coldest Part of In-Reactor Loop, Which Operated at 545°C.

The loops run by Trauger and Conlin had some regions from which grains were removed, but no intergranular cracks were visible. Strained samples of Compere's loop had shallow intergranular cracks similar to those noted in samples from the MSRE, particularly the sample exposed at 545°C (Fig. 109).

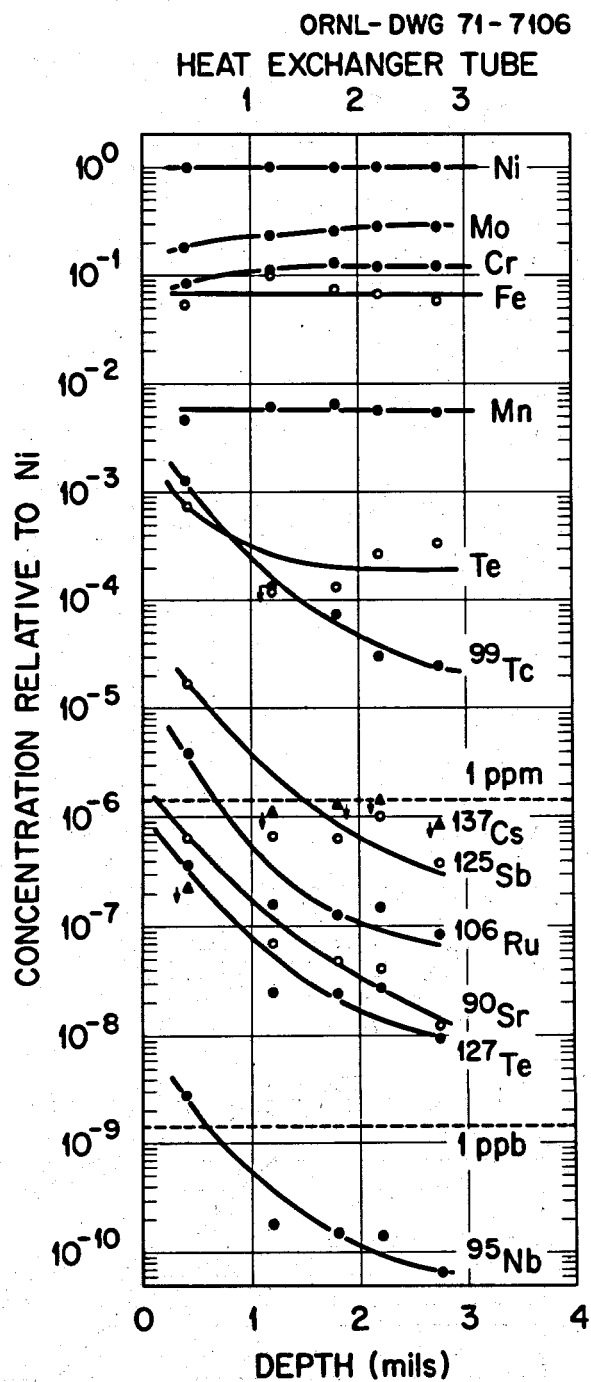
Fig. 110. Concentration Profiles from the Fuel Side of a MSRE Heat Exchanger Tube. Arrows indicate that analytical values were reported as being less than the indicated point.

1. Several of the fission products penetrated the metal to depths of a few mils (Figs. 110 and 111).

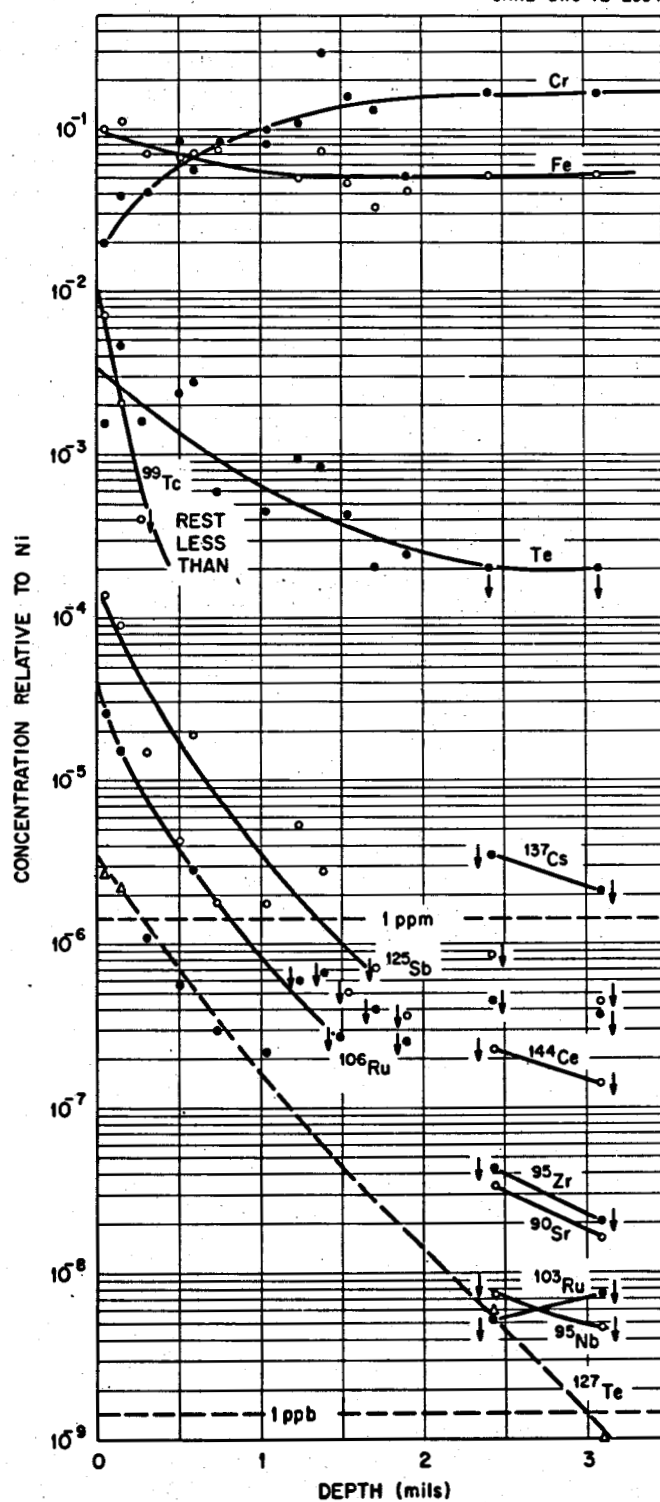
Fig. 111. Concentration Profiles from a Surveillance Sample Exposed in the MSRE for 19,136 hr. Arrows indicate that analytical values were reported as being less than the indicated point.

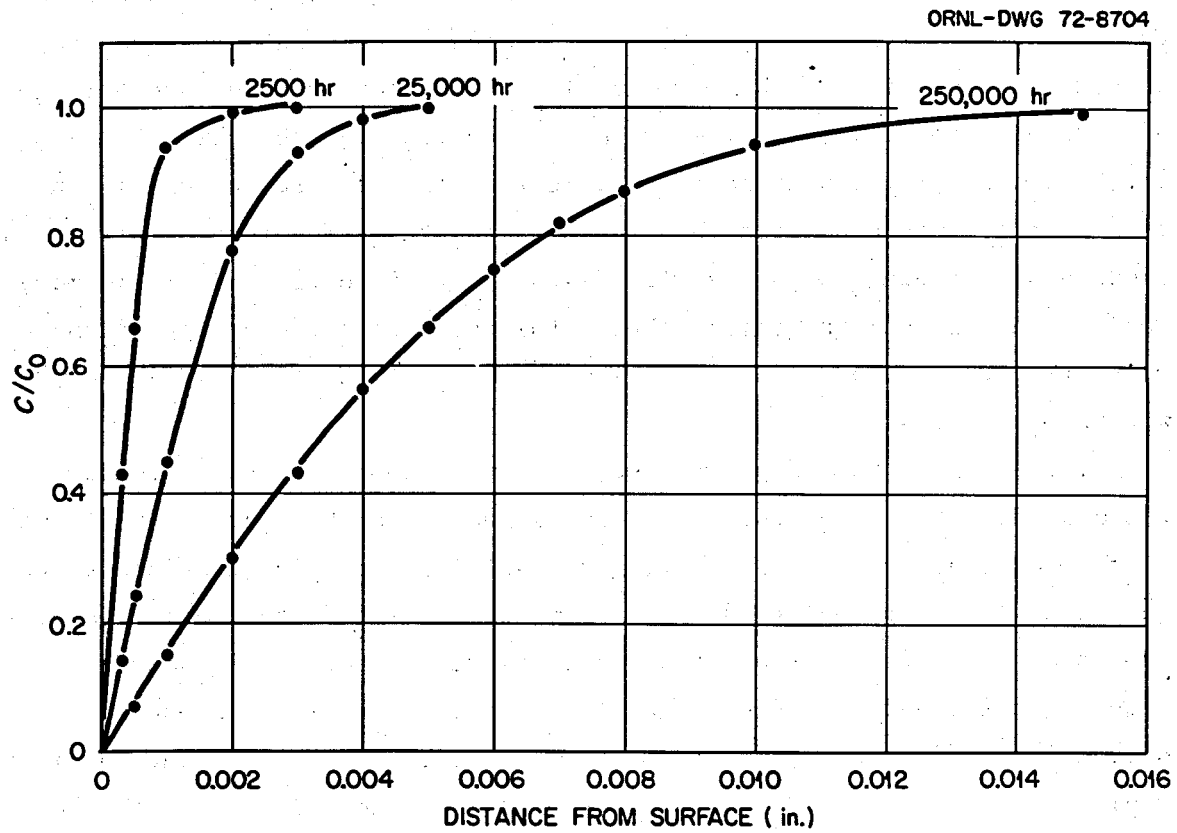
chromium could have been removed. The most extreme case would occur when the chromium concentration at the surface was maintained at zero so that the driving force for chromium diffusion toward the surface would be a maximum. The calculated chromium concentration profiles based on the assumption of zero surface concentration and the measured diffusion coefficient of 1.5×10^{-14} cm²/sec are shown in Fig. 112 for various times. The measured chromium profile for the thimble (Fig. 66) showed depletion to a depth of only 0.8 mil (0.0008 in.) which is somewhat less than the calculated depletion depth shown in Fig. 112. However, the assumption of zero concentration of chromium used in calculating the curves in Fig. 112 is too severe, and it is reasonable that the measured chromium depletion profiles would be less than those calculated. The rate of diffusion along grain boundaries, as we will discuss more in detail later, is more rapid than through the grains. Thus, the depth of chromium depletion along the grain boundaries could be much greater than the 0.8 mil measured within the grains.

Fig. 112. Calculated Chromium Profiles at 650°C in INOR-8 Assuming Zero Surface Concentration of Chromium.

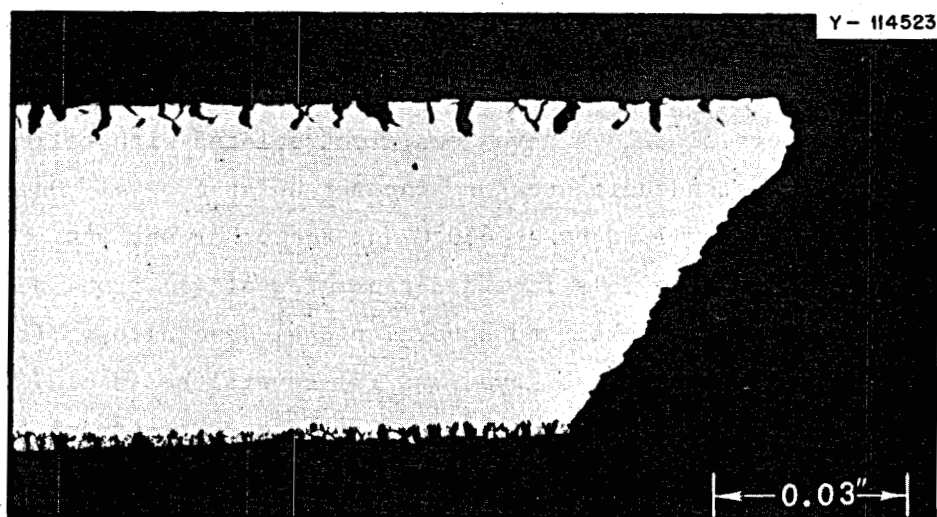
MSRE Thimble - 31,000 hr in Fuel Salt at 650°C
 1.4×10^{17} atoms/cm² of Te

2. The cracks produced in INOR-8 by exposure to tellurium look quite similar to those formed in the material from the MSRE (Fig. 113).

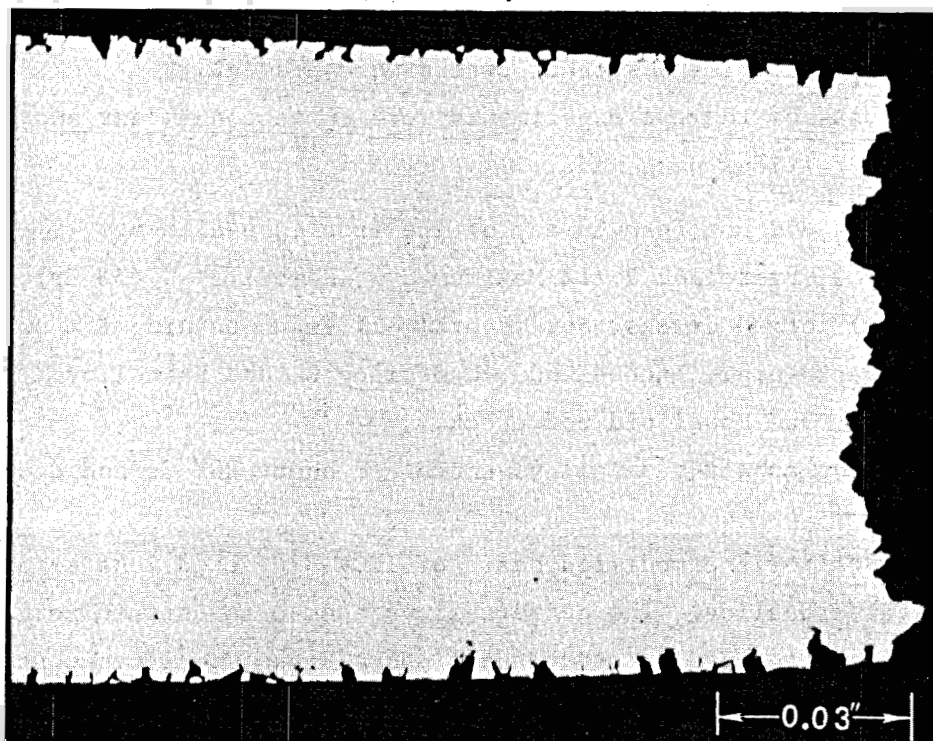
Vapor Plated with 5.4×10^{18} atoms/cm² of Te
 Annealed 1000 hr at 650°C

Fig. 113. Samples of INOR-8 Strained to Failure at 25°C. The upper photograph was made of a piece of the MSRE thimble. The upper side was exposed to fuel salt and cracked when strained. The lower side was exposed to the cell environment and the oxide that formed cracked during straining.

The lower specimen was exposed to tellurium vapor on both sides and deformed. The cracks are similar to those formed on the surface of the upper sample that had been exposed to fuel salt.
