ORNL-2833
UC-25 - Metals, Ceramics, and Materials

CORROSION ASSOCIATED WITH
HYDROFLUORINATION IN THE
OAK RIDGE NATIONAL LABORATORY
FLUORIDE VOLATILITY PROCESS

METALLURGY DIVISION

A. E. Goldman and A. P. Litman

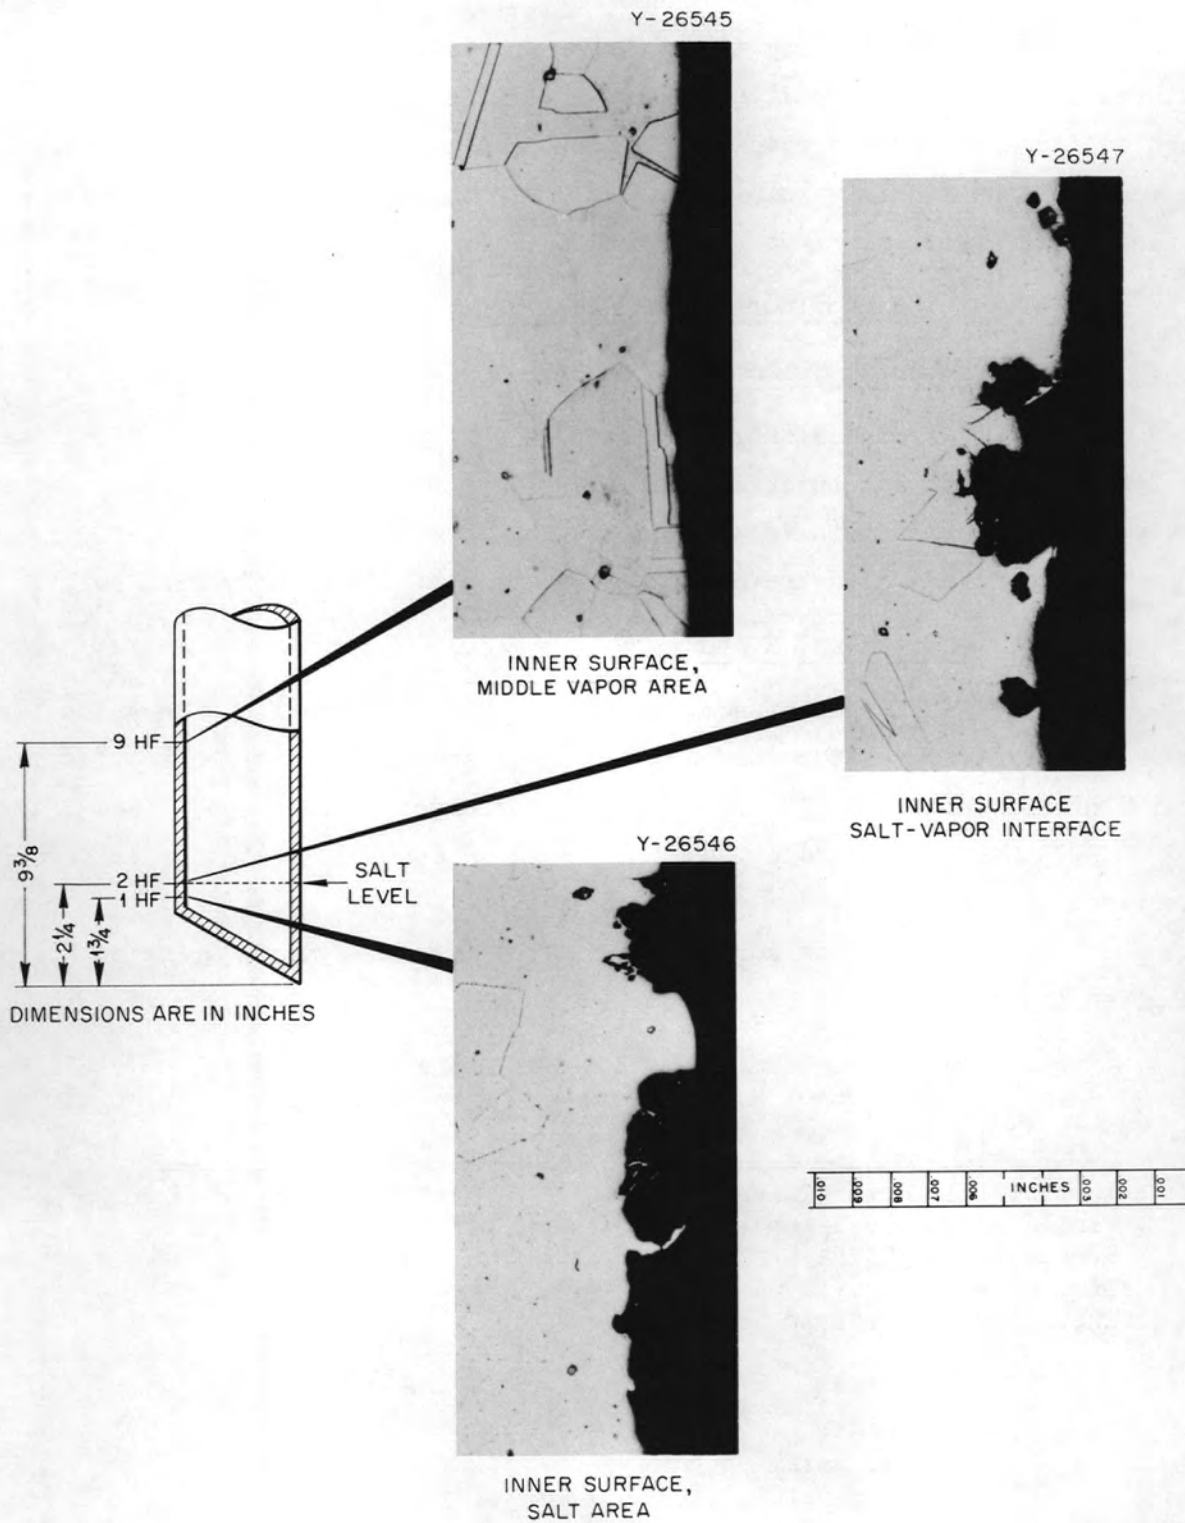
UNCLASSIFIED
ORNL-LR-DWG 32070R2

greater than 30 mils/month. In addition, a portion of the middle vapor region also had losses of the same magnitude. Of particular interest are the metallographic sections removed from these three major loss regions which are pictured in Fig. 3. The salt and salt-vapor interface samples had extremely rough surfaces and showed evidence of pitting attack. However, the sample removed from the middle vapor region had a smooth surface and no indication of preferential corrosion was noted.

Fig. 3. Chemical Development Section A Inconel Hydrofluorinator.
Etchant: glyceria regia. Reduced 24%. 250X.

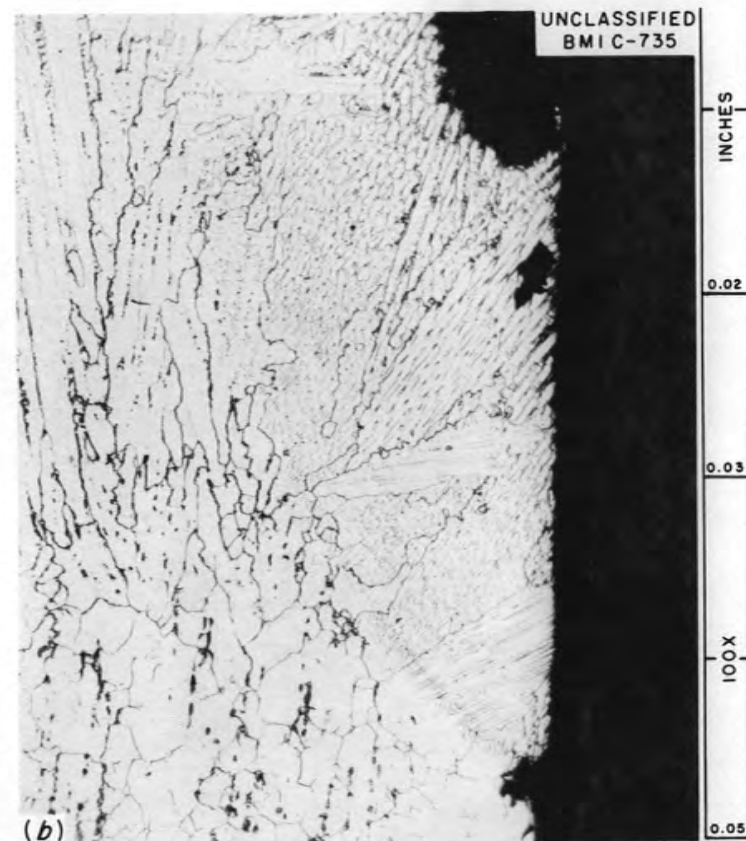
(b)

CROSS SECTION OF WALL FROM LOWER PORTION OF SALT
REGION IN PROXIMITY TO DRAFT TUBE

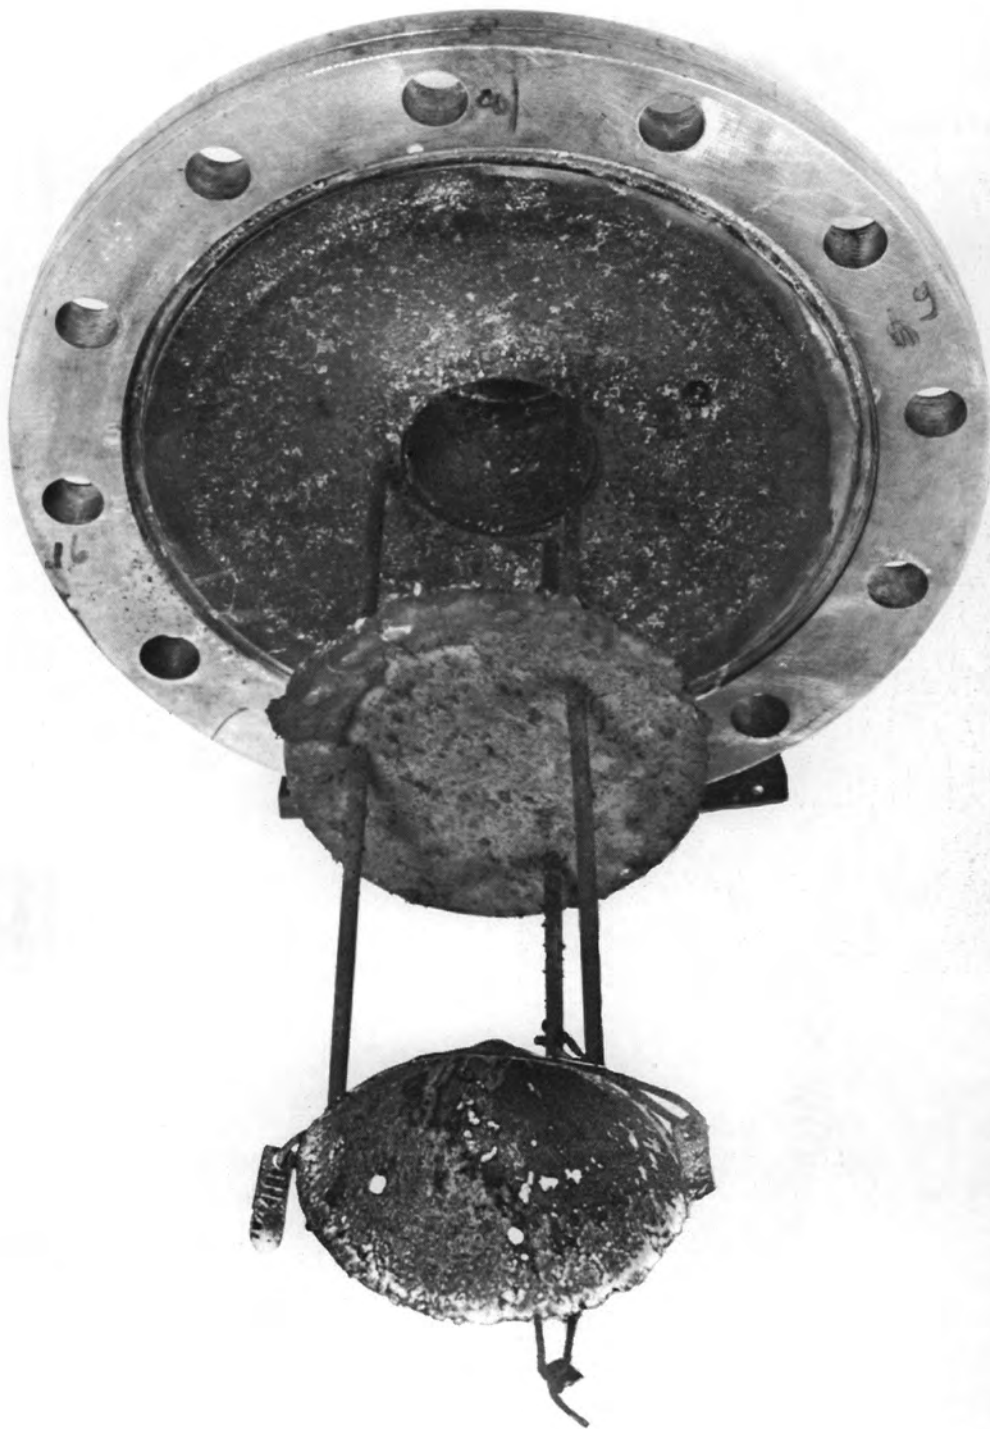
Unclassified
ORNL Photo 46668

A few INOR-8 and molybdenum coupons were exposed to the environments of runs Nos. 9 and 10 in the semiworks-scale dissolver. The coupons were suspended from the conical baffle, as shown in Fig. 23, at the vapor-salt interface. Removal of the coupons after run No. 9 revealed no noticeable attack, based on weight change or visual observation. The coupons were reinserted for run No. 10 which proceeded without the presence of zirconium metal in the system. After run No. 10, it was found that the molybdenum coupon had lost about 10% of its weight and the INOR-8 coupons had lost 22 and 29 wt %, respectively. Both materials also suffered a severe pitting attack. Figure 25 shows the visual appearance of the test specimens while Fig. 26 illustrates typical microstructures of the coupons.

Fig. 23. Baffle Assembly used in Mark I INOR-8 Hydrofluorinator Dissolver. Corrosion specimens are suspended from conical baffle. Approximately one third actual size.

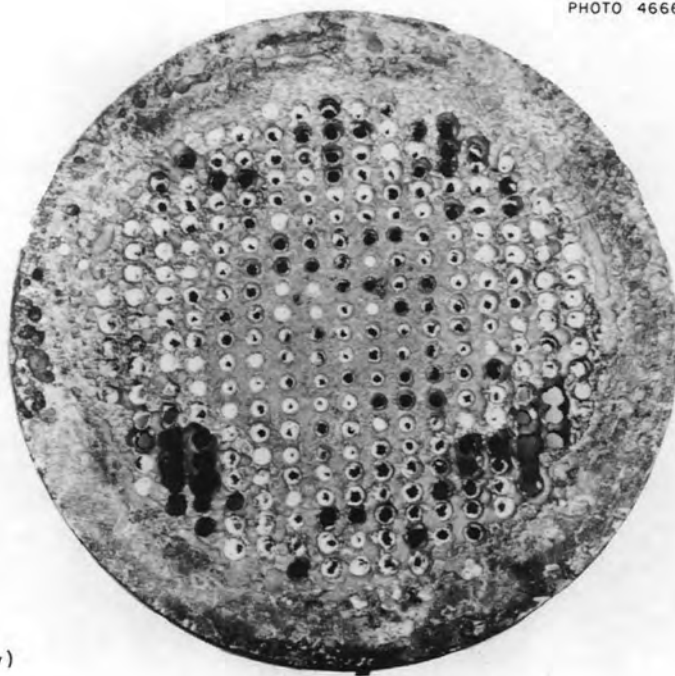
(a)

GAS INLET SIDE

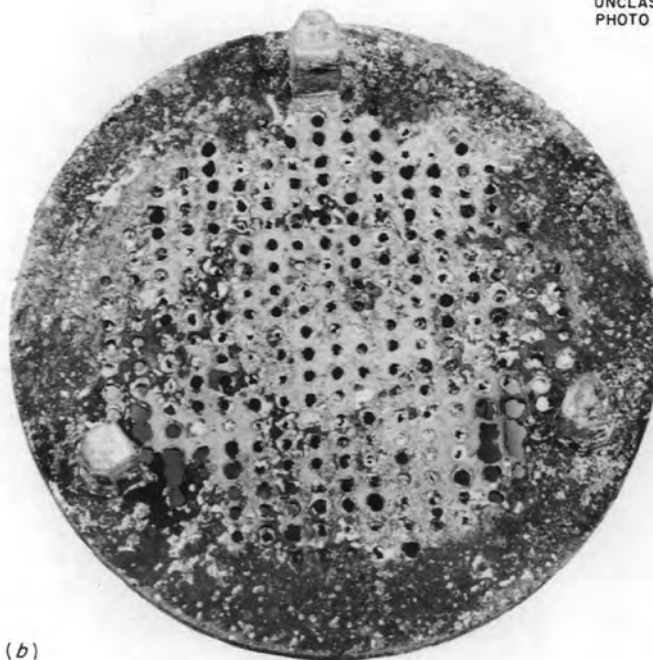
(b)

GAS OUTLET SIDE

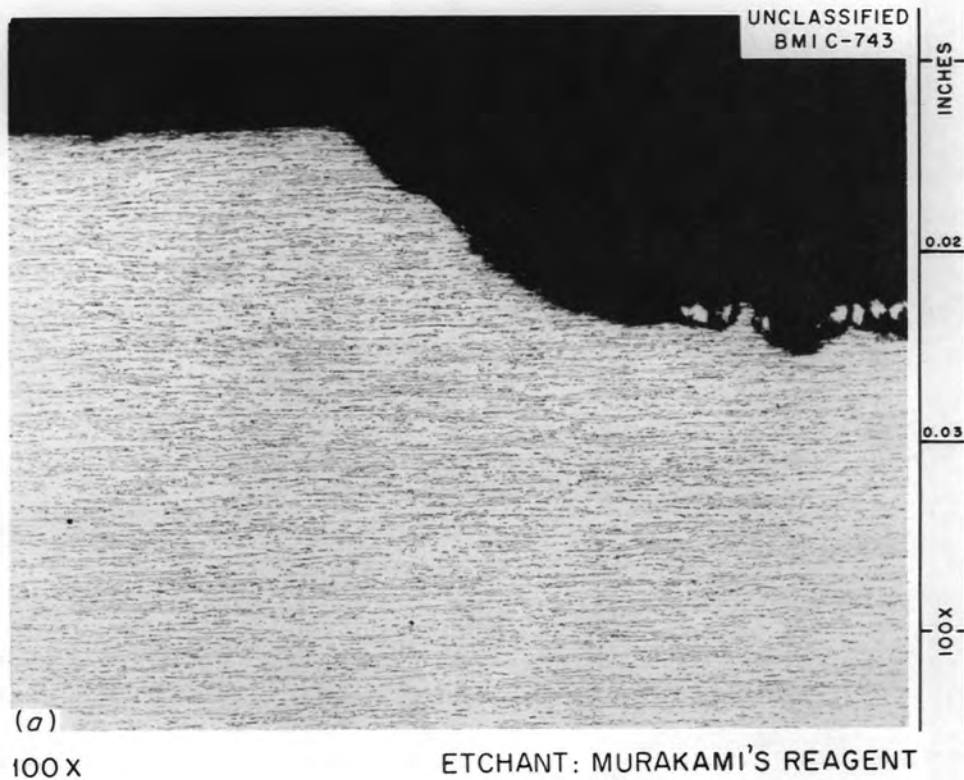
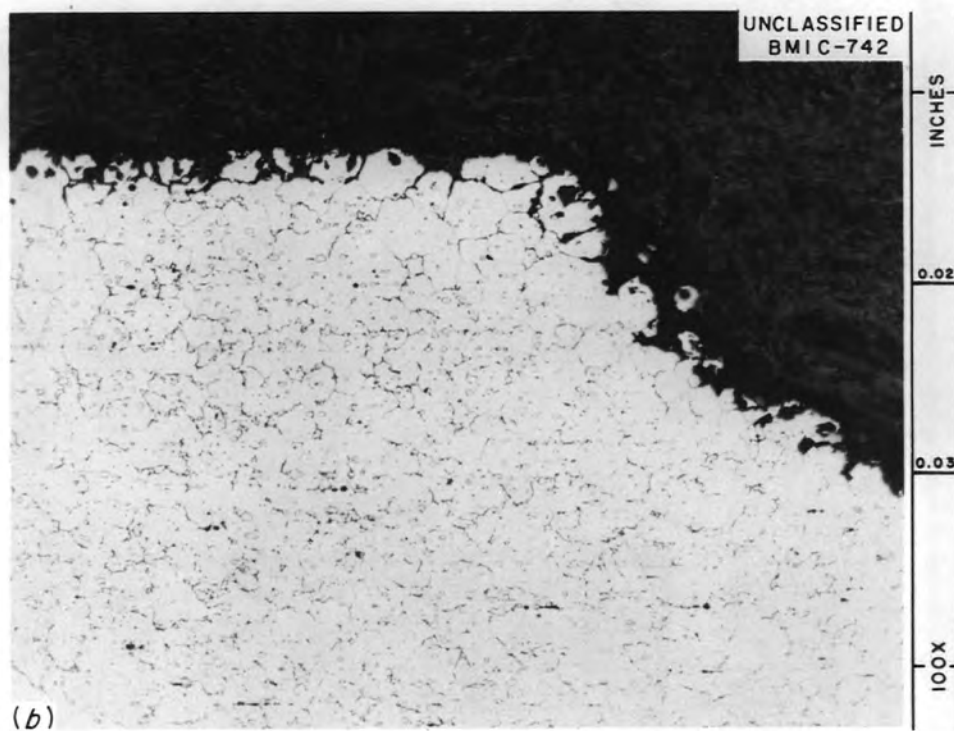
Fig. 26. Typical Microstructures of (a) Molybdenum, and (b) INOR-8 Corrosion Specimens Exposed in the Mark I INOR-8 Hydro-fluorinator Dissolver. 100X.

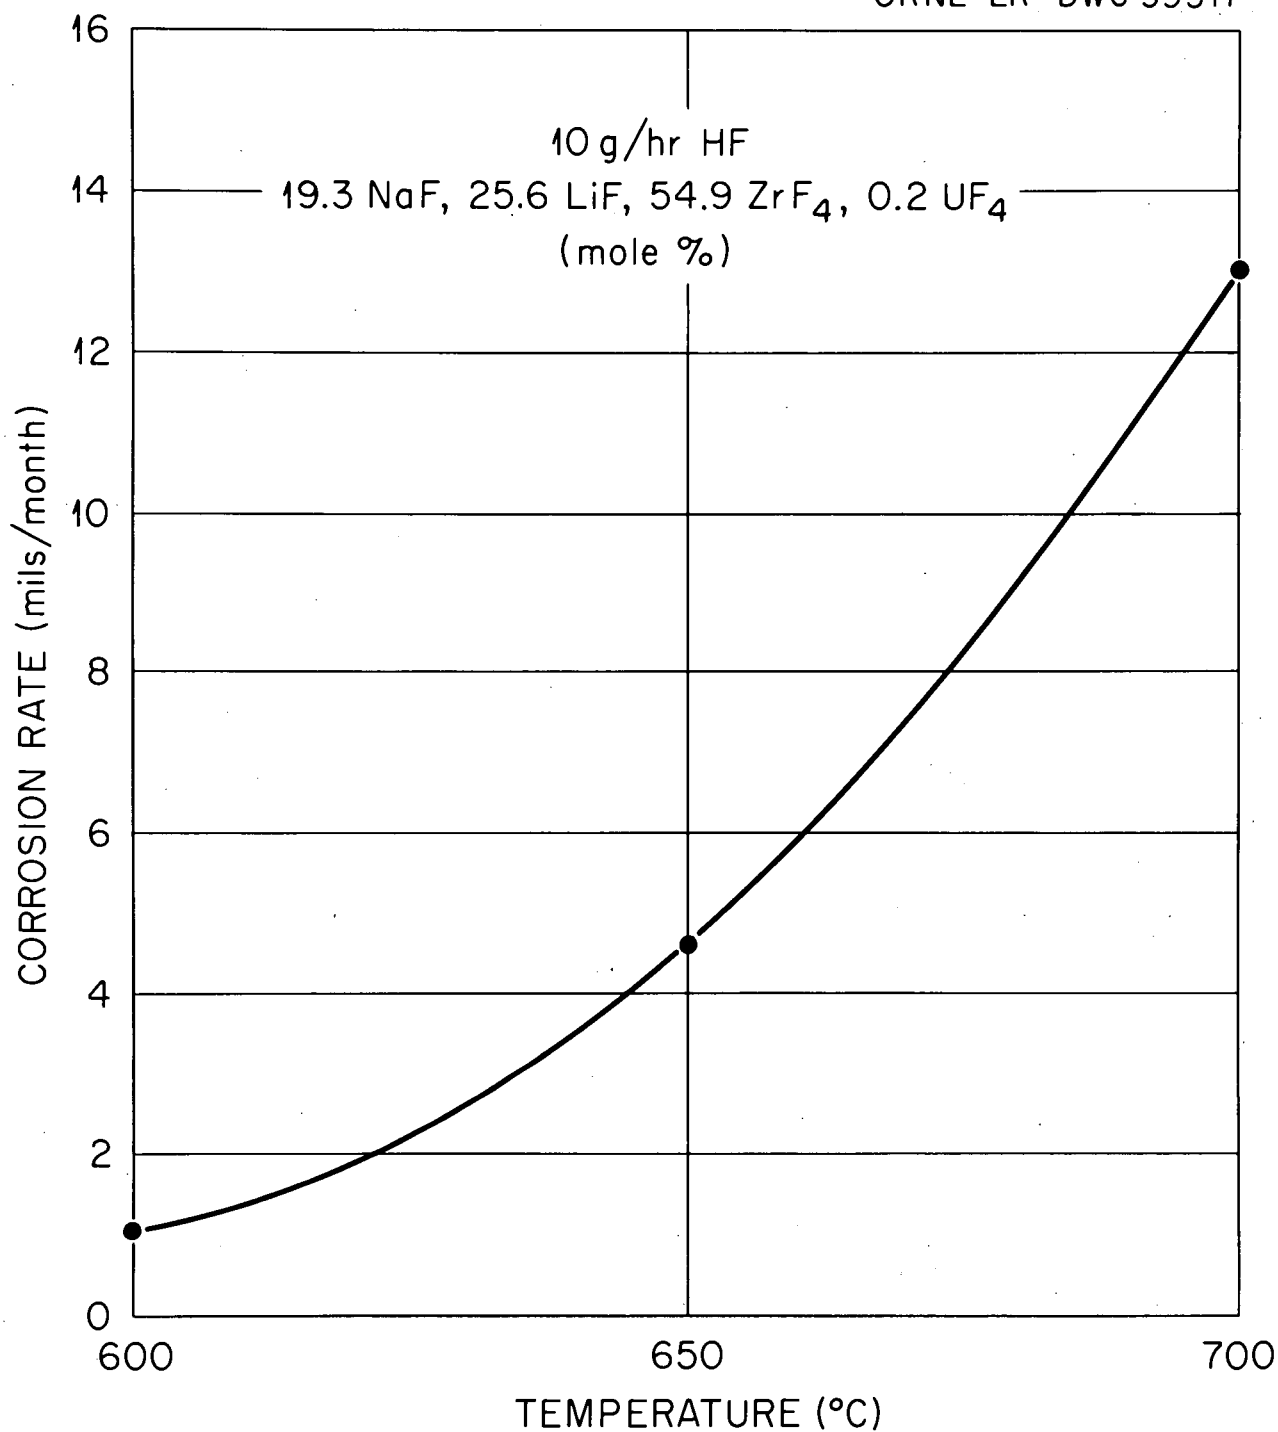
UNCLASSIFIED
ORNL-LR-DWG 39517

Fig. 32. Vapor-Salt Interface Corrosion Rates on INOR-8 at Three Temperatures. Ref. Paul D. Miller et al., Construction Materials for Hydrofluorinator of the Fluoride-Volatility Process, BMT-1348 (June 3, 1959).

between that portion of the specimen submerged and the portion at the interface line. This potential difference is easily influenced by the relative solubility of hydrogen fluoride in the salt and the partial pressure of hydrogen fluoride in the vapor. The increased corrosion rate found with increased hydrogen fluoride flow rates is cited to support this theory.

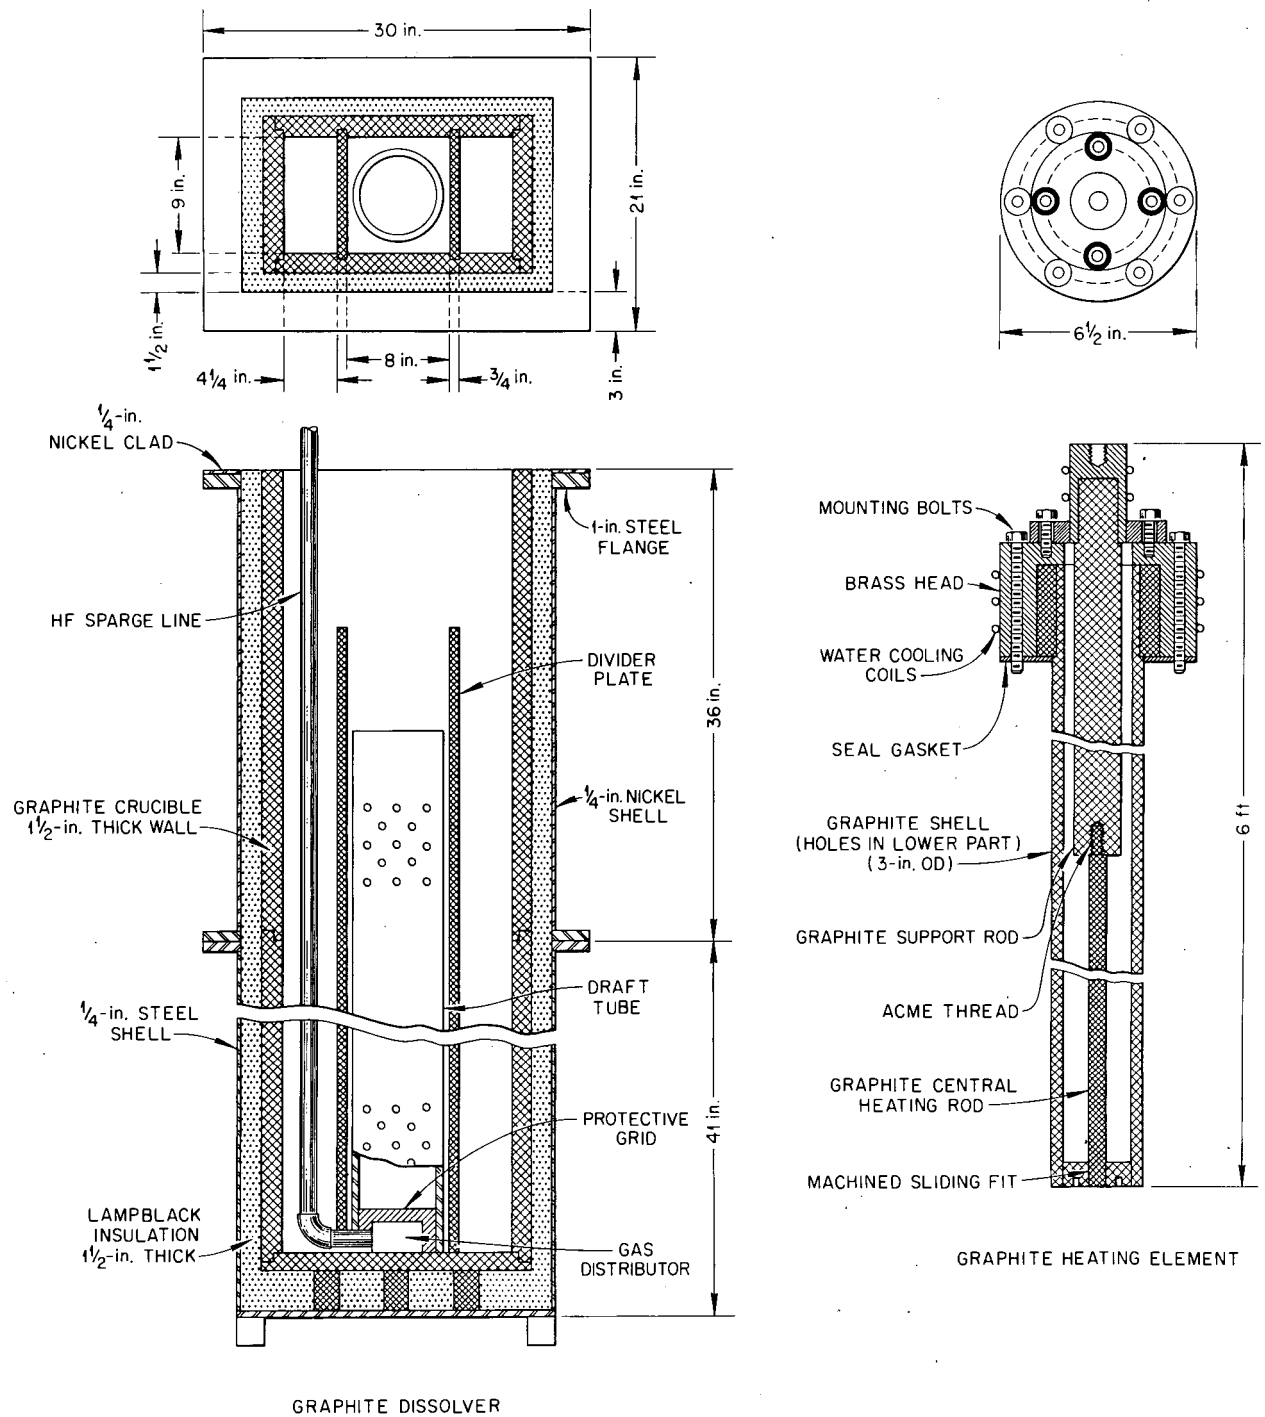
A hydrofluorinator dissolver, fabricated from slabs of graphite and thermally insulated with carbon black, subsequently was installed at ANL for use in demonstration process runs. The vessel was designed so that salt penetrating the graphite or leaking through mating surfaces would freeze and be immobilized. This was accomplished by providing internal electric resistance heaters, thick graphite walls (1.5 in.) and insulation (1.5 in.) so that the outer-wall temperature is below the salt melting point. Cross sections of the graphite dissolver and a heating element are shown in Fig. 35. To date, a number of dissolution runs using simulated fuel elements has been completed. The only reported difficulties with the vessel have been intermittent salt plugging of the slug-charging chute and off-gas lines and replacement of a graphite heater and the salt-transfer line. The latter components cracked during shutdown periods.

Fig. 35. Argonne National Laboratory Graphite Dissolver Vessel and Heating Element. Ref: Chemical Engineering Division Summary Report, January, February, and March, 1958, ANL-5858, p 25.

the ANL hydrofluorinator dissolver, was rejected by ORNL personnel charged with the selection of a material for the Volatility Pilot Plant dissolver vessel. This rejection was based on graphite's poor structural properties and the concern that problems would arise in decontamination and uranium recovery from large porous graphite bodies.
